REPORT

Subject	Report
MV Estonia	4006 4100-2
Bow ramp flooding tests with complete car deck	Project manager
	Björn Allenström
Customer/Contact	Author
VINNOVA	Björn Allenström
Order	Date
VINNOVA Dnr. 2005-02852, proj. No. P27987-1 of 2006-02-24	2007-05-31

This report is a complement to SSPA report 4006 4100-1 that described manoeuvring tests in calm water and in waves as well as flooding tests through the bow ramp mainly carried out in SSPA's manoeuvring and seakeeping basin (MDL). In this report complementary bow ramp flooding tests with the ship model of M/V Estonia equipped with deck No. 2 (main car deck) were carried out in SSPA's towing tank.

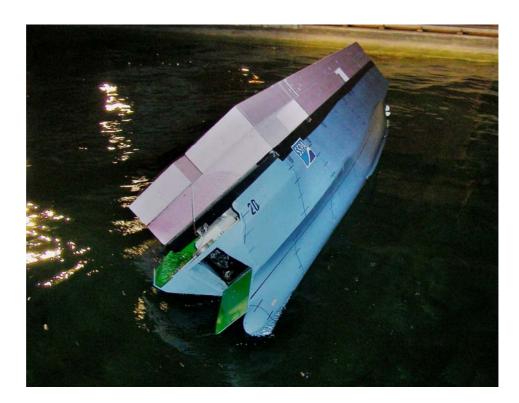
In both test runs a heel angle of about 15 degrees to starboard occurred after just a few seconds after the ramp was opened corresponding to a full scale time of about half a minute. After about one minute full scale time the heel angle was in the order of 25 degrees. The ship model got a final heel angle of about 46-47 degrees after about 3-4 minutes.

Since no more water could enter the ship model and stay there permanently, and the superstructure was intact, the ship model stayed in the 46-47 degree stable heeled position.

Ship model in a stable heeled position
