DISASTER INVESTIGATION

All about the M/V Estonia disaster 1994

A contribution to better ferry safety at sea

© Anders Björkman, 2001 (and updated later), 2009

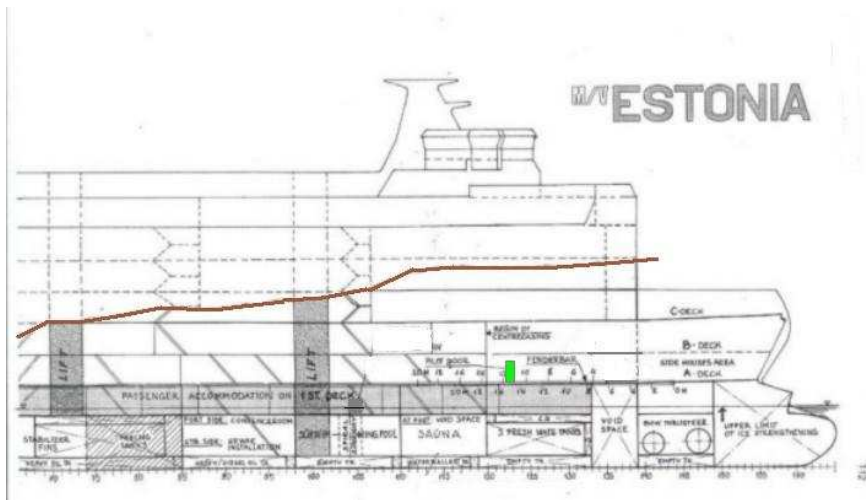
Fig.1.1.5 - Pilot door at fr. 122 starboard side

In this stable but sinking condition with 15 degrees list the starboard side of the superstructure was below water. It seems that the starboard pilot door at about frame 122 in the side was also open at this time, [1.4](#), [1.16](#) and [2.24](#) - the crew was unloading cargo through the door (!?) or it was not properly locked - and that therefore water also started to enter into the superstructure causing further listing.

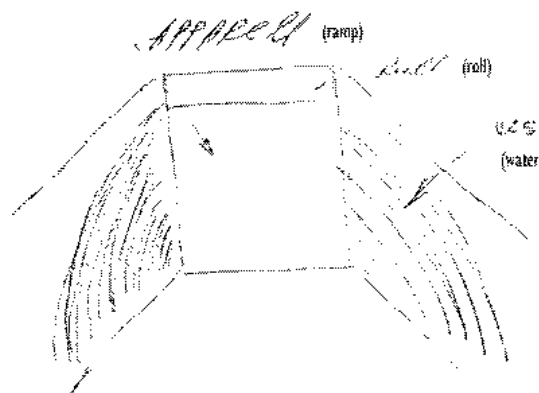
Figure 1.3.2 - The closed ramp at the forward end of the superstructure two minutes after the sudden listing. Fig. 6.1 in (5).

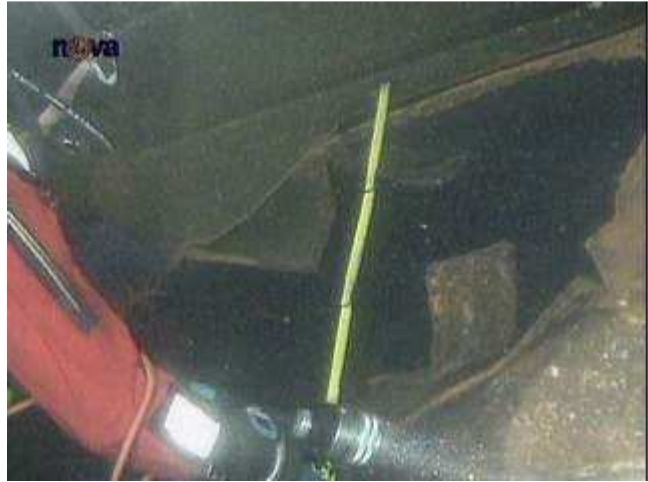
The attachment - as found in the archive in December 2000 - is however only a copy of the sketch of Stenström's alleged attachment (to the fax - act I15), which does not show a visor, with various comments in English - it is the damages in figure 8.1 in the Final Report (5). There is no visor on the sketch. All of the observations are repetitions of observations made on 2 October by the 'Halli' and already reported to the media by the Commission [1.12](#). But the big damage opening in the steel structure - probably due to explosives seen in figure 1.14.1 right is not mentioned. It is just above letter A on the starboard side - filmed at 22.45 hrs - in the sketch (act I16) below - figure 1.14.2. The sketch in act I16 is probably a falsification.

Figure 1.14.1 - The damage that the Commission censored

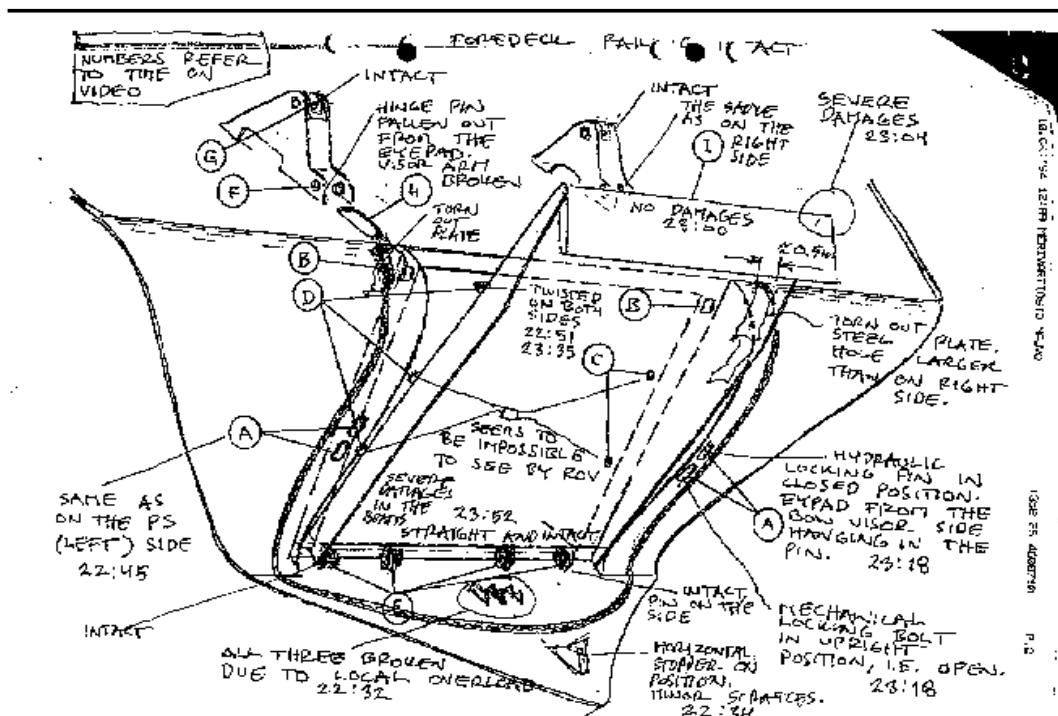
Figure 1.14.2 - Attachment to fax I16

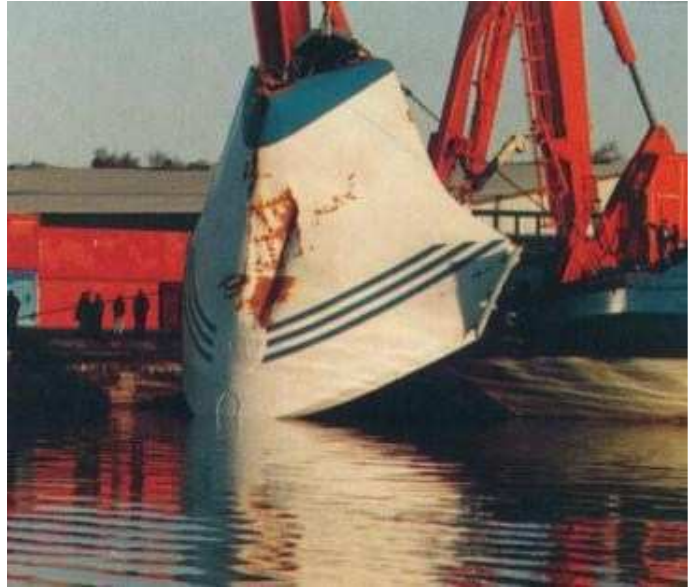
The Commission - which reported to the media mid-November about the salvage - said that the visor, when still attached to the 'Estonia' *before* the sudden listing - the accident - had been lifted by ten meters waves and then crashed down on the fore peak deck, which had been observed by eye witnesses.⁴⁵ The visor was otherwise in perfect condition. The accident was caused by *design fault*. These repetitions of earlier inventions were of course necessary to indoctrinate the public that the visor loss had caused the accident. Note the big indent in the visor in fig. 1.14.4. The Commission suggested it was caused when the visor fell down on the bulbous bow of the 'Estonia'.

Fig 1.14.4 - The 'Estonia' visor after salvage

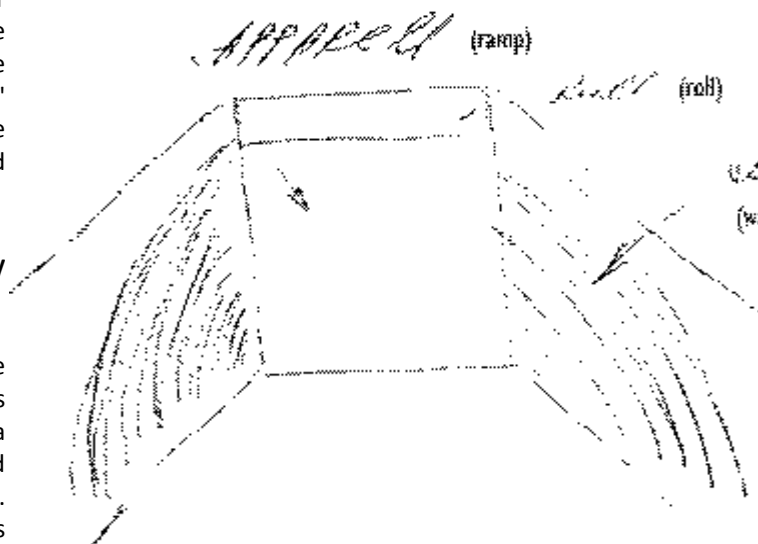
The Final report does not even include proper drawings of the ramp and its locks and hooks. The upper two hooks had a breaking strength of 25-40 tons each and the four side locks about 25 tons each. The Final report states that the ramp was ripped open, but there is no evidence at all for this. When the wreck was filmed early October 1994 the ramp was evidently closed. Not one film shows an open ramp.

Figure 1.30.1 - Figure 6.1 of (5) - Closed ramp at the forward end of the superstructure after listing

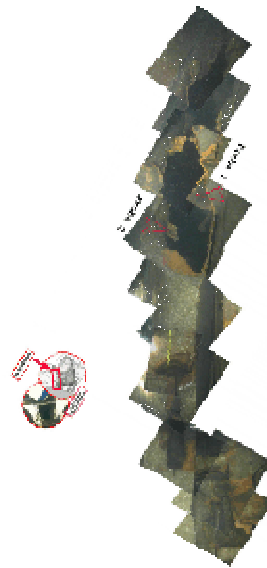
Figure 2.24.1 - The big damage in the superstructure

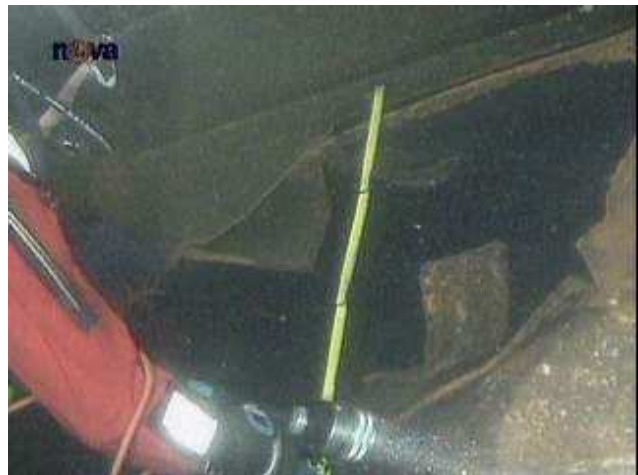
Figure 2.24.3 Diver prepares cutting off test pieces from the damage

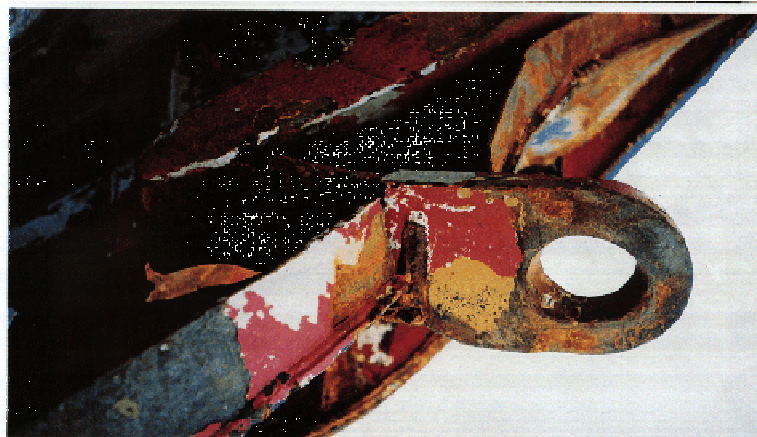
Figure 3.7.3 - Figure 10.5 in (16) Visor lug of the bottom locking device.
Starboard is right in the photo

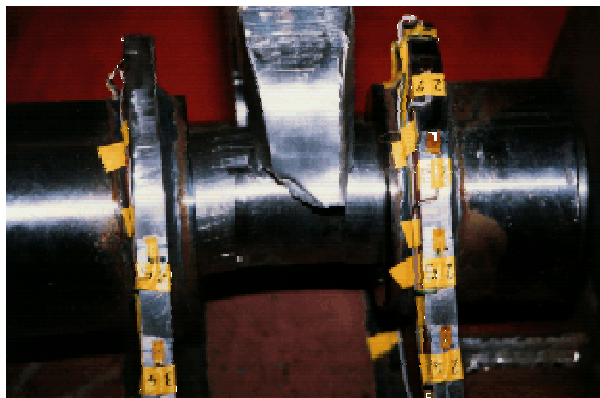
Figure 3.7.4 - close up of broken visor lug and deformed locking bolt

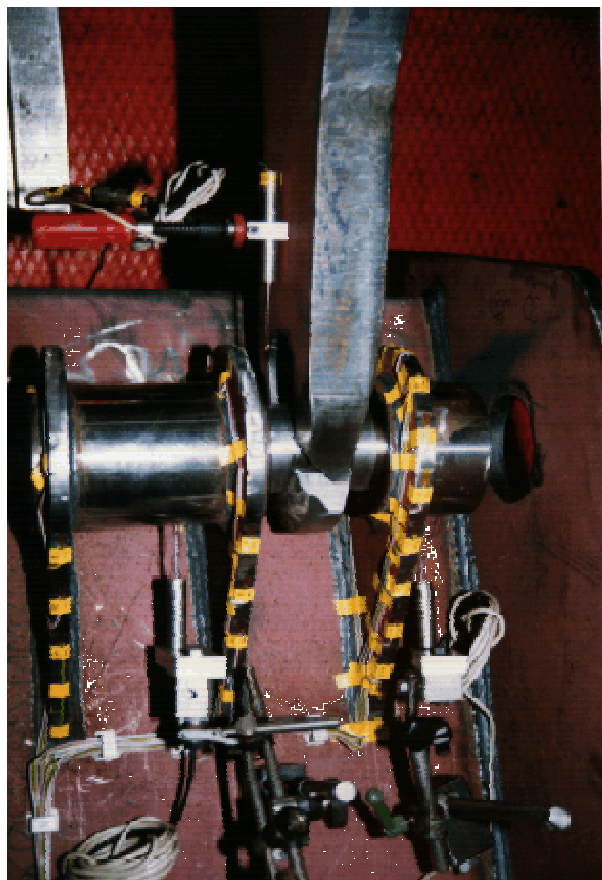
Figure 3.7.5 - the visor lug breaks at 210 tons load

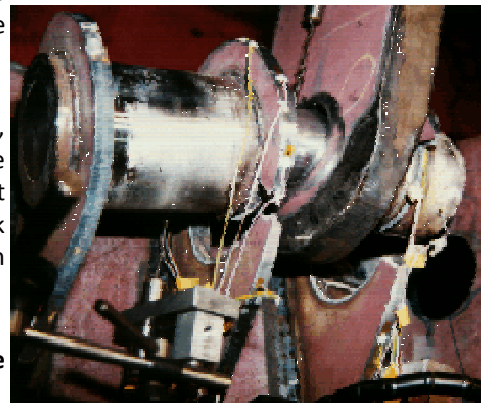
Fig 3.7.7 The Atlantic lock broken - the port lug (left) is bent and not ripped apart!

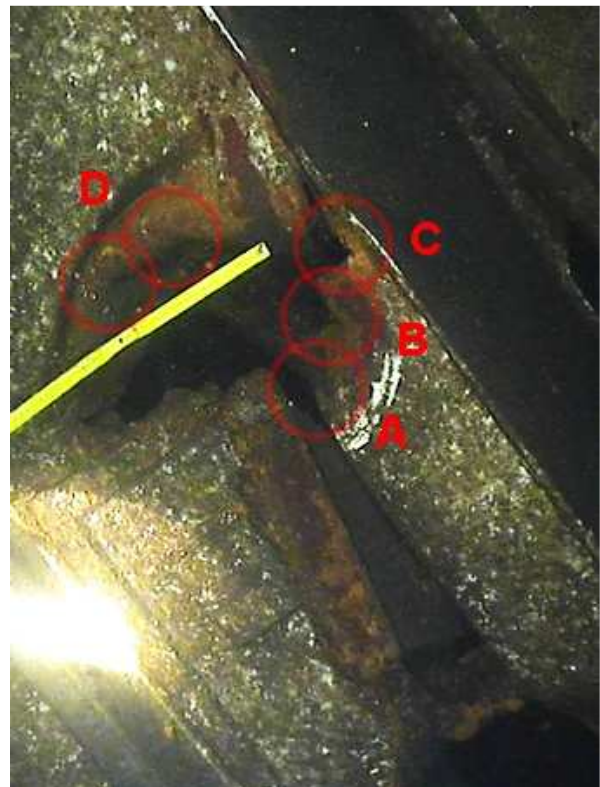
Fig. 3.8.1 - SB side lug in its recess. Recess top severely damaged (Source: International Fact Group)

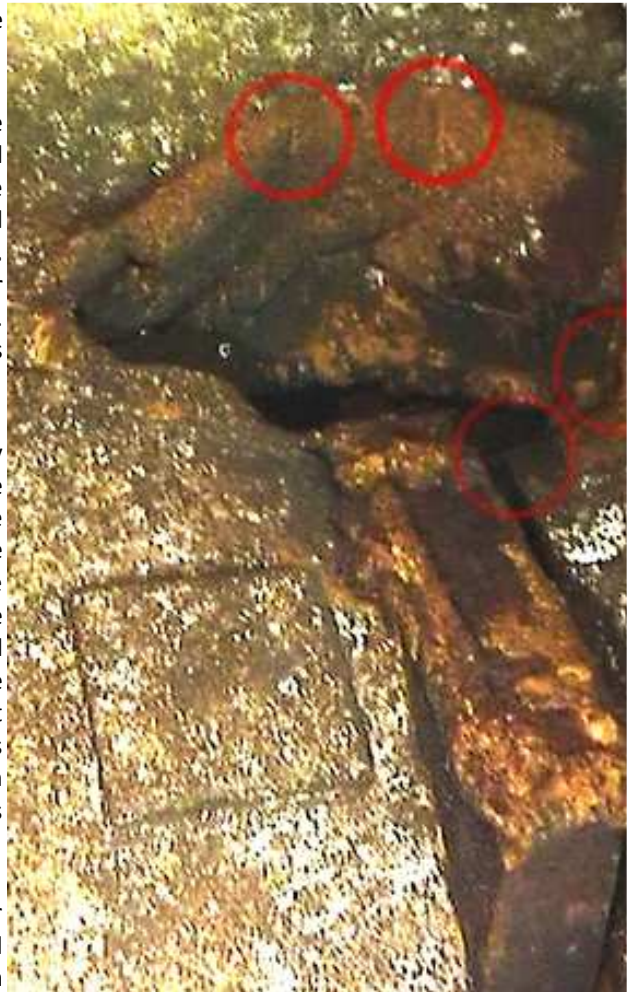
Fig. 3.8.2 - SB side lug in its recess. Recess top severely damaged (Source International Fact Group)

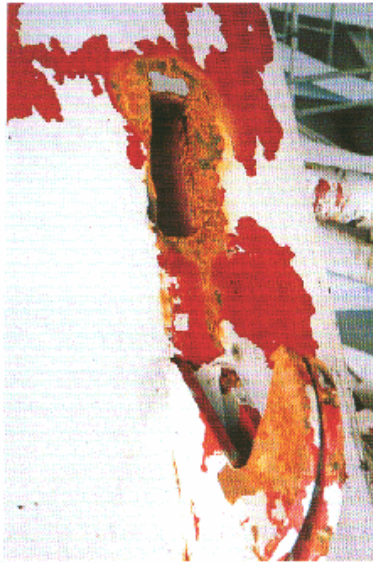
Fig. 8.19 of (5) Damages to port side lock lug. The manual lock hook below.

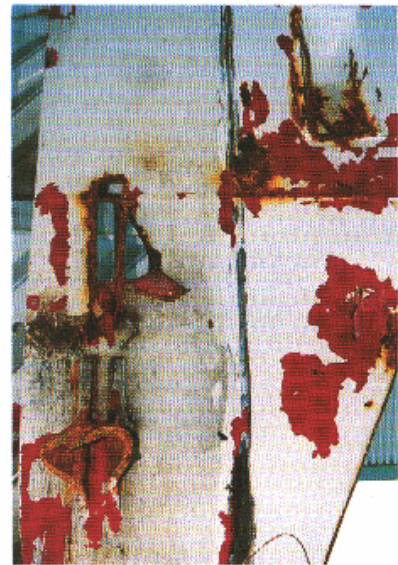
Fig. 8.20 of (5) Damages to starboard lock lug. The manual lock hook - damaged - below.

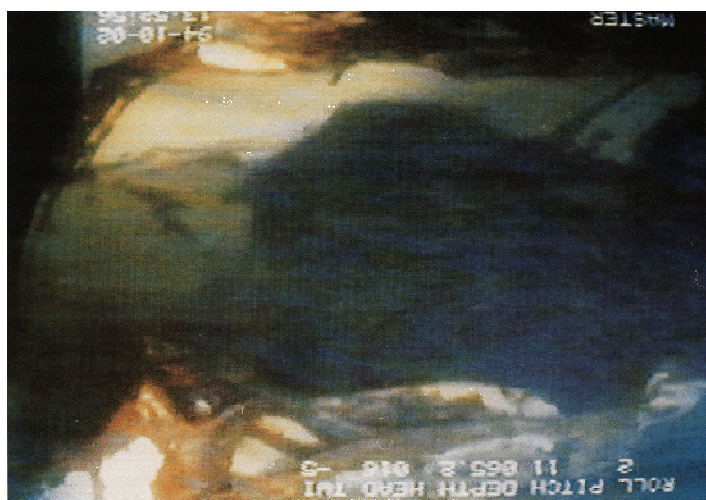
"The (superstructure no. 4 upper) deck was torn open from the visor operating actuator openings and forward (figure 11.4 (see below)). The openings continued for some length down the front bulkhead (figure 11.5 (see below)). The deck damage was extensive, while the openings in the bulkhead had rather clean-cut edges".

FIG 11.4 Skador på däckat orsakat av fästören för visirets hydraulcylinder

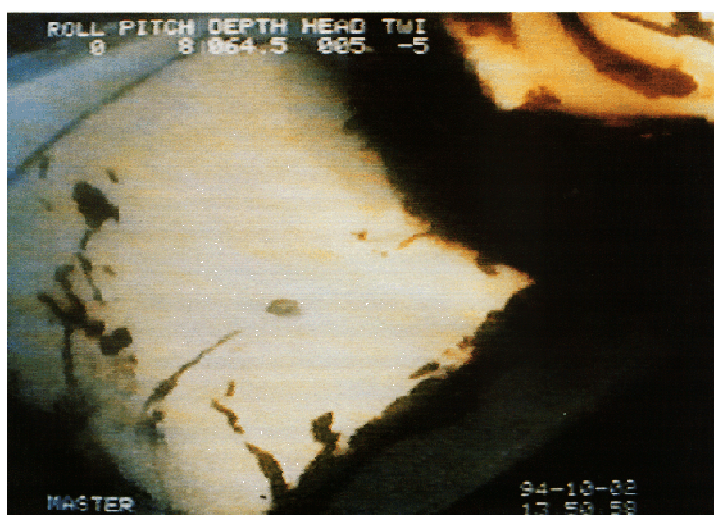
FIG 11.5 Skador på frontskottet orsakat av visirets hydraulcylinder

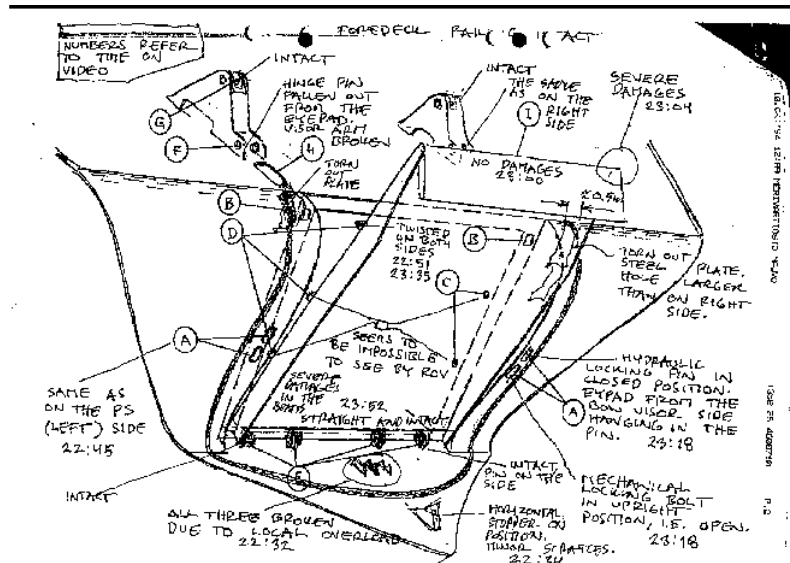
Figure 3.10.5 - Appendix to fax 10 October 1994 - 'Summary of damages at the bow' (act I16)

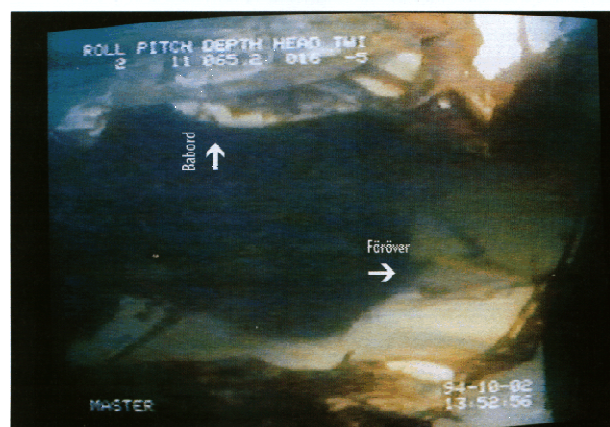
Figure 3.10.6 - Fig.8.2 of the Final Report (5) - 'Damaged deck and front bulkhead in front of the opening for the visor operating actuator on the port side'

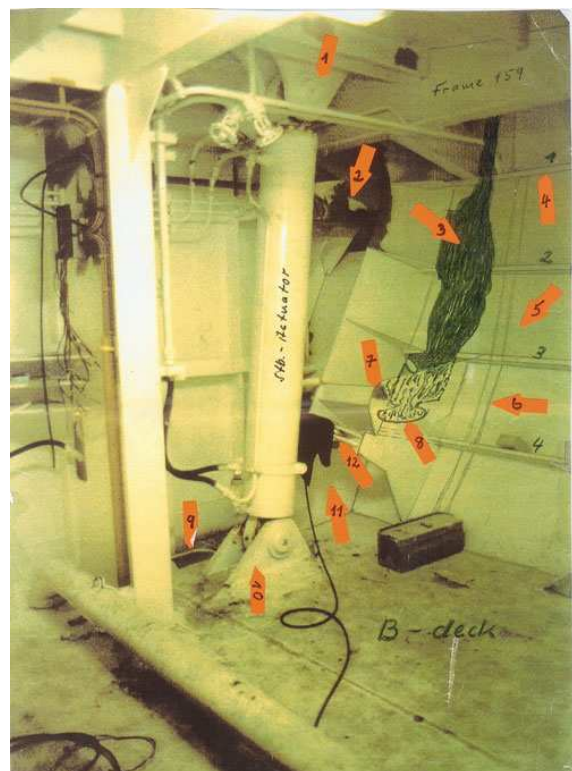
Figure 3.10.7b Starboard front bulkhead with a big damage - seen from inside.

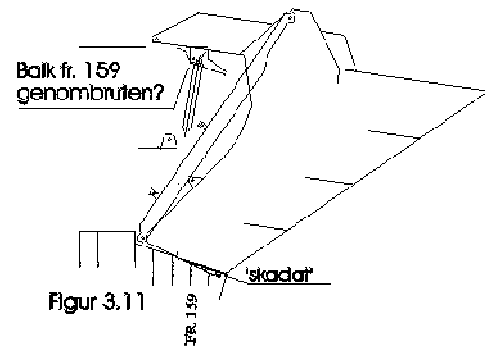
"Deck beam 159 broken, fore peak deck and visor bottom damaged"
