LIES AND TRUTHS ABOUT THE M/V ESTONIA ACCIDENT

Anders Björkman ©

January 1998

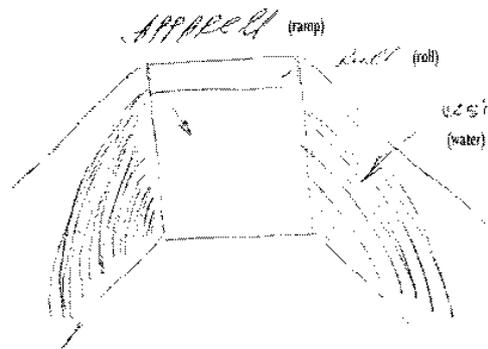
Note August 2000 - in fact the systems engineer had already told the Commission on 28 September 1994 that the ship was leaking, that the bilge pumps were running and that the sudden listing occurred when the car deck forward ramp was still in place (as seen on the supervision monitor at least two minutes after the listing).

Much later he provided the sketch right of what he saw at least two minutes after the sudden listing, i.e. a closed but leaking ramp.

You wonder of course if he really saw what he has sketched - at the time the ship was listing about 15° and, according to other info, trucks and lorries were parked inside the ramp, so that you could only see the tops (roofs) of the trucks on the monitor and not the ramp itself.

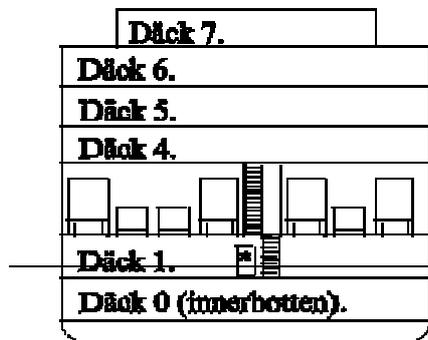
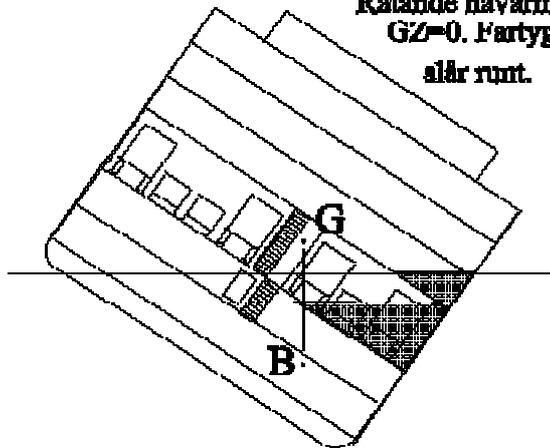
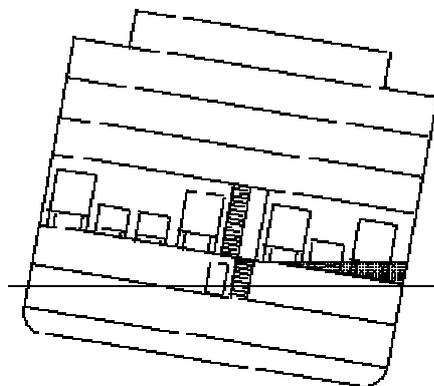
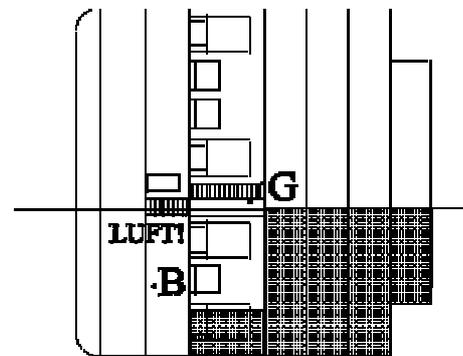
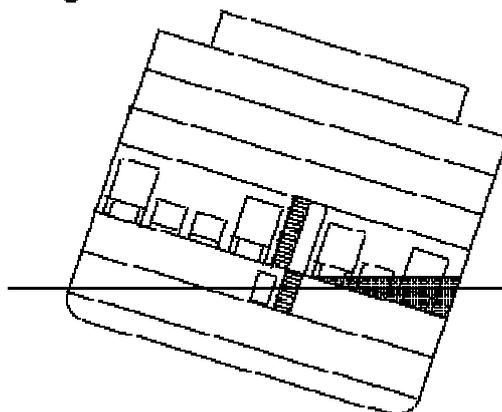
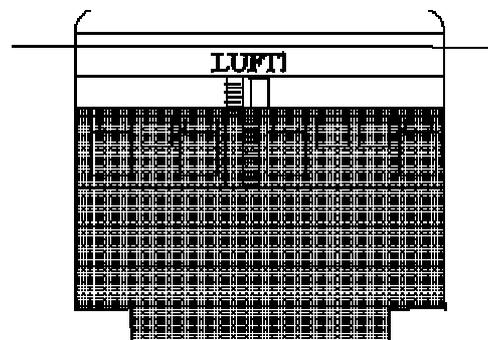
Figur 2.16.1. Vatten på bildäck. 1D. 2000 ton vatten på bildäck, nu under krängd vattenlinje. 34° krängning. Vatten på däck 4 och 5. Däck 1 är torrt. Rätande hävarm $GZ=0$. Fartyget slår runt.

If water leaks into the car deck of the *superstructure* (figure 2.16.1), the vessel heels about 10° with 600 000 litres on the deck. Fig. 2.16.1B. This water does not flow down to deck no. 1 inside the *hull*, as the door openings are at the centreline and fitted with 20 cms high sills. The water is always trapped on the side of the sloping deck.

(Translation of Swedish text in figure 2.16.1 above - Water on car deck. 1A. Initial position. 1B. 600 tons of water on the car deck above the heeled waterline. No water flows down to deck 1. 1C. 1 200 tons of water on the car deck, which is still above the heeled waterline. 20° list. 1D. 2 000 tons of water on the car deck, now below the heeled waterline. 34° list. Water on decks 4 and 5. Righting lever $GZ=0$. The ship turns upside down. 1E. 90° list at instable capsizing. The ship turns upside down in seconds. Centre of gravity G outside centre of buoyancy B! 1F. Final condition. Ship floats upside down on the undamaged, tight hull).

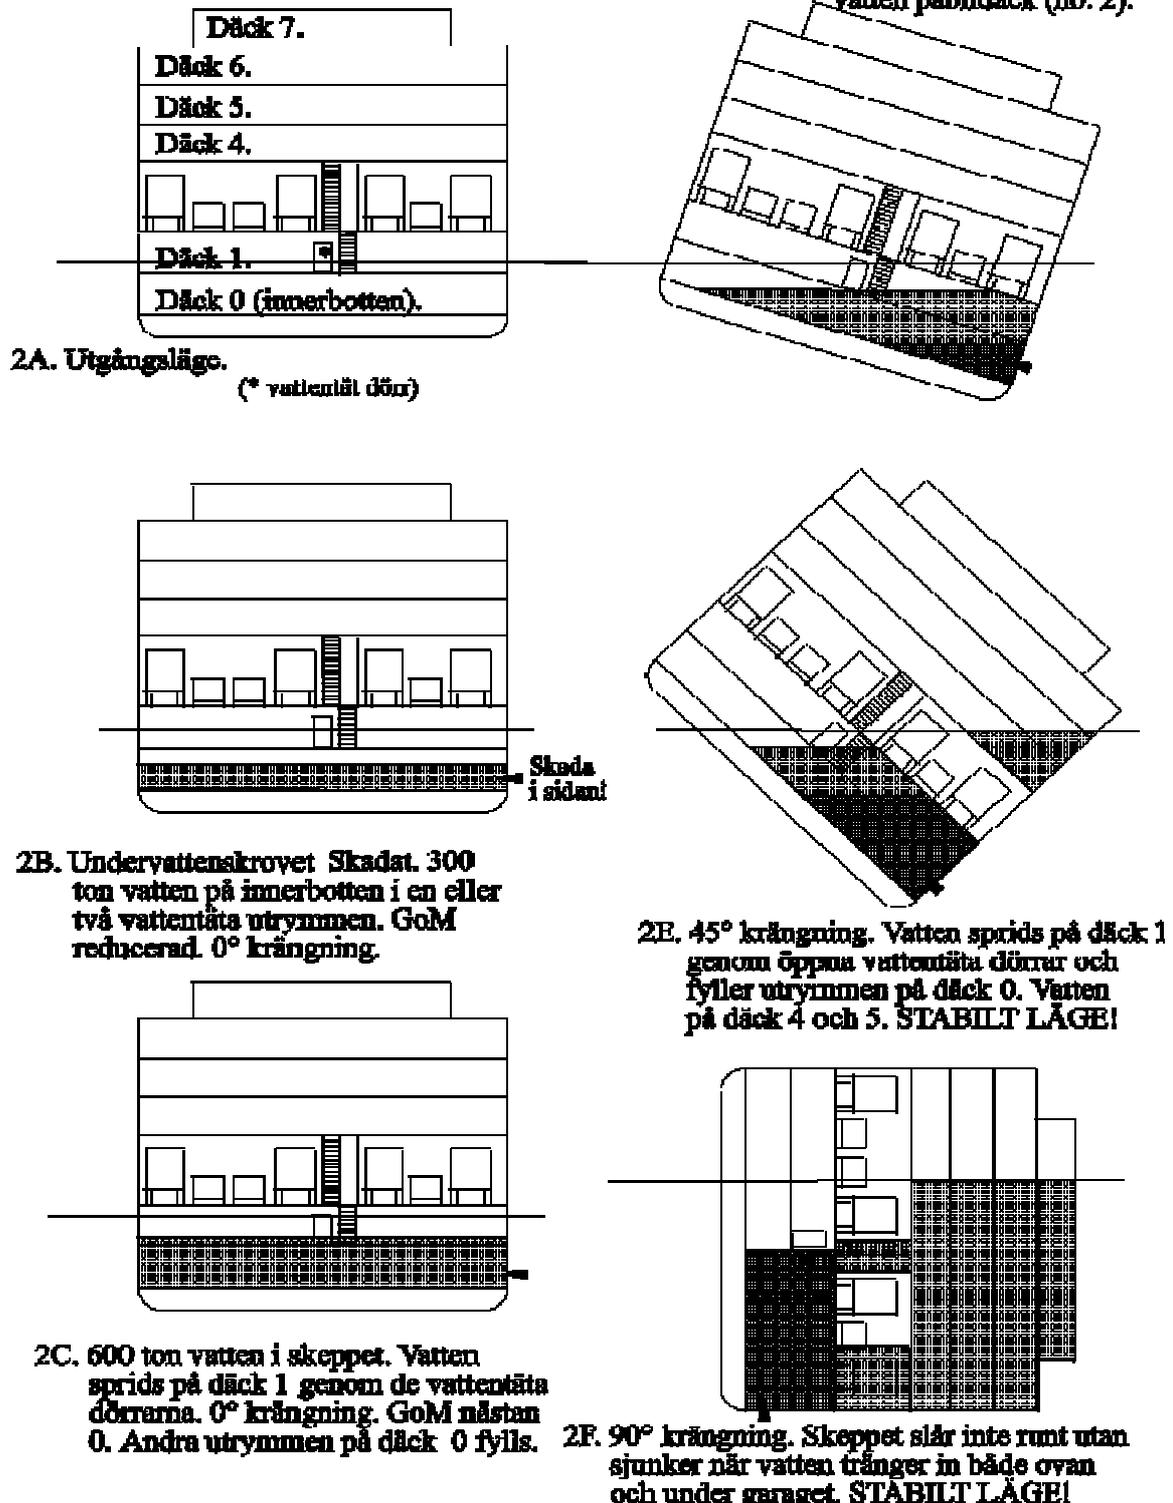
Fig. 2.16.2 Vatten under bildäck. 2D. Skeppet har krängt 15° (GoM <0) till nytt jämviktaläge där fria vätske- ytor är mindre (GoM >0). Inget vatten på bildäck (no. 2).

If a watertight compartment in the hull below deck no. 1 below the car deck of 'Estonia' is flooded (figure 2.16.2) with abt. 1 000 tons of water the stability, the metacentric height GoM, is reduced by 0.8 meter due to free water surfaces (loss of inertia to prevent the vessel to list). If two compartments are flooded (fig. 2.16.2B) the metacentric height is reduced 1.6 meters and there remains only 0.5 meter of GoM. It means that the ship is still stable, but that she rolls slower. This is the rule requirement. Ships shall survive with two flooded compartments of the hull.

(Translation of Swedish text in figure 2.16.2 above - Water below car deck. 2A. Initial position. 2B. Underwater hull damaged. 300 tons of water in one or two compartments. GoM reduced. 0° heel. 2C. 600 tons of water in the ship. Water spreads through open watertight doors. GoM almost 0. Other compartments on deck 0 flooded. 2D. Ship has heeled (GoM<0) 15° to a new equilibrium (GoM>0), where free water surface effects are smaller. No water on the car deck. 2E. 45° list. Water spreads through open watertight doors and fills compartments on deck 0. Water on deck 4 and 5. Stable condition! 2F. 90° list. The ship does not capsize, when water enters both below and above the car deck. STABLE CONDITION!).

If three compartments are flooded (>2 200 tons) the initial stability becomes negative and the ship may suddenly list 50°. But because it is only 2 200 tons of water in the *hull*, it becomes stable again, when it has listed a certain angle - fig. 2.16.2D, because the free water surfaces are reduced by the heeling, when the water is pushed up against the watertight car deck. Open watertight doors are temporarily 'on the dry' and no water spreads. Also the righting lever (GZ) is positive at larger angles of heel.

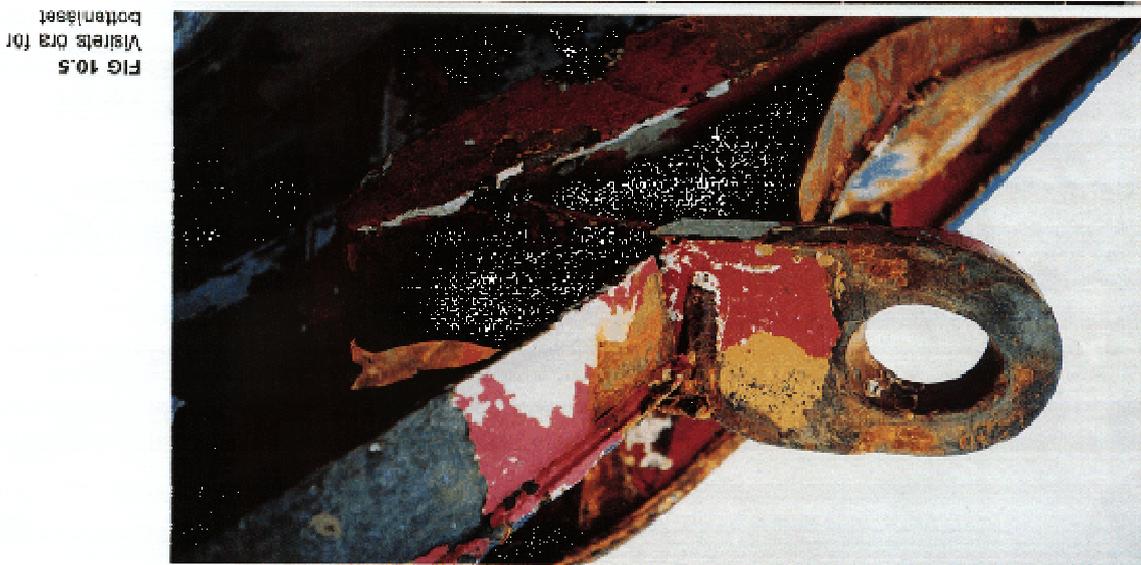
The visor lug was bent to starboard (see figure 8.10 in the Final Report (13) and [4.10] or fig. 10.5 from the Part Report below) and its connection to the lower support girder was damaged:-

the support girder web and face plate were buckled on starboard side and were fractured on port side.

JAIC has never commented upon the visor lug damages. If, as alleged by JAIC, the visor was damaged by an excessive vertical slamming load, it would have pulled out the lug from the lock without bending the lug (and without buckling and fracturing the lug support girder web and face plates) [Appendix].

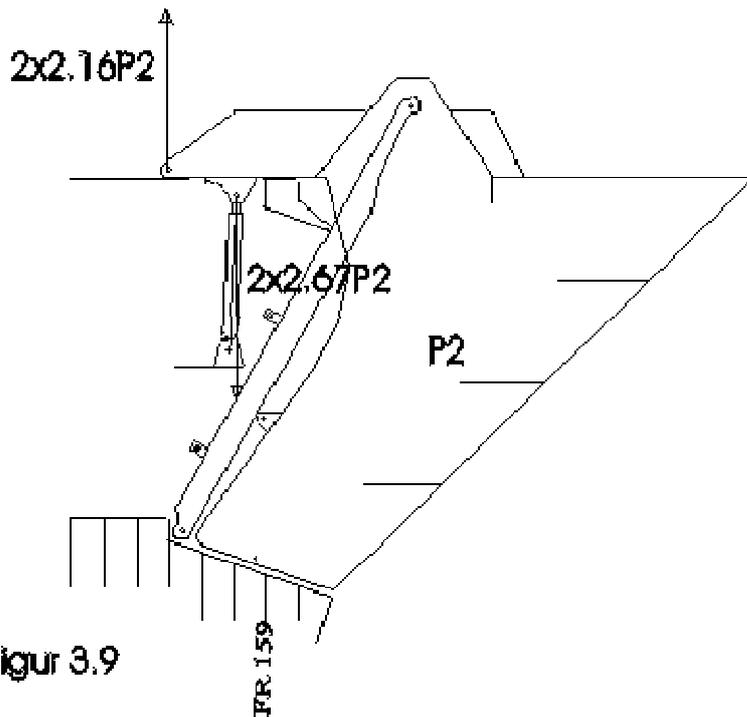
Figur 3.9

Say that the upward load was P2 (including the visor weight). The load P2 causes a tensile force $2.67 \cdot P2$ in each hydraulic piston and a compressive load of $2.16 \cdot P2$ in each hinge. See figure 3.9 below. JAIC assumes that the compressive load $2.16 \cdot P2$ was enough to break a hinge and that the tensile load $2.67 \cdot P2$ was enough to rip off a piston from its support. Nobody heard when the pistons' supports were ripped away and when the hinges broke.

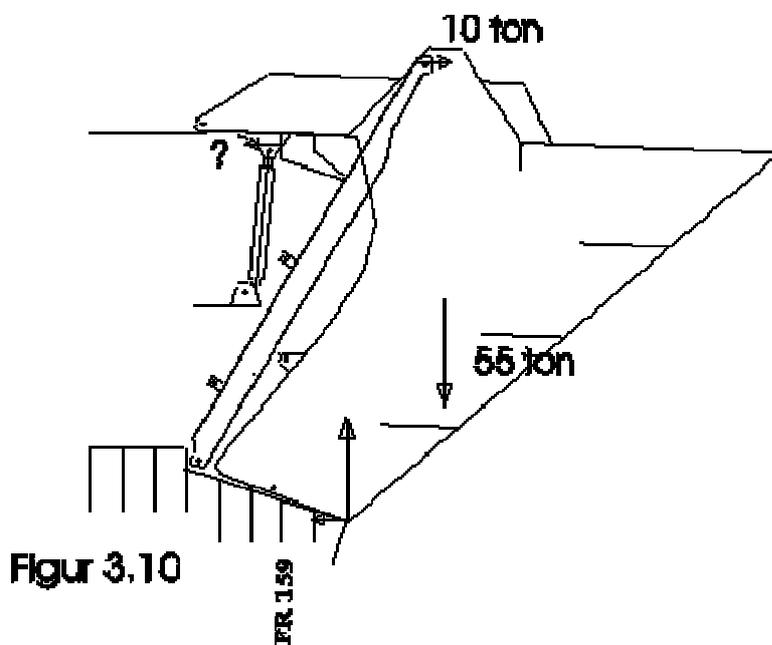
Figur 3.10

If the visor was loose as shown above, it would probably move forward and rest on the ramp, which protrudes up into a recess built on top of the visor. See figure 3.10. Actually the bottom of the visor would rest on the extension of the car deck - the fore peak deck - forward of the ramp, the top aft end of the ramp recess on top of the visor would rest against the top of the ramp and the lifting pistons would rest against the deck beam at fr. 159. If a wave load exceeding the weight of the visor was acting on the visor, it would lift the visor up on the focsle deck aft of the visor! This did not happen. As can be seen from the geometry of the arrangement the hydraulic lifting pistons upper eyes must eat through the deck beam at frame 159, before the visor recess starts to touch the ramp top, and nobody heard this.

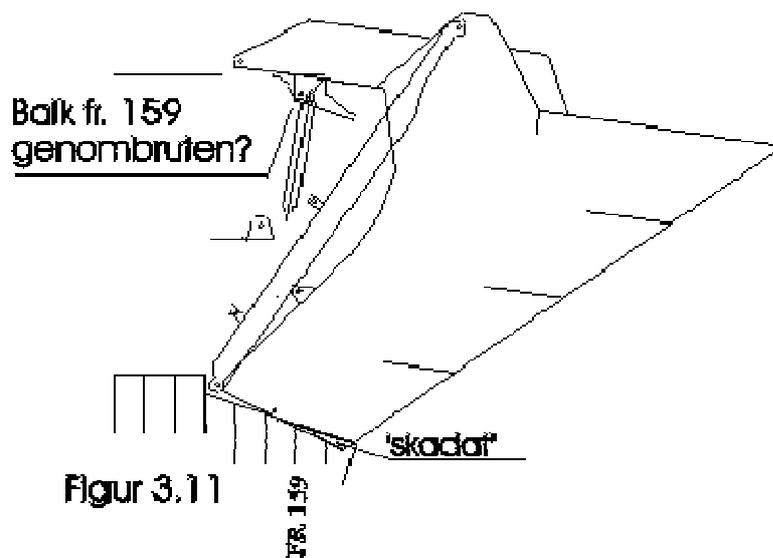
After the ramp had been dislodged from its locks, JAIC alleges that the ramp shifted forward to a partly open position and little water flowed in. See figure 3.11. The time for this alleged event is at 01.15 hrs, when it was observed by 3/E Treu on the VDU of the garage in the ECR [1.9], but when it was not reported by the engine crew to the bridge [4.23].

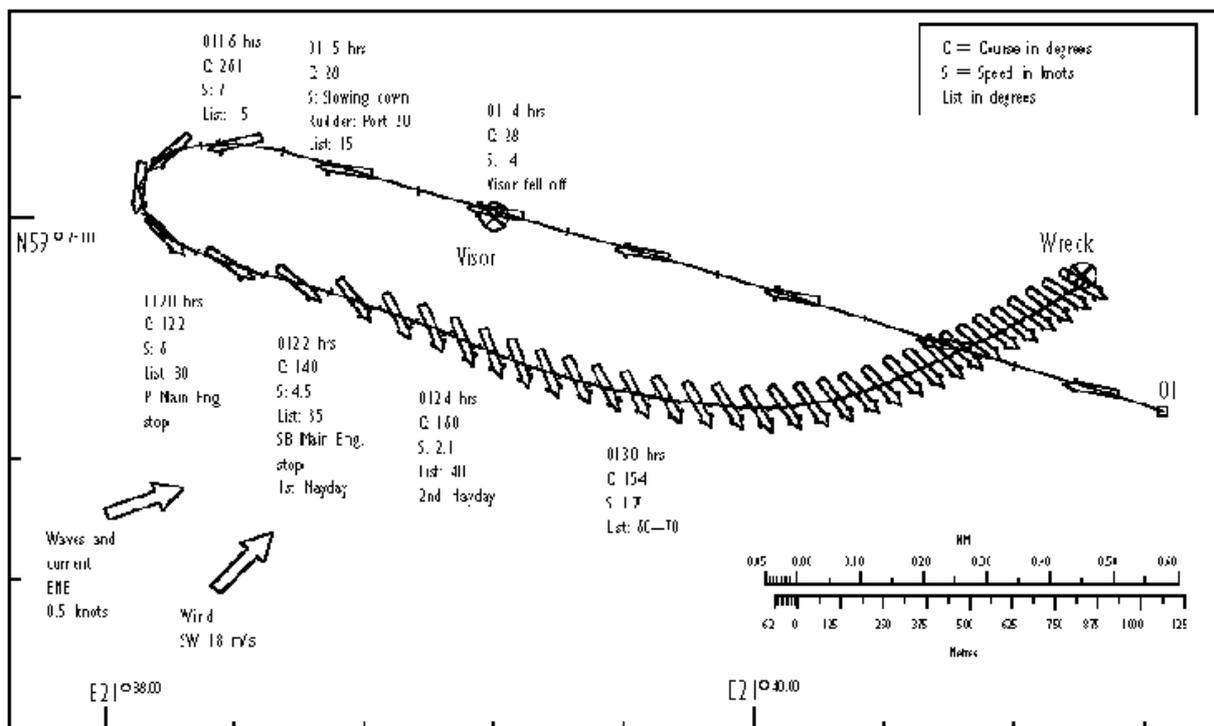
In Figure FR13.2 of the Final Report the JAIC's course of events is illustrated [2.23].

In the figure the visor falls off at 01.14 hrs and between 01.16 hrs and 01.20 hrs the vessel turns sharply 180°, when the speed drops to 6 knots, and sails back to Tallinn on course 107° for ten minutes (but with a starboard yaw of 40-50°, so that the heading (course) is 122-160°. Then she drifts. The figure FR13.2 assumes that the wave direction is ENE (247.5°), while Table FR5.4 says it could as well have been NNE (216°), a difference of 30°. The angle of heel is increasing all the time. The various data in Figure FR13.2 is listed in the table:-

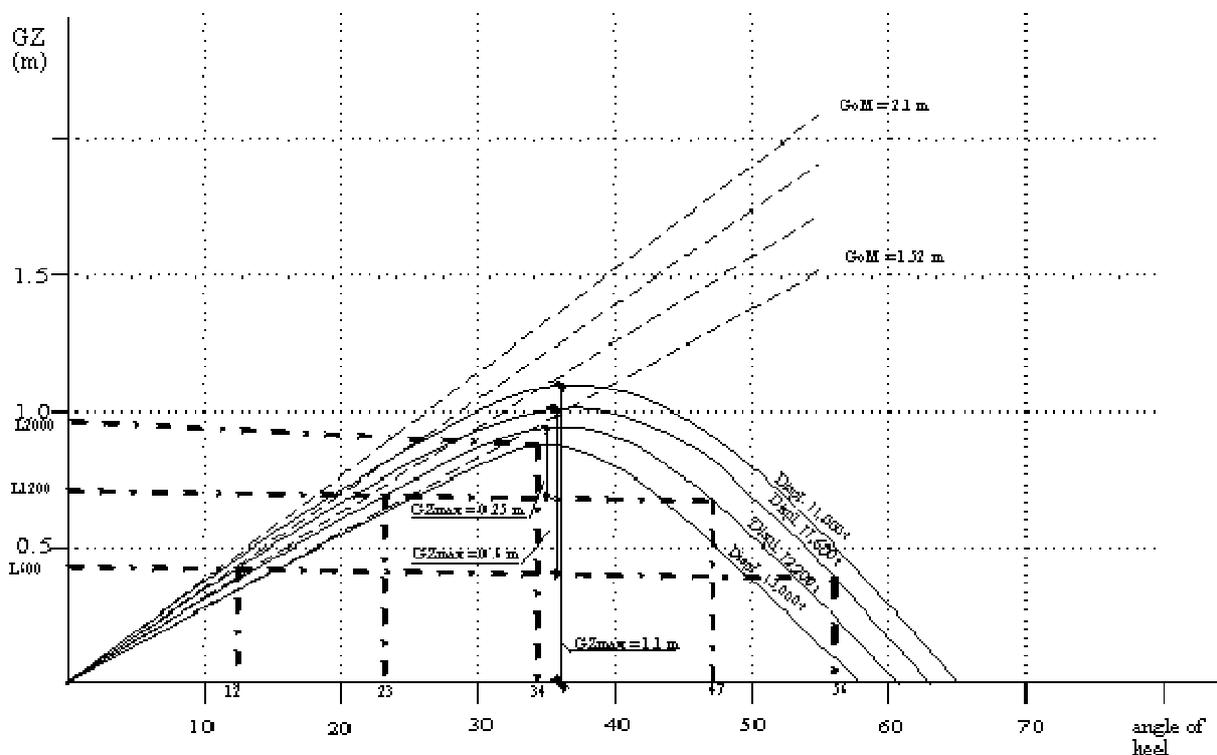
Fig. 5.5 - M.V. 'ESTONIA' Assumed GZ curves for displacements 11,000 - 13,000 tonnes

In figure 5.5 (below) is shown the assumed GZ (j) curves for the 'Estonia' at displacements, D, 11 000, 11 600, 12 200 and 13 000 tons (j = angle of heel). Water on a ro-ro (bulkhead) deck inside the superstructure is an **intact stability** matter (as the underwater hull is undamaged) - you only 'load' extra cargo (water!) on the side of the ro-ro deck in the *superstructure*. The only unusual thing is that the displacement (D), draft (d), angle of heel (j), etc. increase, when water is loaded (trapped) on the side of the ro-ro deck in the superstructure.

With no water in the superstructure, Displ = 11 000 t, the stability was very good, for example GZmax was about 1,1 meter and the range of positive GZ was 65°. Intact stability GoM was 2,1 m.

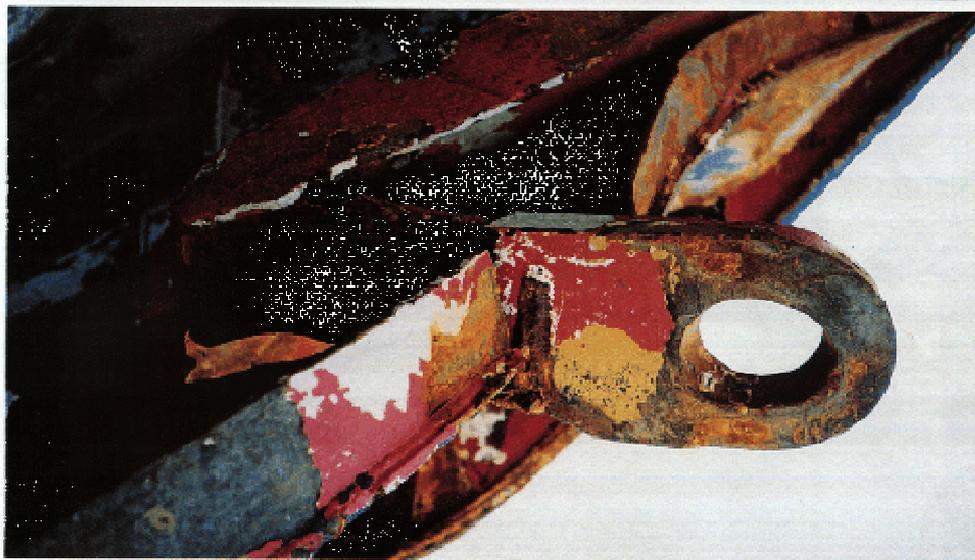
FIG 10.5
Visor lug from
bottom view

The damaged lug is bent 15-20° to starboard and is twisted say 5-8° around itself - lower part to port, upper part to starboard. The starboard face flat on the horizontal lowermost web is buckled - to aft at the lug and forward further to starboard, i.e. the starboard web plate itself is buckled, but is still welded to the lug. The port face flat on the web is fractured in the welding to the lug (and the lug is pushed down (or the web plate up) ca 10-15 mm). The port web plate has also fractured (you can see the opening on the photo above behind the port face flat) and the lug itself is probably fractured where it is welded to the web plate. The web plate is also fractured at a distance beside on the port side and forward of the lug.

The damages can be explained by an impact load from starboard (when 'Estonia' hits the wave surface at >34° list). The lug is pushed against the bolt housing on port side and the lug is bent to starboard, and the starboard web plate and face flat are buckled, and the port web plate and face flat are fractured. The visor rotates against the ship, when the other connections are ripped apart, which explains the other damages on the lug and its connection to the web. It should be clear that the damages are not a result of a tensile force pulling the visor out from the hull as proposed by the JAIC one day before finding the visor [1.7]. Then the lug eye would have pulled open (the weakest part of the whole lock assembly). The JAIC suggested already 4 October 1994 that the lock had been pulled open (as the fore peak deck assembly on the wreck appeared damaged - the above damages on the visor itself were not even known or analyzed until the visor was salvaged mid-November 1994. The drawings of the lock assembly were not available for study by the JAIC in October 1994.

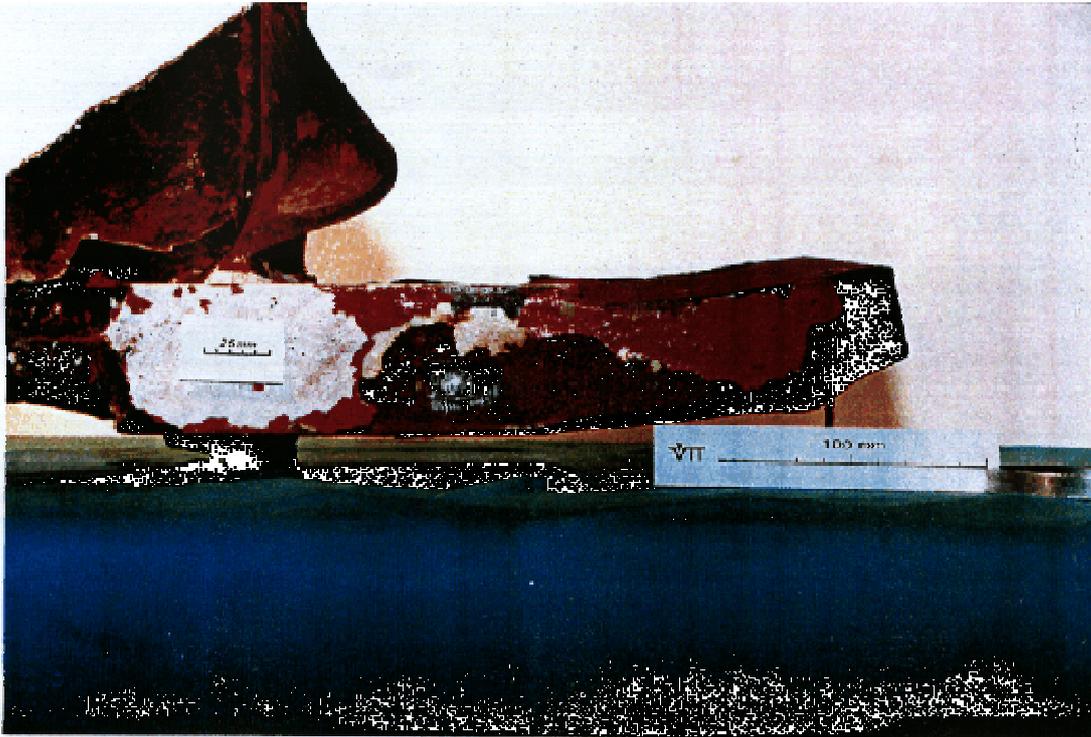
Figure 14. Top view of Atlantic lock visor lug after removal from visor. Lug aft end bent to starboard, bending of stem is very small and practically undetectable.

It is clear that the lug is still welded to the buckled starboard side face flat of the bottom web plate, which is also buckled. Supplement no. 511 notes that: "The aft end of the lug is bent to starboard and the surrounding base plating of the visor has fractured on port and has buckled at starboard. This suggests that a fairly high starboard facing load in the bottom part of the visor has acted sometimes and apparently during the accident. Such a situation could have developed if a clockwise twisting rotation around the ships longitudinal axis of the visor occurred due to lifting action at the port side. Contact marks in the bottom locating horn recess on starboard suggest that the lower portion of the visor has been forced to port at some stage of the sequence of events. The resulting and remaining total sideways displacement of the aft end of the lug is on the order of 10 cm."
