DISASTER INVESTIGATION

All about the M/V Estonia disaster 1994

A contribution to better ferry safety at sea

© Anders Björkman, 2001 (and updated later), 2009

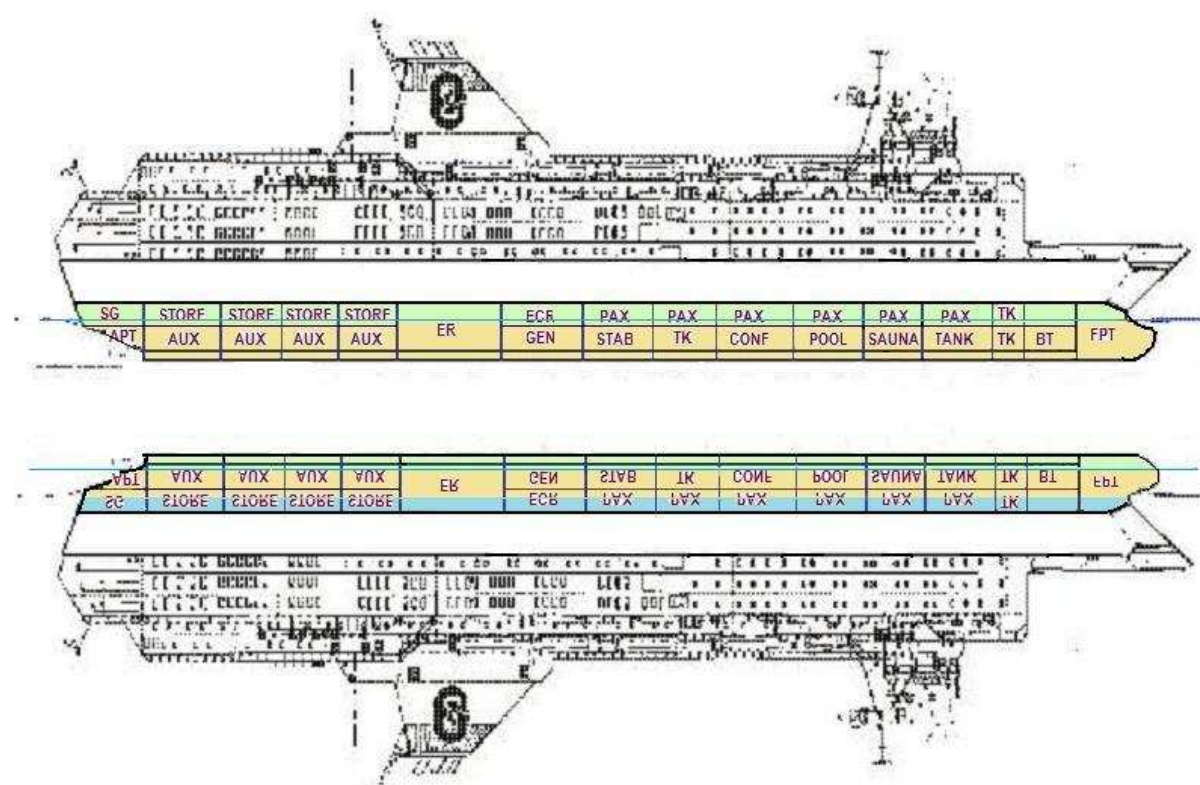
No details or calculations (!) are available in any reports about the capsized *floating* condition at 01.30 hrs and why/how it changed in the next 20 minutes permitting *sinking*! As seen in below (simple) figures the M/S Estonia, *prior capsize*, floated normally on/displaced 11 930 m³ buoyancy in the hull (10 666 m³ air, 1 264 m³ solids, permeability 0.894, in 14 watertight compartments) according Archimedes with 6 886 m³ volume *above* waterline but *below* the watertight main deck (6 156 m³ air and 730 m³ solids, permeability 0.894) *reserve buoyancy*. Total hull volume is 18 816 m³. Everybody agrees to that.

In fig 1. below Estonia (full scale) floats in the **water**. Her **displacement**, i.e. the volume of water below water line pushed aside by the hull, is abt. 11 930 m³ (10 666 m³ air, 1 264 m³ solids in **14** watertight compartments) and she has abt. 6 886 m³ (6 156 m³ air, 730 m³ solids) **reserve buoyancy** between waterline (WL) and main

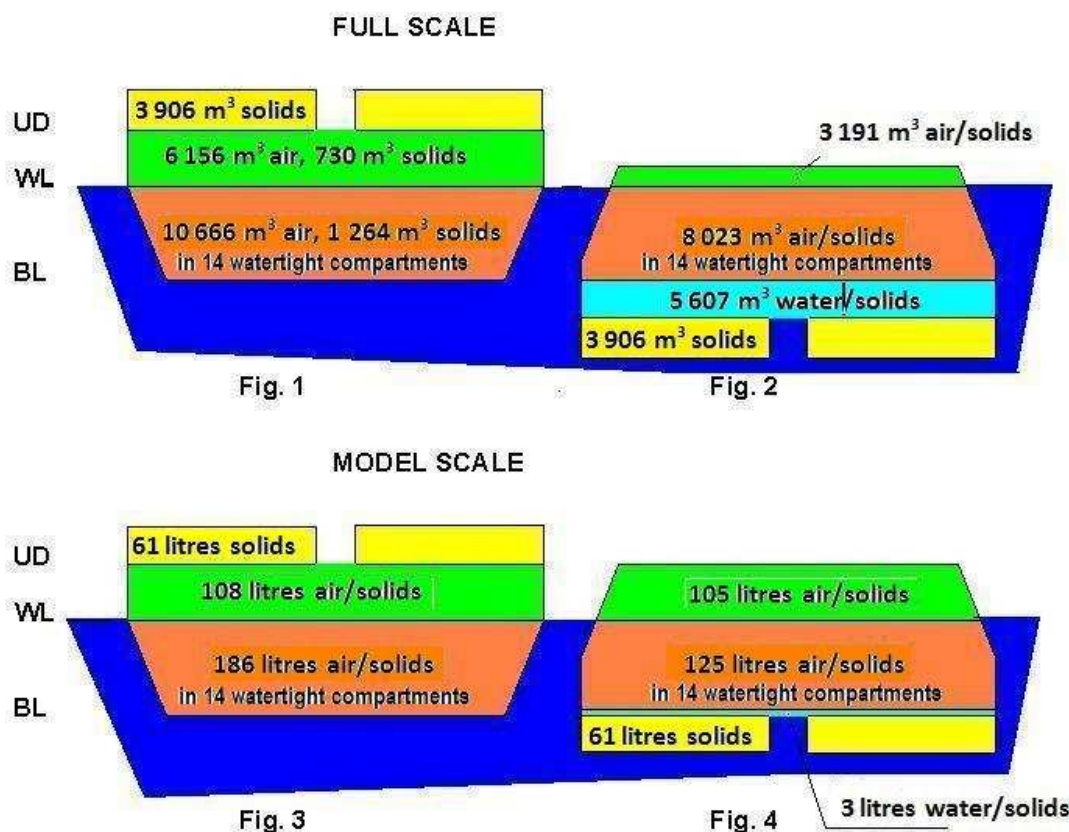
When Estonia has capsized, fig. 2, she floats upside down due to buoyancy of solid material now below water + air trapped inside the hull. The air in the hull is compressed due to external water pressure at a new equilibrium. The bottom of the compressed air bubble in every watertight compartment is say 5 metres below waterline and the air has been compressed to abt. $11\,215\text{ m}^3$ at abt. 1.5 bar.

As you still need $11\,930\text{ m}^3$ **buoyancy** to float on and you have $3\,906\text{ m}^3$ in superstructure and deckhouse + $11\,215\text{ m}^3$ compressed air at 1.5 bar in the hull, there is abt. $3\,191\text{ m}^3$ volume of the hull that remains above waterline. That's where the **reserve buoyancy** ended up. Estonia thus floats upside down with >2 metres of the hull above waterline, WL. $5\,607\text{ m}^3$ of original air volume in the hull is replaced by **sea water**.

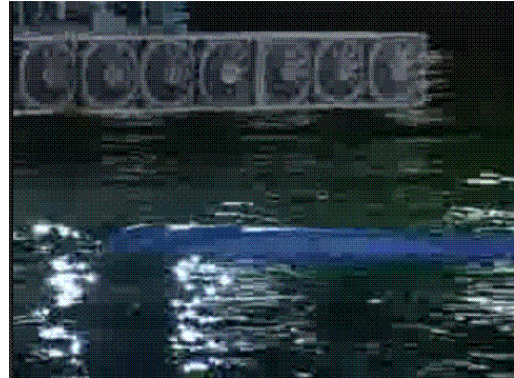
Fig. 5 - SSPA model of Estonia floats after capsizes!

"A number of tests were carried out where the model capsized, trapped air and remained floating upside down. The volume of this trapped air was measured, and a mean value was found to be around 40 litres (2 560 m³ full-scale) . Also the pressure of the trapped air was measured. The scaling laws give for the present situation that about 20% of the trapped air should be evacuated to give a proper remaining amount of trapped air in the model, see Appendix 1. In this case around 8 litres (512 m³ full-scale) could be let out in order to fulfil the scale laws. The two valves in the bottom of the model were calibrated giving a flow of 6.7 litres (429 m³ full-scale) each per minute at the actual pressure. This means that one valve could be held open a little more than 1 minute during the test."

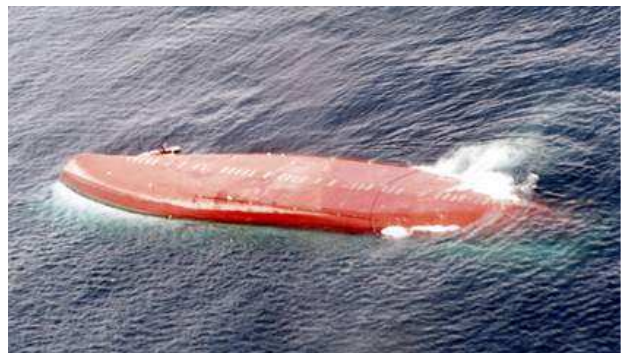
The author is working with ferries for 30 years - and with the *safety* of ferries. Evidently - if, say, 2 000 tons of water had come into the *superstructure* 2.5 meters above waterline, the ferry would have capsized immediately - and floated upside down – figure P1.

Figure P1 – Floating capsized ferry

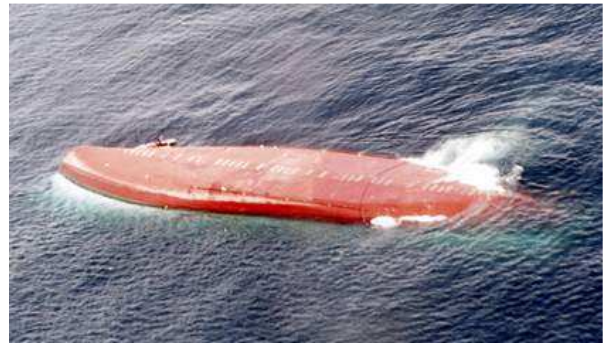
The Final report (5) investigates only *one* cause for the sudden listing - **water on top of the car deck inside the superstructure** - and states erroneously that the 'Estonia' then sinks slowly during 30 minutes instead of capsizes immediately, when the angle of list is 40 degrees to float upside down, [1.9](#) and [1.15](#), on the undamaged, watertight **hull** - fig. 1.1.1.

Figure 1.1.1 – Capsized, floating ferry

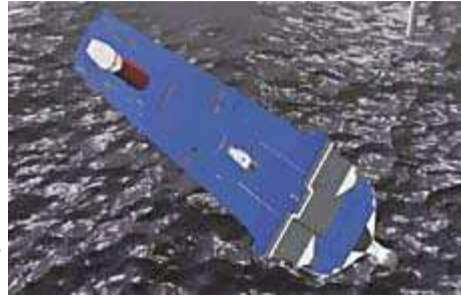
If the 'Estonia', with unchanged speed (>14 knots) and course forward during only *one* minute, had lost its visor and, if the ramp had been pulled fully open, then big waves would have filled up the car deck in the *superstructure* every fifth or sixth second [Appendix 4](#) due to pitching. Each wave added at least about 180 tons of water, which was pushed inside on the car deck with a velocity of about 7 m/s. The whole ramp opening (30 m²) would be filled up, three, four meters above the car deck, when the bow was down into the wave; all cargo (trucks and cars) should have been pushed aft, light fittings and TV cameras for monitoring would have been torn away and persons on the car deck would have been smashed to pieces by the water.

Fig.1.1.2 - 'Estonia' after 1 minute

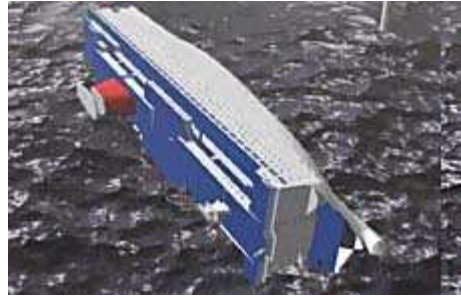
The immediate damage would have been enormous. The waves straight into the car deck superstructure space would have caused an enormous noise - it would have been like the ship colliding with a wall. When the waves were stopped by the cargo on the deck, the water would spread on top of the deck inside the superstructure, but it is probable that the ferry would trim on the bow, stop and list *immediately* already after only five, six waves - in less than a minute. The ferry would have lost its propulsive power already at 30 degrees list (after five waves), would have been impossible to control and would have stopped. A ship naturally cannot sail at 14 knots with an open bow ramp in four meters high waves, Beaufort 7, when the fore ship moves up five meters and down five meters as suggested by the Commission!

Fig.1.1.3 - 'Estonia' after 2 minutes

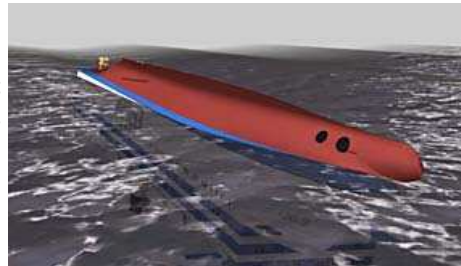
Then the ferry would have capsized, [1.9](#), [1.15](#) and [2.16](#) in one minute, the deck house windows would have been smashed, the deck house would have been flooded and the ferry would float upside down on the undamaged underwater *hull* and its undamaged water- and air-tight compartments.

Fig.1.1.4 - 'Estonia' after 3 minutes

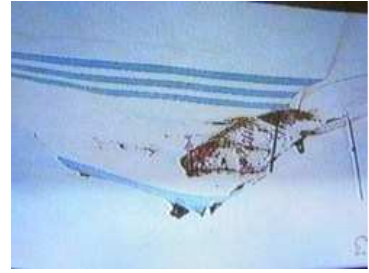
The 'Estonia' sprang probably a big leak at about **00.55** hrs in the hull, when several persons aboard experienced hard shocks [2.1](#). The shocks were not caused by waves hitting the hull - it was something else. The first shock was a collision between an unknown object and the visor causing a big indent 6-8 meters above waterline. It could only have been caused by a contact with an *outside* object. The Commission suggests that the visor collided when it fell off against bulbous bow, but it is not possible. The second shock ripped open the side shell below waterline. One or two hull compartments started to fill up. In principle there was no danger. The 'Estonia' should have floated after leakage and with one or two compartments full of water, if the watertight doors were closed.

Fig.1.1.6 - The buckle in the 'Estonia' visor - what caused it?

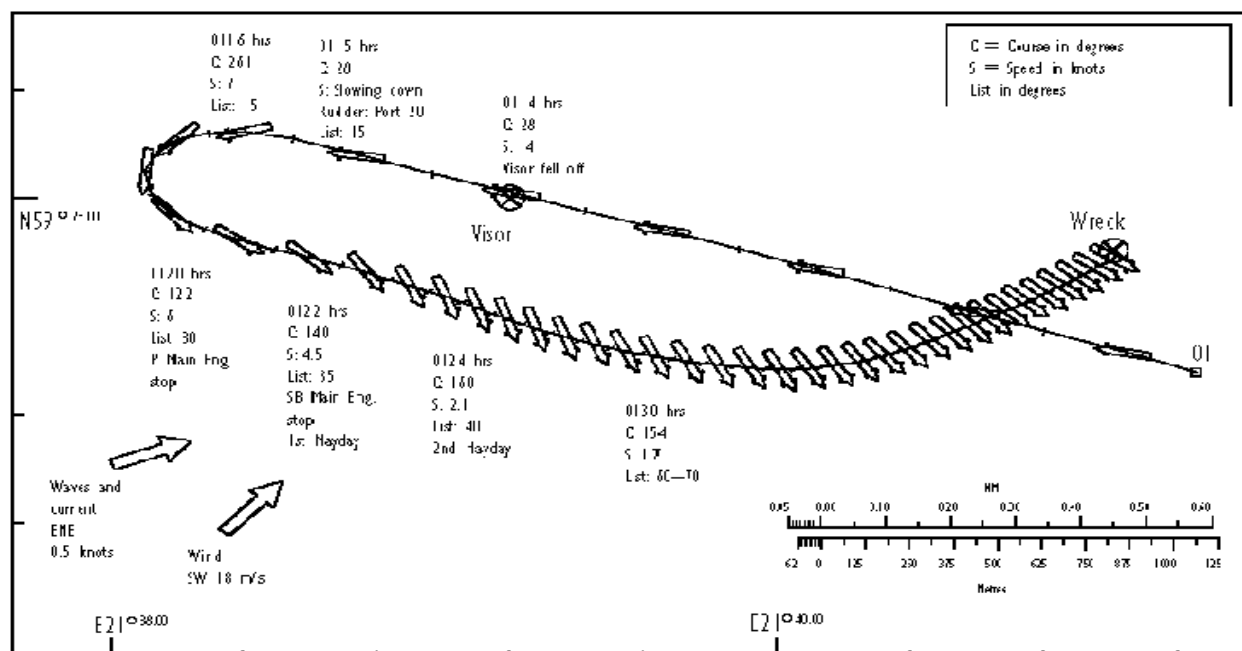
Figure 1.9.2 - Sequence of events as per the Commission (fig. 13.2 in (5))

The plot is in fact a falsification. It shows the movements of a completely *undamaged* ship, which makes a 180° turn and then drifts due to (exaggerated) wind and (exaggerated) currents - it never sinks, e.g. at the Wreck position - but continues to drift after that, but those arrows after 01.54 hrs have been edited away (sic) from the plot.

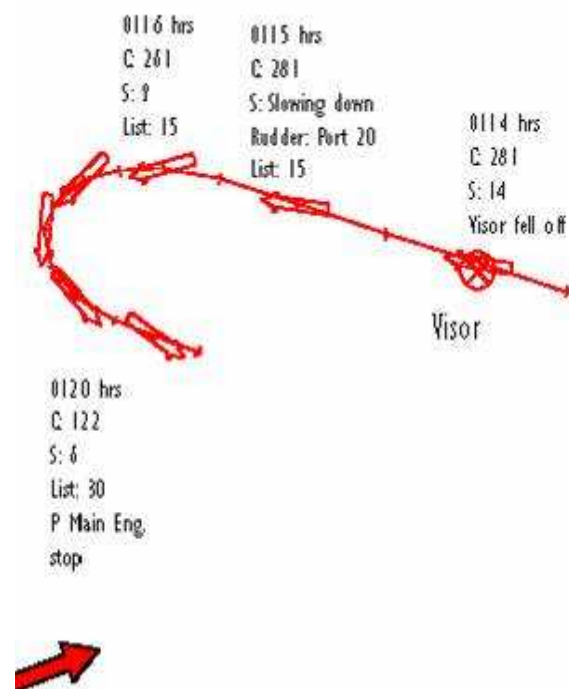
Figure 1.9.2A – 'Estonia' turns 01.16-01.19 hrs

The ship started after two minutes to turn (159°) port according to the Commission, first towards, later away from the waves between 01.16-01.19 hrs on the plot, as in the above plot the visor falls off at 01.14 hrs. The evidence for this event - fragments and simulations - is false.

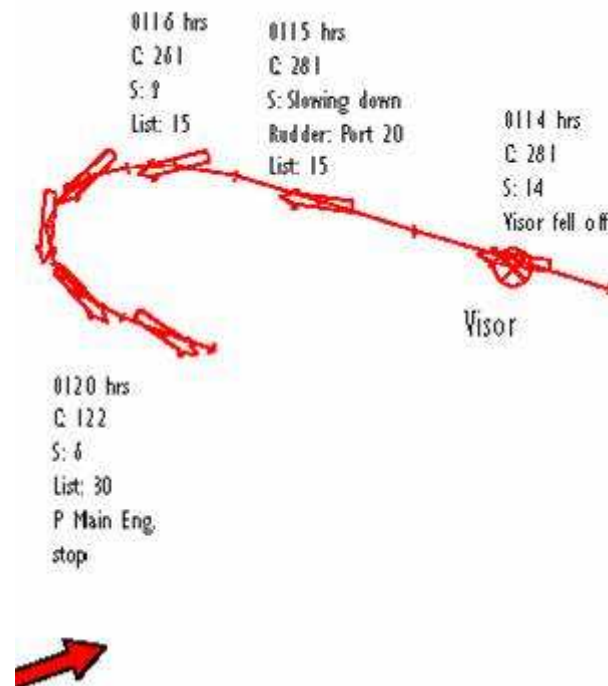
Figure 1.9.2A – 'Estonia' turns 01.16-01.19 hrs

But let's assume that the port turn took place after the alleged loss of the visor and the sudden listing (which either took place at **01.02!** (see below) or after **01.15** hrs) and that the speed then was 10-14 knots and long before the Mayday was sent. How much water would enter through the open bow ramp into the *superstructure* during the suggested manoeuvre?

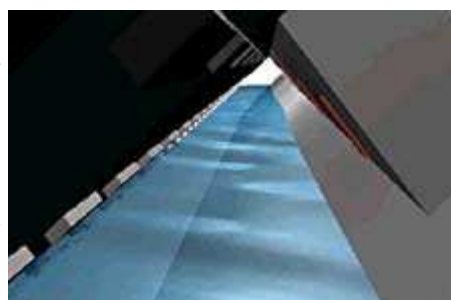
Fig. 1.9.3 Water in the superstructure

Compare figure 2.16.1D. The water reaches the *underside* of deck 4 above! The trim is assumed to be zero. An outside view of the 'Estonia' shortly after that time (01.20 hrs) is figure 1.9.4 right. Evidently nobody can walk on the sloping decks at this time. It is at this time or later that three crew members on deck 1 decide to start evacuation 1.48. The first Huss report seems to have been based on the information about a sudden list, say 14 degrees and then a slowly increasing list, and not based on real inflows. Huss didn't seem to be aware of the fact that the visor was allegedly found 1 560 meters due west of the wreck (that position was not official until December 1994, when the false wreck position was 'corrected'. When Huss started his work, he must have been confused by plenty of disinformation of the Commission).

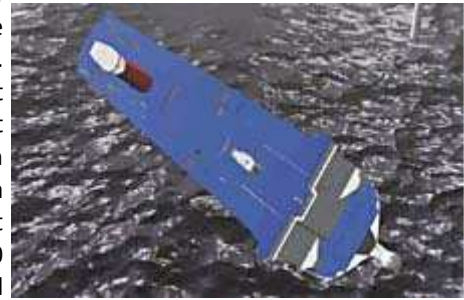
Fig. 1.9.4 'The 'Estonia' listing 45°

But with 2 100 tons of water loaded in the *superstructure* Huss knew - "*The ship is then lost*"! She quickly tips on the side - 90 degrees list - see figure 1.9.5 right. The Commission (Forssberg/Stenström) apparently could not accept the results. **The speed could not be zero after only four minutes**, because the ferry could then not reach the '*position of the wreck*' >3 000 meters east and sink at **01.52 hrs**; Huss first attempt ended >3 000 meters west of the wreck position at **01.20 hrs**! No - after four minutes the 'Estonia' had only turned 120° according to the alleged (false) sequence of events of the Commission/Huss and was only listing <30 degrees.

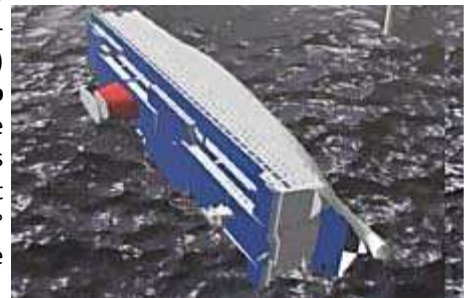
Fig. 1.9.5 'The 'Estonia' capsizing

But Huss knew that the ship was lost, i.e. would have floated upside down as indicated in figure 1.9.6.

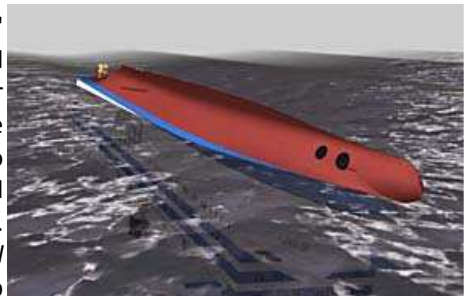
Fig. 1.9.6 'The 'Estonia' floating upside down

It is interesting to note how nonchalantly the '*experts*' consider 2 000 tons of free water in a *superstructure* - as if it was a *small* weight being used in an inclining experiment in harbour. 2 000 tons of extra free water was more or less 60% the total deadweight of the ship of which 80% was already used. And the weight was loose! It was a monster! But on paper it was just an imaginary weight listing the ship - not trimming it - according to Huss. And this monster weight never caused any capsize! Later the Commission suggested that the 'Estonia' floated on the deck house! The windows in the deck house were never smashed. The ferry floated on the deck house!

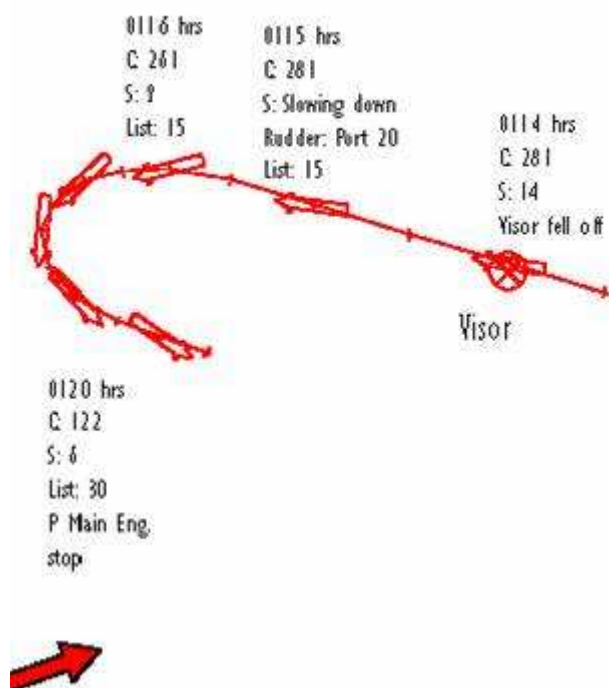
Figure 1.9.2A – 'Estonia' turns 01.16-01.19 hrs

Two minutes and 24 seconds after the loss of the visor, i.e. during the turn, the 'Estonia' steamed according to Huss/the Commission against the waves with about 9 knots, when about **1 200 tons/min** should have flowed into the *superstructure* according to the author's calculations. Huss reduced the inflow to **83.3 tons/min**! The speed was then zero **19** minutes after the loss of the visor! Until then only total **1 500** tons water had entered (during 10 minutes!) into the *superstructure* according Huss, when the angle of heel was only about **29** degrees (according to correct intact stability calculations) at **01.33** hrs. This condition is a safe and stable condition - albeit with a list and much reduced stability range.

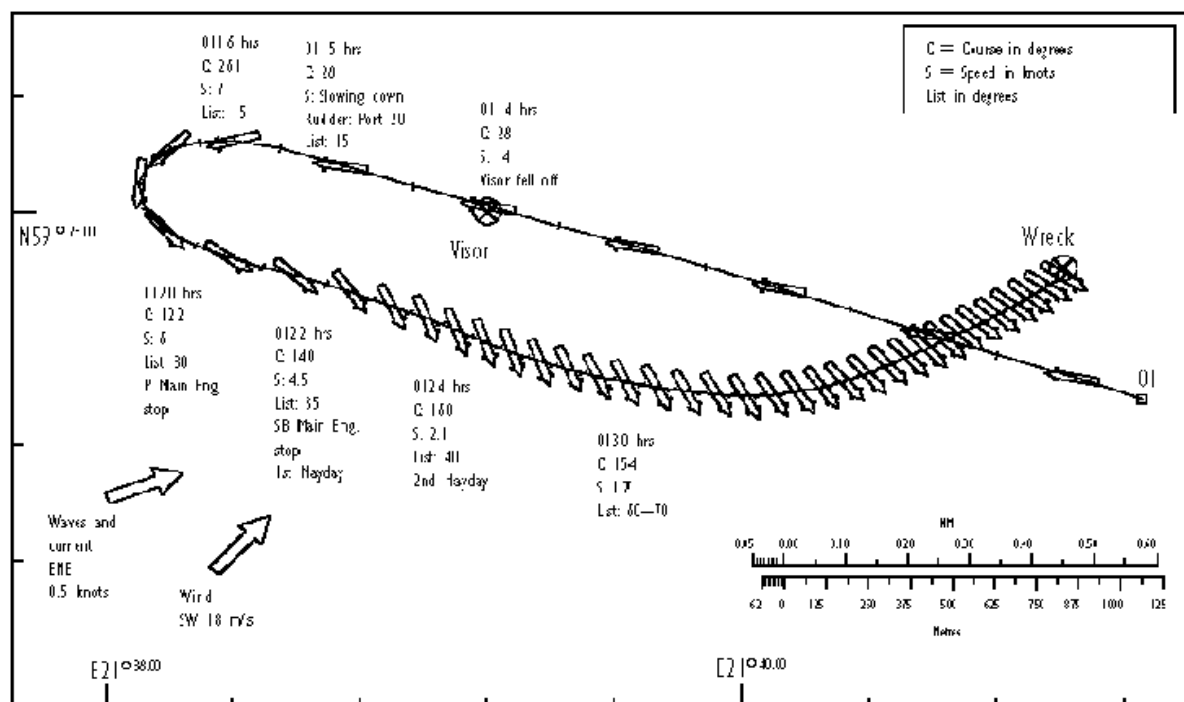
Fig. 1.9.2 - Fig. 13.2 of (5) - The falsified plot of the sequence of events

The simulated ship was assumed to be *intact* (upright) the *whole* time **01.14 - 01.52** hrs and the only (*navigation*) parameters were engine power, rudder action and weather/current. Then Huss/Rosengren managed to produce a plot, where the *undamaged* vessel managed to turn 180° degrees with reduced engine power and speed between 01.16 - 01.20 hrs - "*Good God, the first part of the manipulation was achieved*" - and then they arranged that the intact ship with stopped engines was *drifting* by manipulating the wind/sea current parameters (very strong current!), so that the ship arrived at the wreck position at **01.52** hrs, when they stopped the plot - "*Success, thank you God*" - Huss/Rosengren had managed to get a plot, where the simulated - intact - ship moved between a visor position at **01.14** hrs and a wreck position at **01.52** hrs with a 180° turn. That false plot could then be used as base for further falsifications.

is the figure 13.2 above in the Final report (5) - with no considerations to the physical relationship between angle of list and amount of water on the car deck in the *superstructure*. Otherwise figures 4.12 in supplement no. 522 and 13.2 in the Final report are identical!

Figure 13.2 in the Final Report is a sloppy modification of figure 4.12 in supplement no. 522 to the Final Report by Michael Huss, Ph.D., 'Simulation of the Capsize', which in turn was a theoretical failure trying to reconstruct the accident by the Marine Academy of Kalmar. The modifications between Huss (H) and the Commission/Final report (5) concern, i.a. the angle of heel and the amount of water on the car deck at various times after the visor was lost as shown in the below table: -

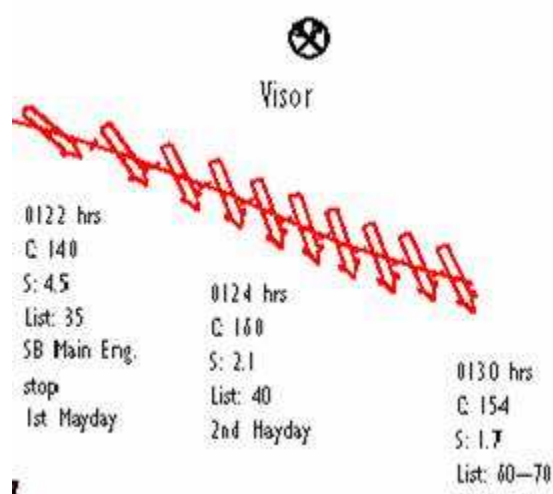
The Commission decided that the angle of list increased to 40 degrees in **10** minutes (inflow 200 tons/min, velocity of heel 4,0 degrees/min at **01.24** hrs) with **2 000** tons on the car deck, and to 50 degrees after **13** minutes (01.27 hrs) with **4 000** tons of water on the car deck (inflow **666** tons/min, velocity of heel 3,33 degrees/min during three minutes), and to 110 degrees (sic) at 01.40 hrs (velocity of heel 4,61 degrees/min), as a result of alleged increasing amounts of water on the car deck in the *superstructure* and *in the deck house*, which is summarized in table 1.9.3 below.

There is no evidence at all for the Commissions figures. The Commission had no idea that the ship would capsize with >2 000 tons inside the superstructure. It is crystal clear that the Commission used the falsified plot of the Huss/Rosengren second attempt but changed the angles of list to further falsify it in the Final report (5)!

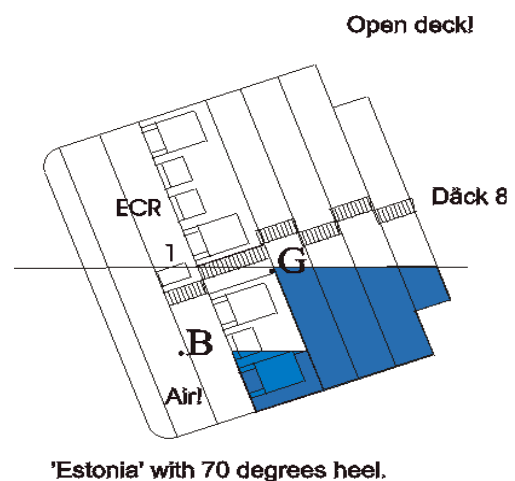
Figure 1.9.7 - the 'Estonia' with 70° list - unstable condition

The higher figure indicates of course that the ship was going to capsize - the heeling moment turning the ship upside down is about 100 000 ton-meter - but in spite of the increased weight and the heeling moment at 01.32 hrs the Commission states that *the ship continued to sail/drift eastwards with a speed >2 knots³⁵ for another 20 minutes.*

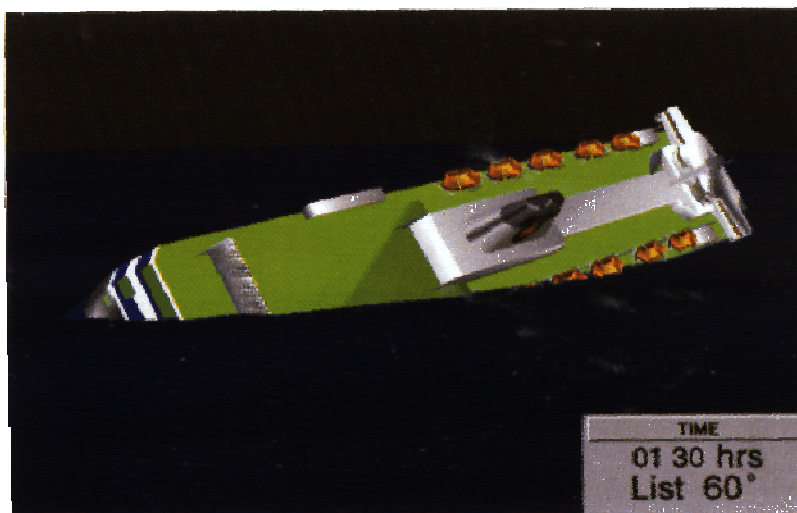
You can see the lifeboats: nos. 1, 3, 5, 7 och 9 starboard, where no. 9 is completely below water and no. 7 is in the waterline, while nos. 2, 4, 6, 8 och 10 port remain on the upper side. You see also two white 'squares' fore and aft of the lifeboats and they are the sloping ramps for the life raft containers that can be thrown overboard. Starboard aft rafts are below water (no white square seen) and should at this time have been ripped off the ramp, opened up and drifted away.

Alternatively they were so hard secured to the ramp that they never released. We do not know how many of the 60+ rafts that was actually released. The number of rafts found has never been published.

Figure 1.9.8 - The position of the 'Estonia' at 01.30 hrs according to the Commission (figure 13.3 in (5)) - "... and the vessel started to sink. At a list of about 80 degrees the bridge was partly flooded. This happened shortly after 01.30 hrs as indicated by the clock in the chartroom ... The emergency generator stopped at the same time ..." (Chapter 13.2.6 of (5))

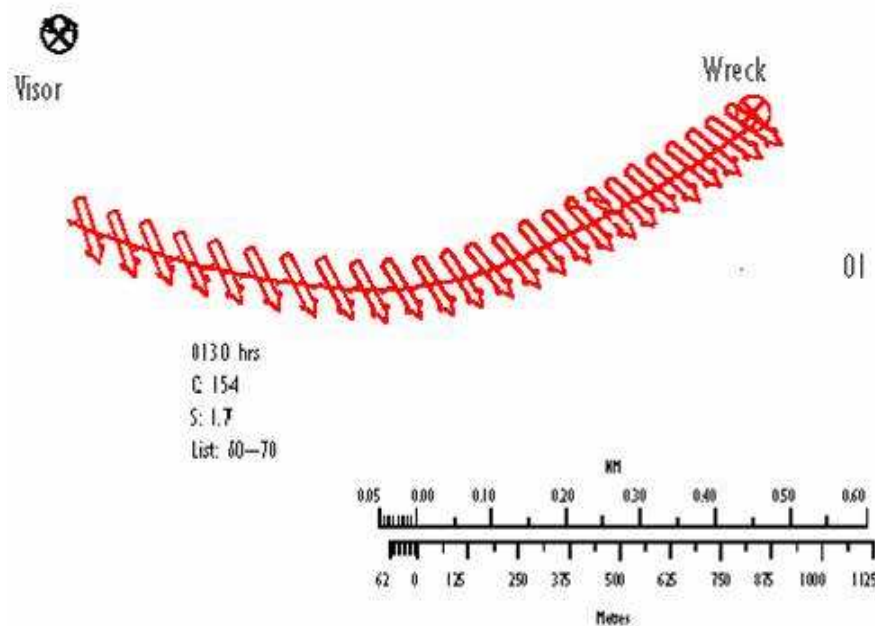
Figure 1.9.2C – 'Estonia' drifts 001.30 – 01.50 hrs with 2.2 knots speed while sinking!

The ship is evidently sinking and should have capsized but Dr. Huss & Co. states that it moves with >2,2 knots (the current is <0.5 knots) sideways (sic) for 22 minutes 1 300 meters northeast to suddenly sink at **01.52** hrs (see figure 1.9.1 above). **However, there are no evidences that the 'Estonia' actually drifted in such a way.** The author thinks that the 'Estonia' sank at **01.32-01.36** hrs, because the clock on the bridge stopped at **01.35** hrs.

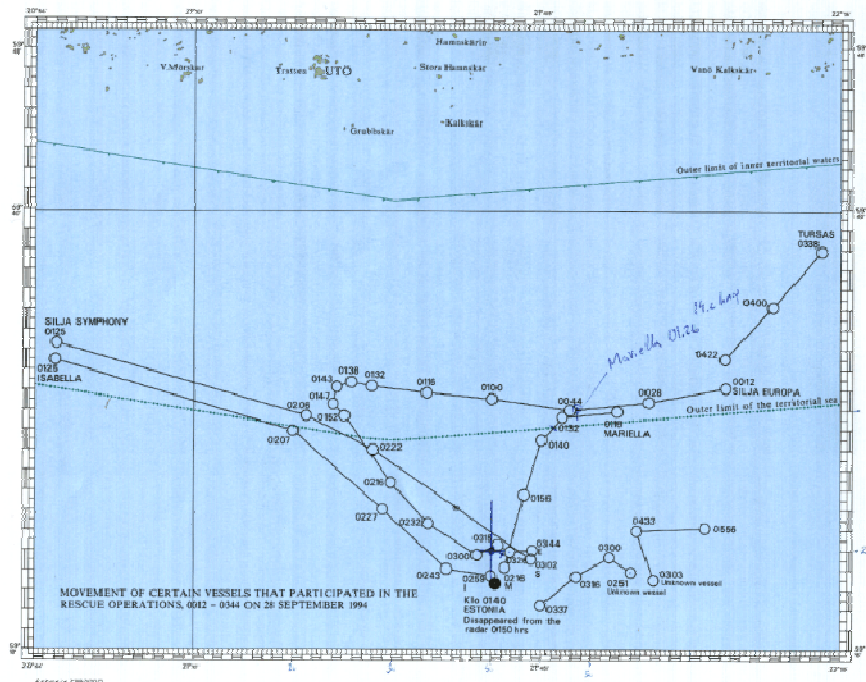
Figure 1.13.1 - Figure 17.1 of the Final Report (5)

All ships in the area were tracked by Finnish shore radar at Utö. You can, e.g. see that the 'Mariella' was about 10 miles astern of the 'Silja Europa' at 01.16 hrs - four minutes before the Mayday! - and that both the 'Silja Symphony' and the 'Isabella' made 21 knots to reach the position of the accident starting at 01.25 hrs. **When the rescue operation was reconstructed, the movements of all ships could be established except the 'Estonia'.** The 'Estonia' was instead marked with a black dot 1,5 nautical miles south (!) of the correct position of the wreck (?) at 01.40 hrs with a note '*Disappeared from the radar at 01.50 hrs*', i.e. it seems that the 'Estonia' was not drifting at all between 01.40 and 01.50 hrs. No explanation to this is given in the Final Report (5). Instead the course of the 'Estonia' was plotted in another diagram developed by Michael Huss and Hans Rosengren much later - the falsification figure 13.2 in (5) [1.9](#), where the 'Estonia' is drifting with a speed >2 knots at 01.25-01.52 hrs.

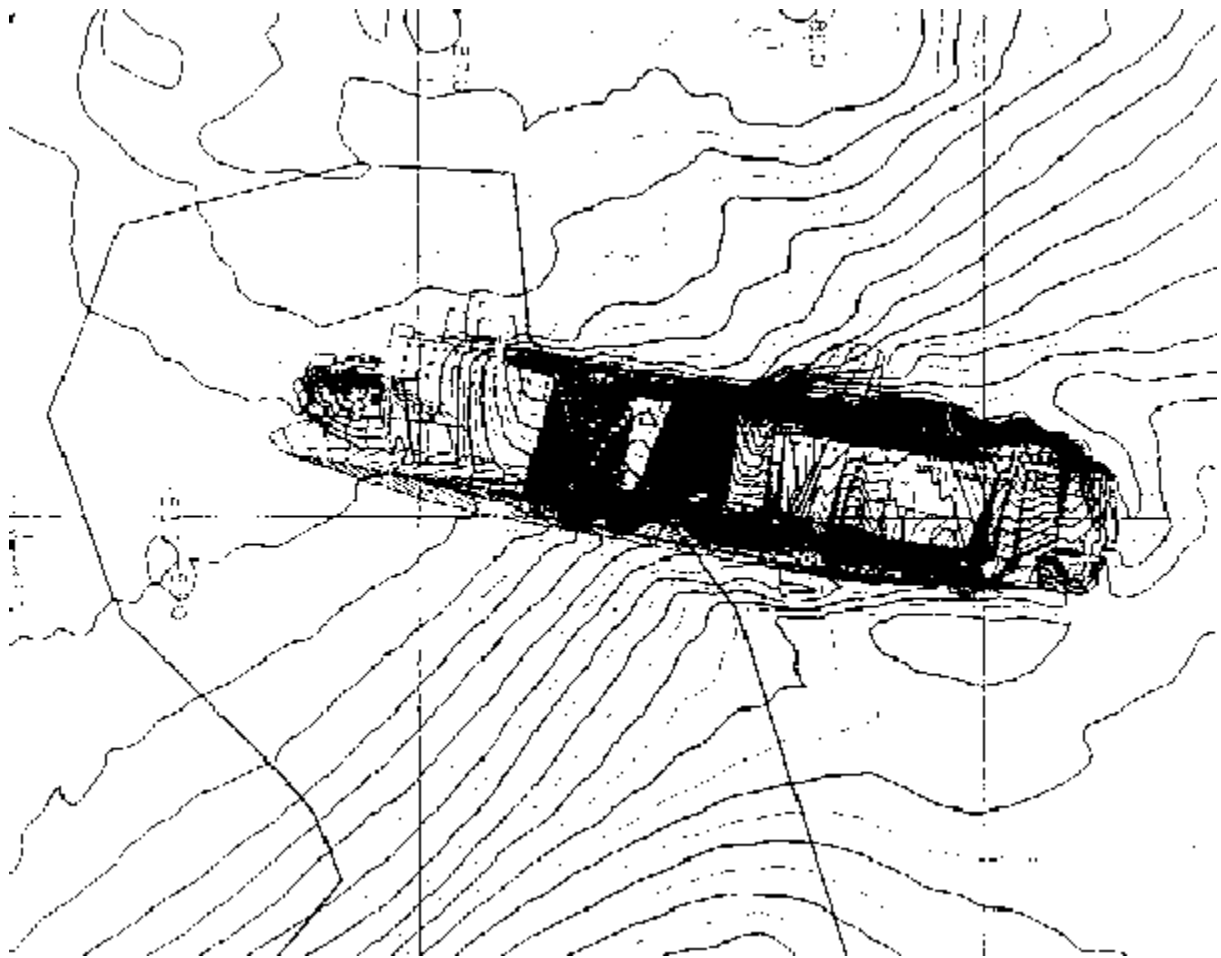
Fig 1.14.3 - A picture of the 'Estonia' on the sea floor - unknown date

The below figure 1.14.3 shows a '*sonar picture*' of the wreck and its surroundings reportedly made the summer 1996 by the Swedish NMA or its subcontractors. However - we do not know when the barimetric depth curves were recorded. Something looking like the visor is seen at the bow (Note that south is up on the picture)

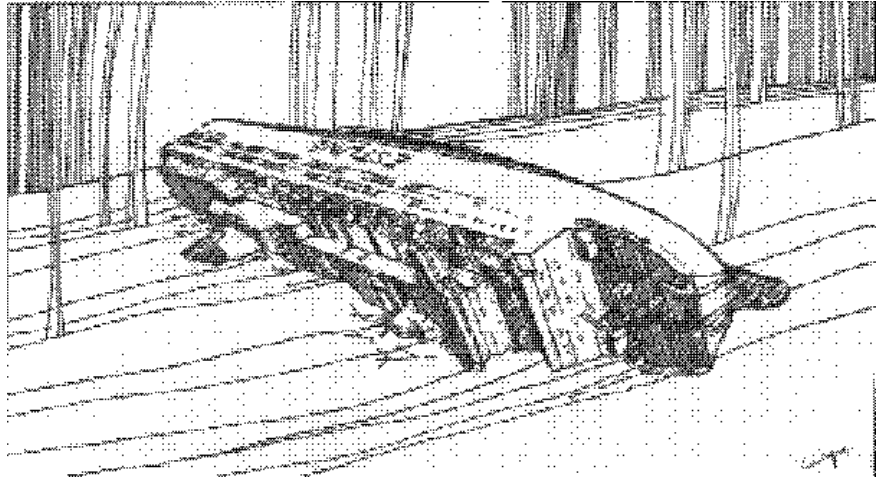
Figure 1.16.1 - the 'Estonia' on the sea floor

The wreck looked something like the picture right when the divers came down at 60-80 meters depth. All work had to be done in artificial light.

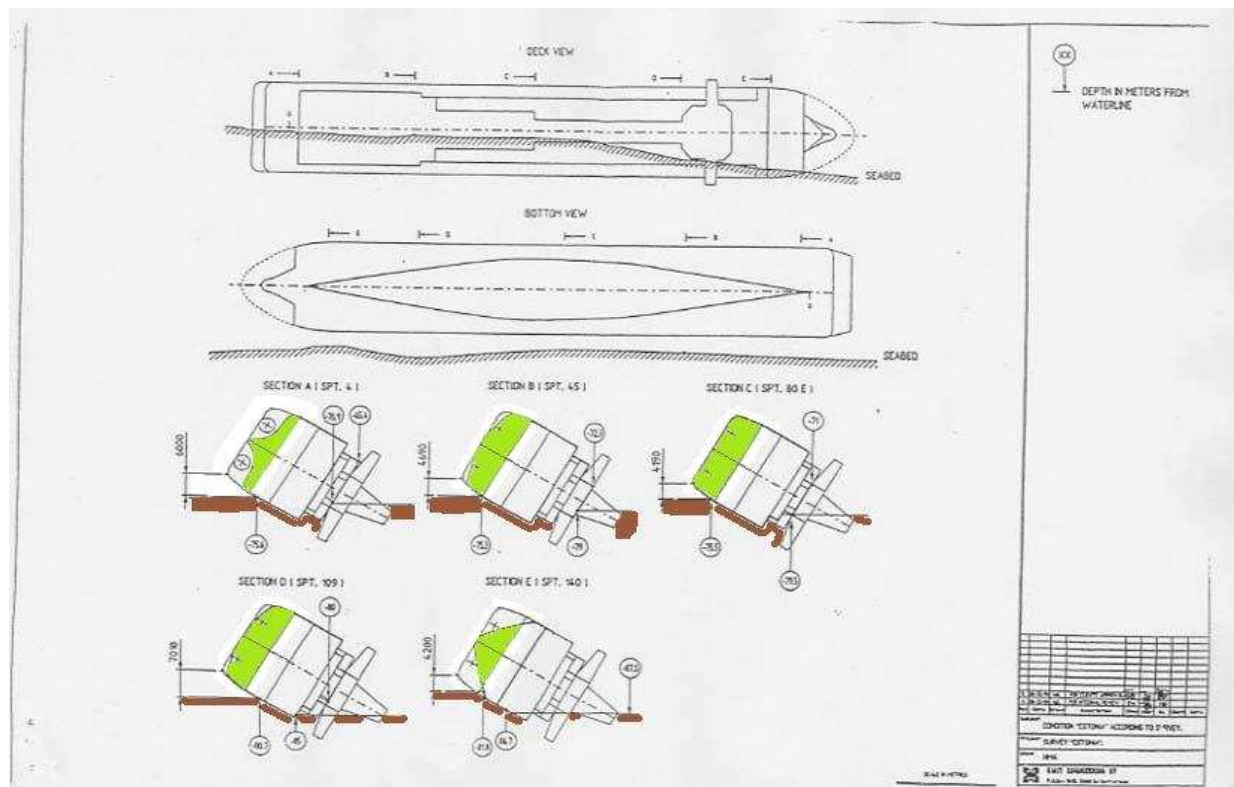
Figure 1.16.2 - the 'Estonia' on the sea floor according to Smit Tak

As can be seen part of the *starboard* superstructure side forward and the **whole starboard underwater hull side below the car deck and the whole flat bottom** are above the **mud line** and could have been examined and filmed. However, all parts of the starboard underwater hull and superstructure *side* are not visible on the films and to see all parts of the flat bottom is impossible. **It seems that the films have been edited!** Another presentation of the forward part of the wreck on the seabed is figure 1.16.3 below (made by Rockwater 1994). We are interested in Section D, i.e. how the starboard side of the hull and the *superstructure* below the bridge rested on the bottom:

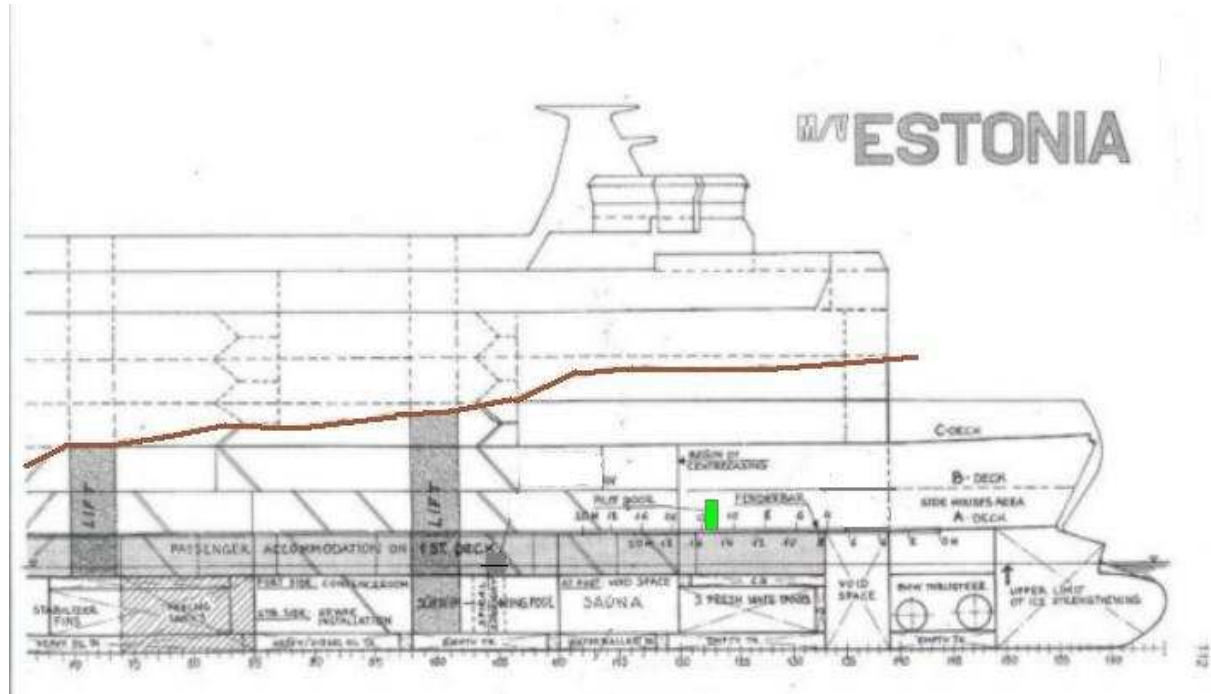
Fig.1.16.4 - Pilot door

The [forward starboard pilot](#) door is situated in that area (at frame 122) and should thus have been visible on the mud line video. However, the video films of both 1 October (seabed survey) and 2 December (mud line survey) have been edited in just that area, i.e. the films have been cut and the *superstructure* side and the pilot door cannot be seen! This pilot door would provide easy access into the car deck space - if it were open! The German group of experts [3.13](#) has suggested that this door was opened just before the accident - the listing - and that crew throw suspect cargo overboard carried in two trucks that had been parked just aft of the forward ramp. These trucks had been loaded last at Tallinn. If the starboard forward pilot door were open, when the ship listed due to hull leakage, massive amounts of water would have entered there and collected on deck 2 and assisted the listing.

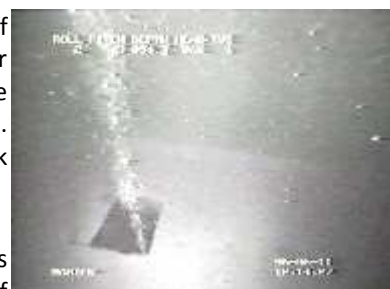
Fig.1.16.8 - Aft hole in shell at deck 1 port side at abt 55 m depth

Deck 1 (inside the hull) - the divers cut two holes in the port (upper) side of the hull - figures 1.16.8 and 1.16.9 - and inspected 16 cabins and 20 meter corridor from inside - it took 11 hours and 14 minutes. JAIC says that the holes were sealed to prevent access after the 1994 dives but this is not true. The pictures right are from 1996, when further unreported inspections took place.

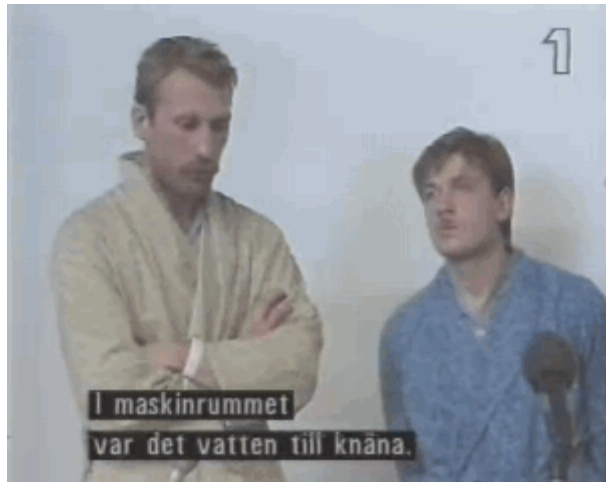
In two descriptions we are told that the water was knee high on the car deck. We now know what would have happened then - immediate capsizing and floating upside down. So where was the water knee high? In the engine room? 3/M Treu had announced just that on television on the afternoon of the accident (picture right). He says *'In the engine room there was water to the knees'*.

Figure 1.18.1 - *'In the engine room there was water to the knees'.*

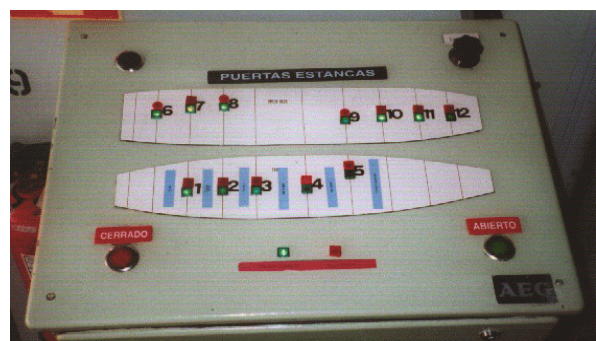
There are twelve watertight doors in the hull - five doors (nos. 1-5) on deck 0 between engine rooms, which is in order, and seven doors (nos. 6-12) between crew and passenger spaces on deck 1, which is totally illegal according to SOLAS. Three watertight bulkheads have two watertight doors each (doors nos. 1 and 7, nos. 2 and 8 and nos. 5 and 9 are located on top of each other in the same bulkheads).

Figure 1.23.1 - Incorrect watertight door control panel - year 2002

The indication is green for an open door and red for a closed door. The doors can be remotely opened from the bridge with the green push button to the right, which is illegal. Naturally the doors can be remotely closed with the red push button to the left.

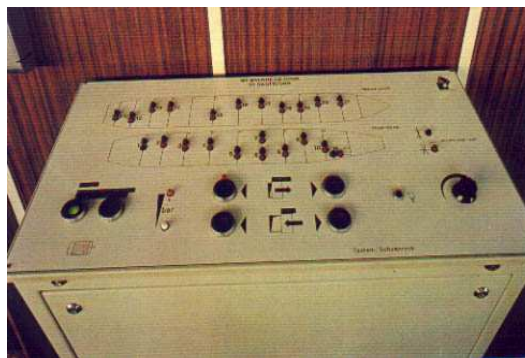
The picture right shows the 'Estonia' control panel for 22 watertight doors. It is a little more complex than the panel shown above. Top are two deck plans with indication lights red/green - deck 1 with 14 watertight compartments and 11 doors (***totally illegal***), deck 0 with another 10 or 11 doors (one door is maybe a hatch in the deck?) most of which are illegal. **The panel confirms that several watertight bulkheads had two or three watertight doors, which was totally illegal.** Bottom left on the panel are two buttons/indication lights - the left is green. Maybe is it on/off for the system. Bottom middle are four buttons and/or indication lights probably used for remote opening (the two upper ones - totally illegal) and for remote closing (the two lower ones). Bottom right is a dimmer and a small button for light bulb control. If it were possible to remote open/close individual doors is unclear.

Figure 1.23.2 - The 'Estonia' control panel for 22 watertight doors

What is clear is that the complete system was wrong. You shall not be able to remotely *open* the doors from the bridge.

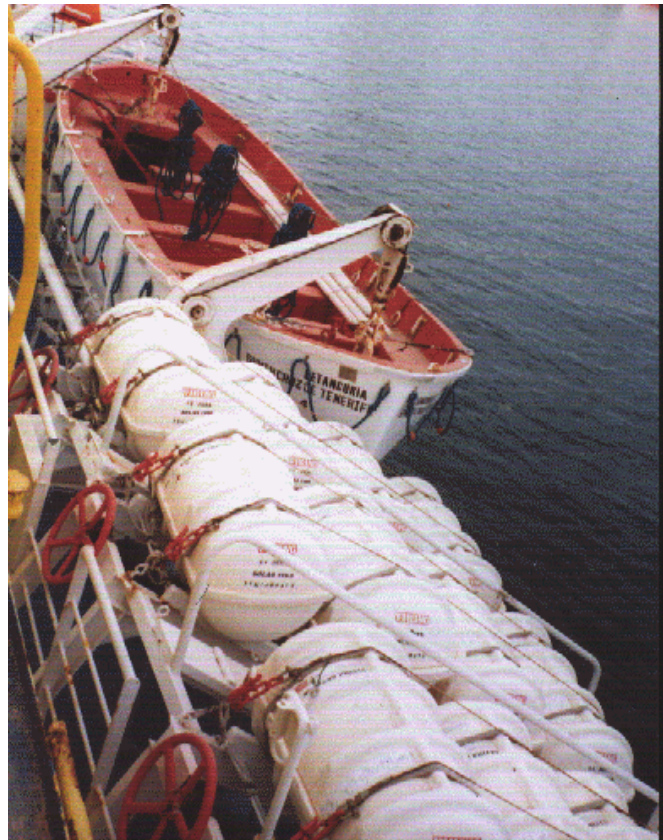
The life rafts were arranged aboard the 'Estonia' as shown on figure 1.33.1 right. The picture is of a similar ferry taken year 2002 (the **arrangement is dangerous and useless**). When abandoning the ship, a crew member shall release the 12 rafts, which then drop freely into the sea. The raft opens in the water and drifts away. The passenger shall either jump from the open deck into the sea or climb down two rope ladders on the side and the jump into the water. The passenger shall then swim to the raft and try to get in! They have to watch out not to be hit by falling raft.

Figure 1.33.1 - Illegal life raft arrangement - year 2002!

It is certain that the 'Estonia' had an identical arrangement - four stations with 12 off rafts each to drop into the water. **The Estonian administration made a serious, criminal error certifying the 'Estonia' with such rafts and arrangements.** Had the accident occurred later, e.g. during the winter, when the water temperature was lower, all persons in the ice-cold water would have died immediately. **That was another reason, why the rafts were not of an approved type.**

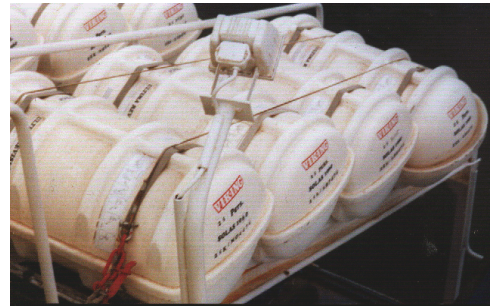
A close up of the illegal life rafts is shown in figure 1.33.2 below. Note that the rafts are of type Solas 60 - totally worthless to save lives.

Figure 1.33.2 - Illegal life raft arrangement - year 2002!

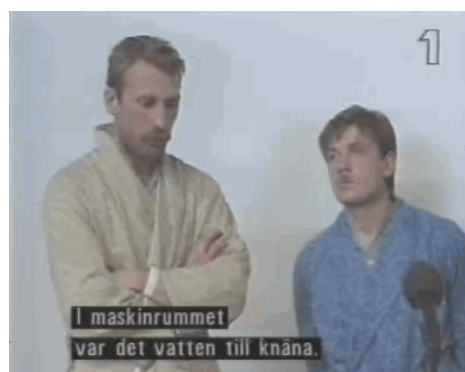
Figure 1.48.1 - Soon after being rescued 3/M Treu (left) and Ass/M Sillaste (right) told the media that 'In the engine room there was water to the knees'.

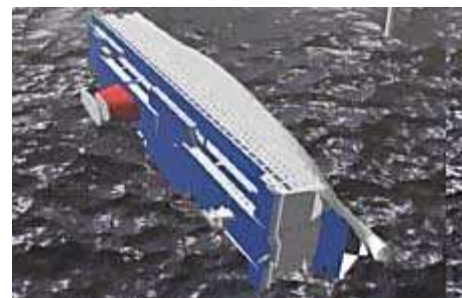
Figure 1.48.3 - "The list was about 90 degrees when they reached deck 8 ..."

OK - our little hero Kadak, who could not stand up, left the ECR with Sillaste via the emergency exit. Where was it? When Kadak quickly reached deck 8, the list was 90 degrees and the deck was vertical like a wall with the now horizontal deckhouse side 12 meters above him. But Kadak states that he was up on the horizontal ship's side 12 meters higher up at abt. 01.30 hrs! How did he get there? Where do you get the life jacket? According to other witnesses Kadak ended up inside a life raft.

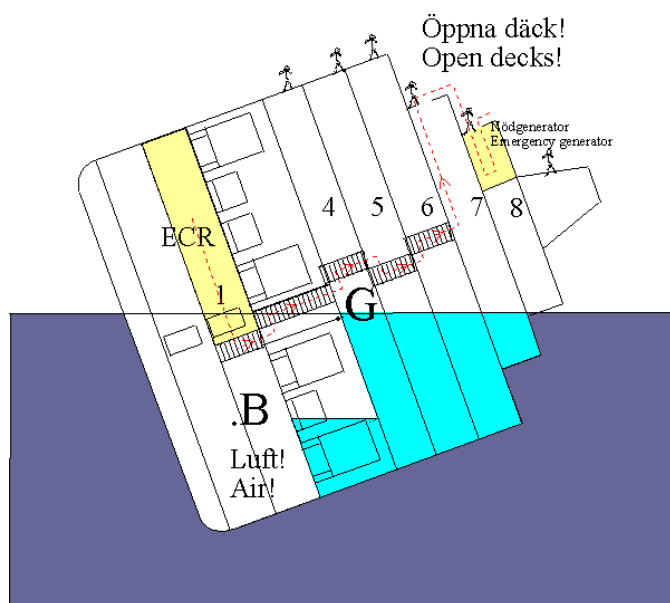
Figure 1.48.4 - The 'Estonia' with 70 degrees heel - escape from the ECR - unstable condition

However - the situation according to the Commission, when the list was 70 degrees at **01.25 -01.30** hrs with 4 000 tons of water on the car deck and 14 000 tons of water in the deck house above and with 300 persons on the open decks and when **Treu** was still in the ECR, is shown in figure 1.48.4 right of a transverse section of the ship at about amidships. South is right, north is left. The wind blows from S to N. The waves are coming from south.

The 'Estonia' floats high above the waterline, as all watertight compartments on deck 0 and 1 below the car deck are dry - it is only water on the car deck and in the deckhouse.

The condition is completely unstable - the centre of gravity of the ship G (no consideration is given to the water in the deckhouse) is 8 meters to the side of the centre of buoyancy B (the air in the hull and the superstructure) and the ship should have capsized, turned upside down immediately.

'Estonia' med 70 graders krängning kl. 01.30.
'Estonia' with 70 degrees heel at 01.30 hrs.

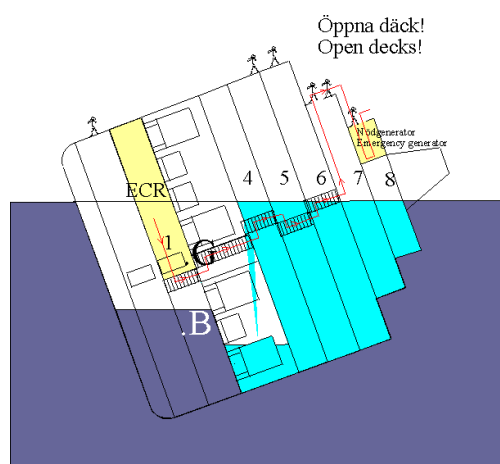
Figure 1.48.5 - The 'Estonia' with 70 degrees heel - escape from the ECR - stable condition

A stable condition with water in the engine room and the work shop and other compartments on decks 0 and 1 below the car deck, when the listing is 70 degrees at 01.30 hrs (28 minutes after the listing at 01.02 hrs - the ship sinks completely below water after another few minutes) is shown in the figure 1.48.5 below.

It has been developed by the author assuming that the underwater hull was leaking and that several compartments on decks 0/1 were flooded as reported by the passengers escaping from deck 1. 300 person have escaped to open decks, >600 persons are according to the Commission trapped inside the ship and **Treu** is still in the ECR on deck 1 port (yellow, upper) side. Survivor RS is on the wall between decks 7 and 8 but further aft of the Emergency Generator room. The ship is trimming on the stern, so RS is closer to the water. When the ship heels another 30 degrees, the funnel, pointing South (right in picture), is under water and RS can dive into the waves that are coming in on the funnel side. The wind is blowing from south (right) to north (left in picture).

Several compartments on decks 0 and 1 are flooded and the centre of gravity **G** (reduced to car deck level due the water in the hull) is just above the centre of buoyancy **B**, i.e. there is balance - stable condition.

'Estonia' med 70 graders krängning kl. 01.30.
'Estonia' with 70 degrees heel at 01.30 hrs.
