DISASTER INVESTIGATION

All about the M/V Estonia disaster 1994

A contribution to better ferry safety at sea

© Anders Björkman, 2001 (and updated later), 2009

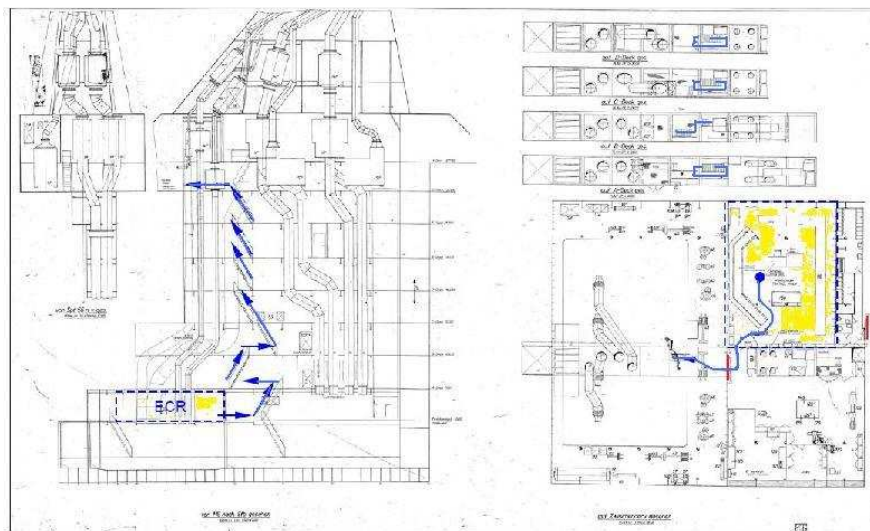
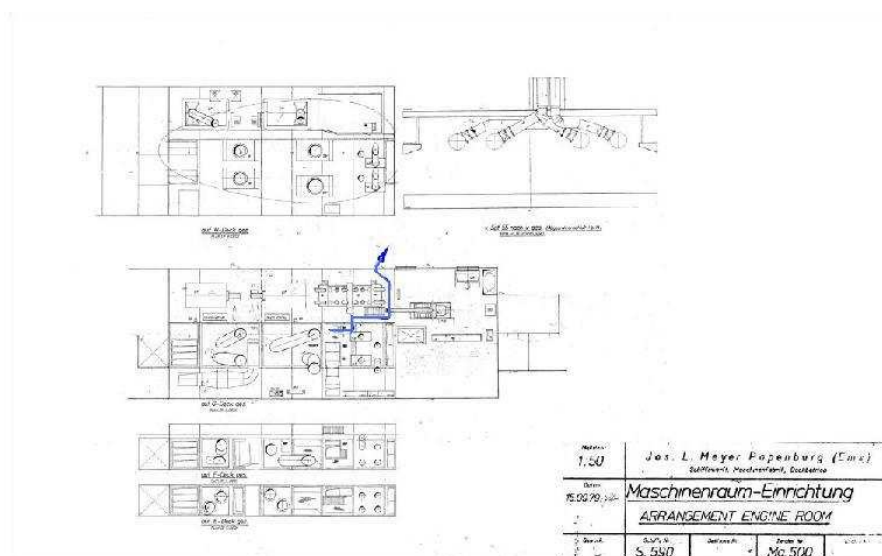
Figure 1.48.6 – Escape route in engine casing

Alternatively they could have escaped through the engine casing using the vertical ladders there. It would have taken longer time, but it was still possible, as long as the angle of list was <20 degrees. They of course had to pass a watertight (but open) door from the ECR into the engine room. Then, after climbing eight ladders they would arrive to the funnel on deck 9 and some other survivors say they saw two of the engine crew there. And it was still time to get out on the port side and jump into the life raft with Linde.

Fig. 63 Extracts from the Jos. L. Meyer drawing No. MA500 showing also the egress route out of the ECR. The detail in the middle showing the exhaust pipes in the funnel is seen from the port side of the vessel looking to the starboard side.

Fig. 64 Extracts from the Jos. L. Meyer drawing No. MA500 showing also the upper parts of the egress route out of the ECR in detail

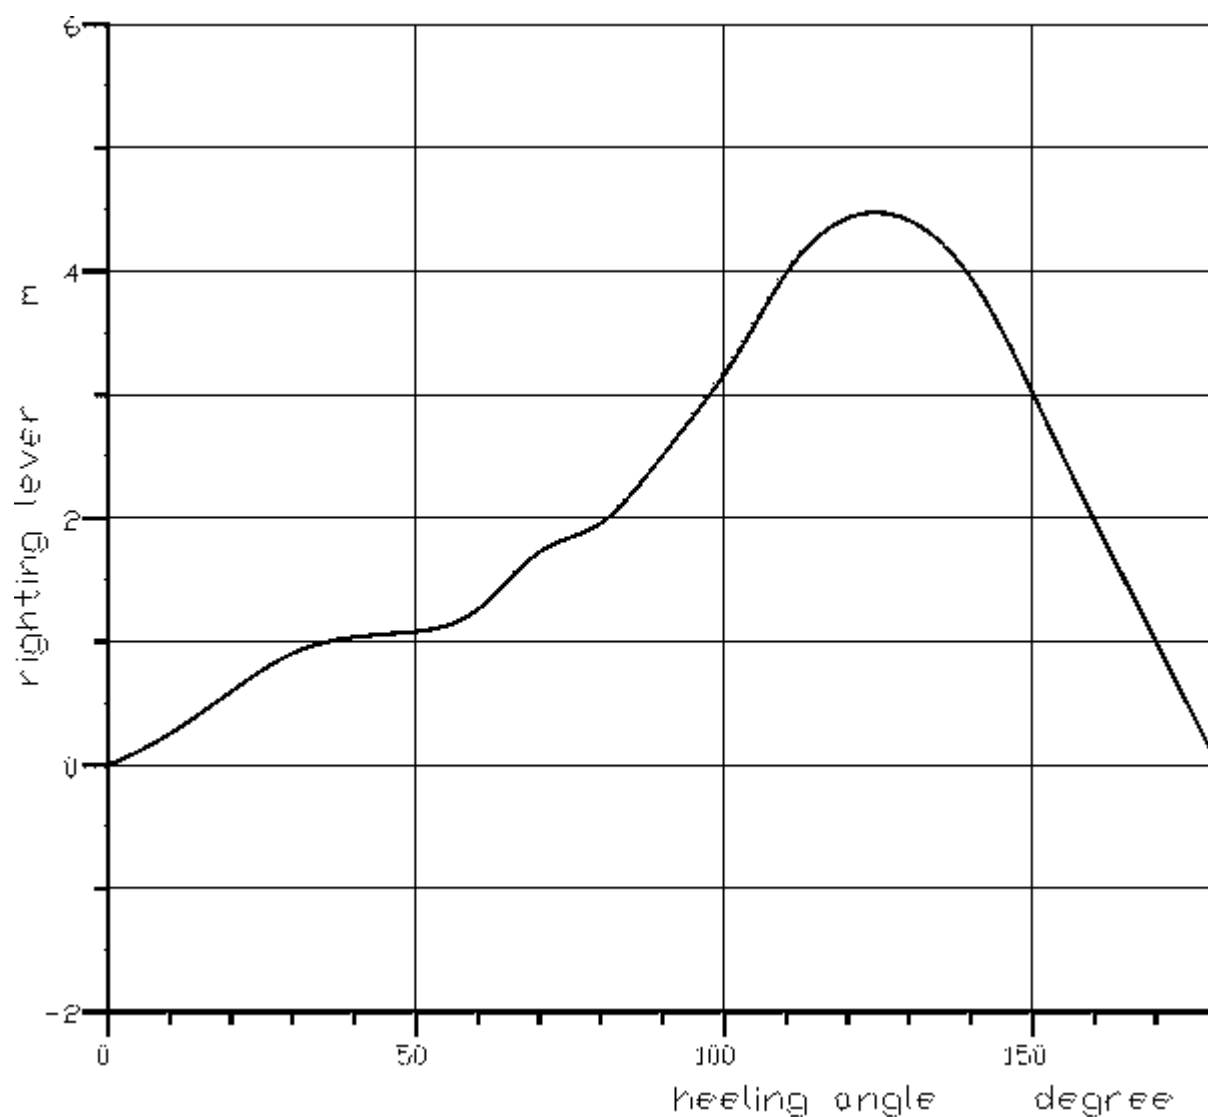
Figur 1. GZ-kurva för lastfall L2 - Figure 1. GZ-curve for loading condition L2

Anmärkning av Björkman om Figur 1. GZ-kurvan ovan är ej korrekt - den förutsätter att bl.a. hela däckshuset är 100% vattentätt, vilket inte är troligt. Beräkningarna följer ej normala förutsättningar - kurvan är 100% fel. Riktig GZ-kurva är markerad STH nedan, dvs den kurva som gäller för ett oskadat fartyg innan vatten lastas i överbyggnaden.

Remark by Björkman about Figure 1. The GZ-curve above is not correct - it is assumed that, e.g. the whole deckhouse is 100% watertight, which is not probable or normal practice when doing said calculations. The curve is 100% wrong. The correct GZ-curve for the intact vessel prior loading water in the superstructure is marked STH below.

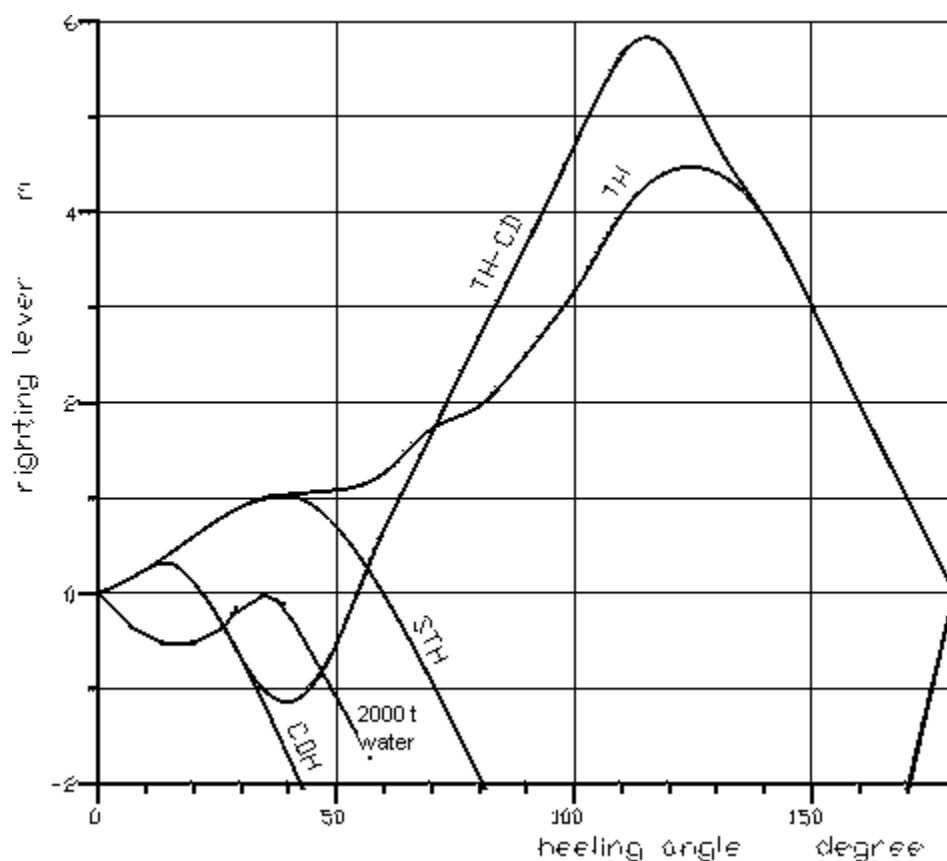
Figur 2. Lastkondition L2 med olika skrovutsträckning - Figure 2. Loading condition L2 with different hull extensions

Figur 2 visar MV Estonias GZ-kurva beräknad för ett och samma lastfall, L2, men för olika skrovutsträckning. Kurvan märkt STH är den GZ-kurva som fartyget får då det beräknas enligt de regler som gäller då man skall beräkna fartygets intaktstabilitetsegenskaper. Den kurvan är beräknad med en deplacerande kropp som sträcker sig i höjdlid upp till överkant av bildäcket. Med ett deplacerande skrov med en utsträckning som STH ger beräkningarna en GZ-kurva för lastfall L2 med ett GZmax på ca 1 m och en stabilitetsvidd om ca 60 grader.

Figure 2 shows the MV Estonia GZ-curve for one and the same loading condition, L2, but for different extents (sic) of the hull. The curve marked STH is the GZ-curve obtained, when it is calculated according to the rules valid, when you calculate the intact stability particulars of the ship. That curve is computed using a displacing body with a vertical extent up to the upper edge of the car deck. With a displacing hull with an extent as STH the calculations gives a GZ-curve for loading condition L2 with a Gzmax of about 1 m and a stability range of about 60 degrees.

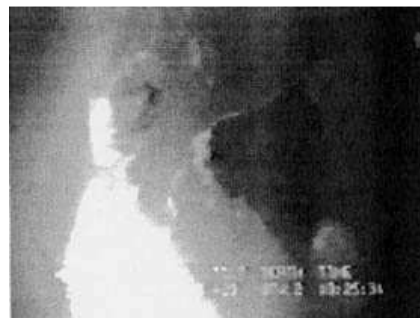
Fig. 2.3.2

The shell plate and the lose shell frames then deformed elastically inboard - like a ripped paper - due to the big pressure difference and a big opening $>0,3 \text{ m}^2$ (say the fracture is 6 meters long and the plate was pushed in 5 centimetres and you have a very big opening $0,3 \text{ m}^2$) developed and water started to fill the compartment - $>50\text{-}100$ tons/minute. Maybe the many surviving crewmembers [1.42](#) were called upon to stop the leakage and failed? Suspect areas with possible corroded hull plates have been observed on the ROV-video taken in December 1994 [1.16](#) - see photos right and below. The German group of experts [3.13](#) believes the engine crew had been called upon to try to secure the visor or the leaking ramp, but there is no evidence that the visor was lose at this time. The water on deck 0 started to spill out in the centreline corridor on deck 1 above at about **00.56** hrs - it had risen up through the staircase - where several passengers observed it. The watertight doors to the flooded compartment on deck 0 must then have been closed.

The water inflow had then been reduced due to pressure balance outside/inside, but the compartment was almost full to deck 1 level and spilled out when the ship rolled. Then the fracture in the bilge plate suddenly developed further - if the bilge plate and frame structure were corroded, so were the forward and aft bulkheads in the sauna compartment, and these were now under pressure - the compartment was filled with water. It is assumed that the fracture first developed aft into the conference room/sewage tank room at **00.57** hrs - and the room was flooded and filled up quickly - the water level in the other compartment may have dropped.

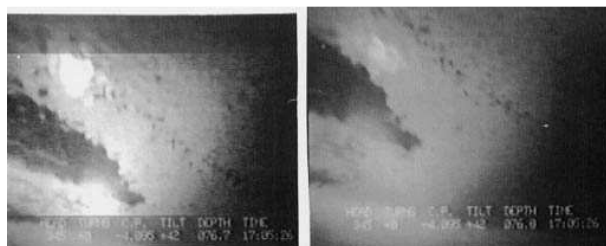
Fig. 2.3.3+4

Then the fracture developed aft into the empty starboard heeling tank - the bulkhead split with another bang at **01.00** hrs - and the heeling tank filled. This resulted in the sudden listing at **01.02** hrs! Then more water flowed in and spread everywhere through open watertight doors. Many passengers heard the 'bangs' - they thought that there was grounding or collision - but splitting plates also makes big noise - the ship hull is like a violin box.

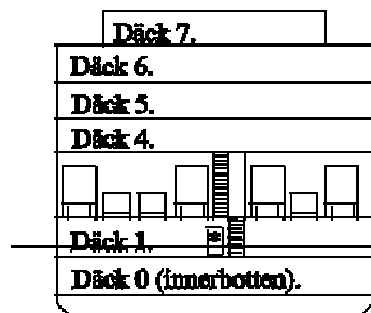
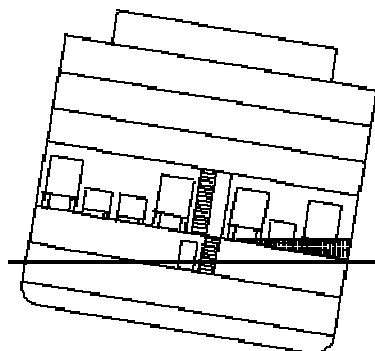
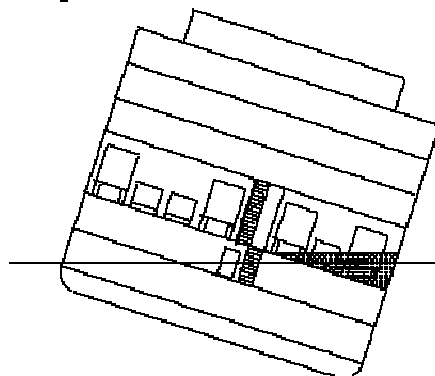
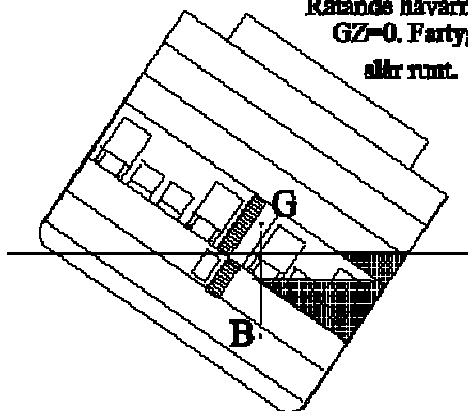
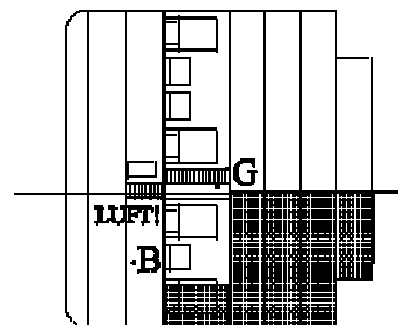
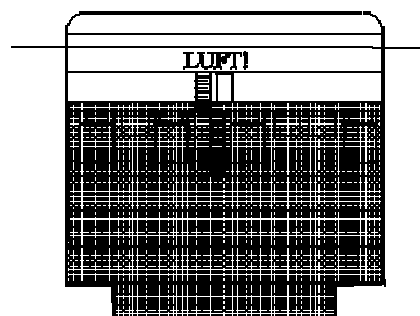
Figur 2.16.1. Vatten på bildäck. 1D. 2000 ton vatten på bildäck, nu under krängd vattenlinje. 34° krängning. Vatten på däck 4 och 5. Däck 1 är torrt. Rättande hävarm $GZ=0$. Fartyget slår runt.

1A. Utgångsläge. (* vattenstikt dör)

1B. 600 ton vatten på bildäck ovanför krängd vattenlinje. 10° krängning. Inget vatten rinner ner till däck 1.

1C. 1200 ton vatten på bildäck, som fortfarande är över krängd vattenlinje. 20° krängning.

1E. 90° krängning under instabil kapsejsning. Färjan slår runt på mycket kort tid (sekunder). Tyngdpunkt G utanför flytcentrum B!

1F. Slutläge. Skeppet flyter upp-och-ned på oskadat, tätt undervattensskrov.

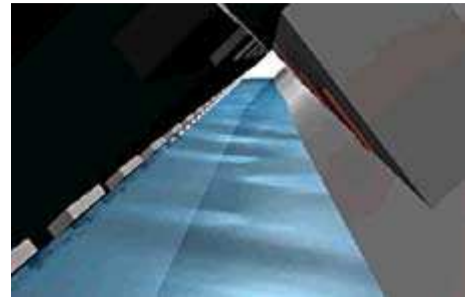
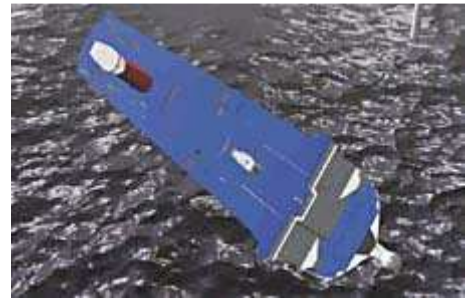
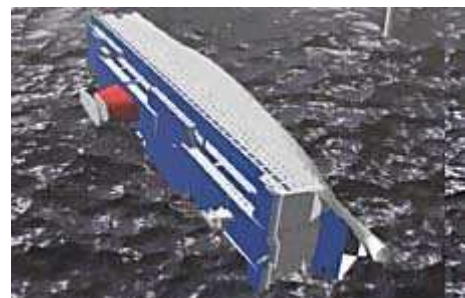
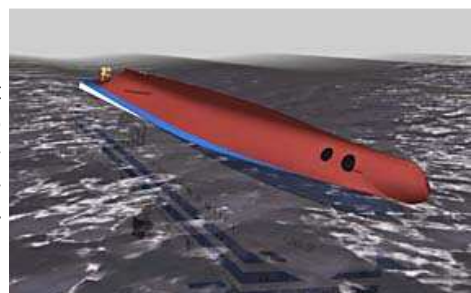
The Commission however clearly showed that the deck house (decks 4-7) was not watertight, because the Commission stated that the deck house was flooded with 7 000 ton/min of water in two minutes, nineteen minutes *after* the loss of the visor but twenty minutes *before* the ship finally sank, but that this sudden inflow then stopped - how is not explained - so that the ship floated for another twenty minutes on a *watertight part* of the deck house, and the Swedish NMA (Franson/Selén) also thinks that there is an *unaccounted buoyancy force* in the deck house, which prevented the 'Estonia' to capsize. **The 'Estonia' was from stability point of view not really damaged - the water on the car deck was just 'extra', un-fixed cargo being 'loaded' - or loading itself on the lowest point on the deck 2 inside the superstructure! Why the un-fixed, loose, extra water didn't flow out through the bow opening, when the ship stopped, is a mystery.**

Fig. 2.16.3A - Water on the car deck

Fig. 2.16.3B - >40 degrees list

Fig. 2.16.3C - On the side

Fig. 2.16.3D - Floating upside down

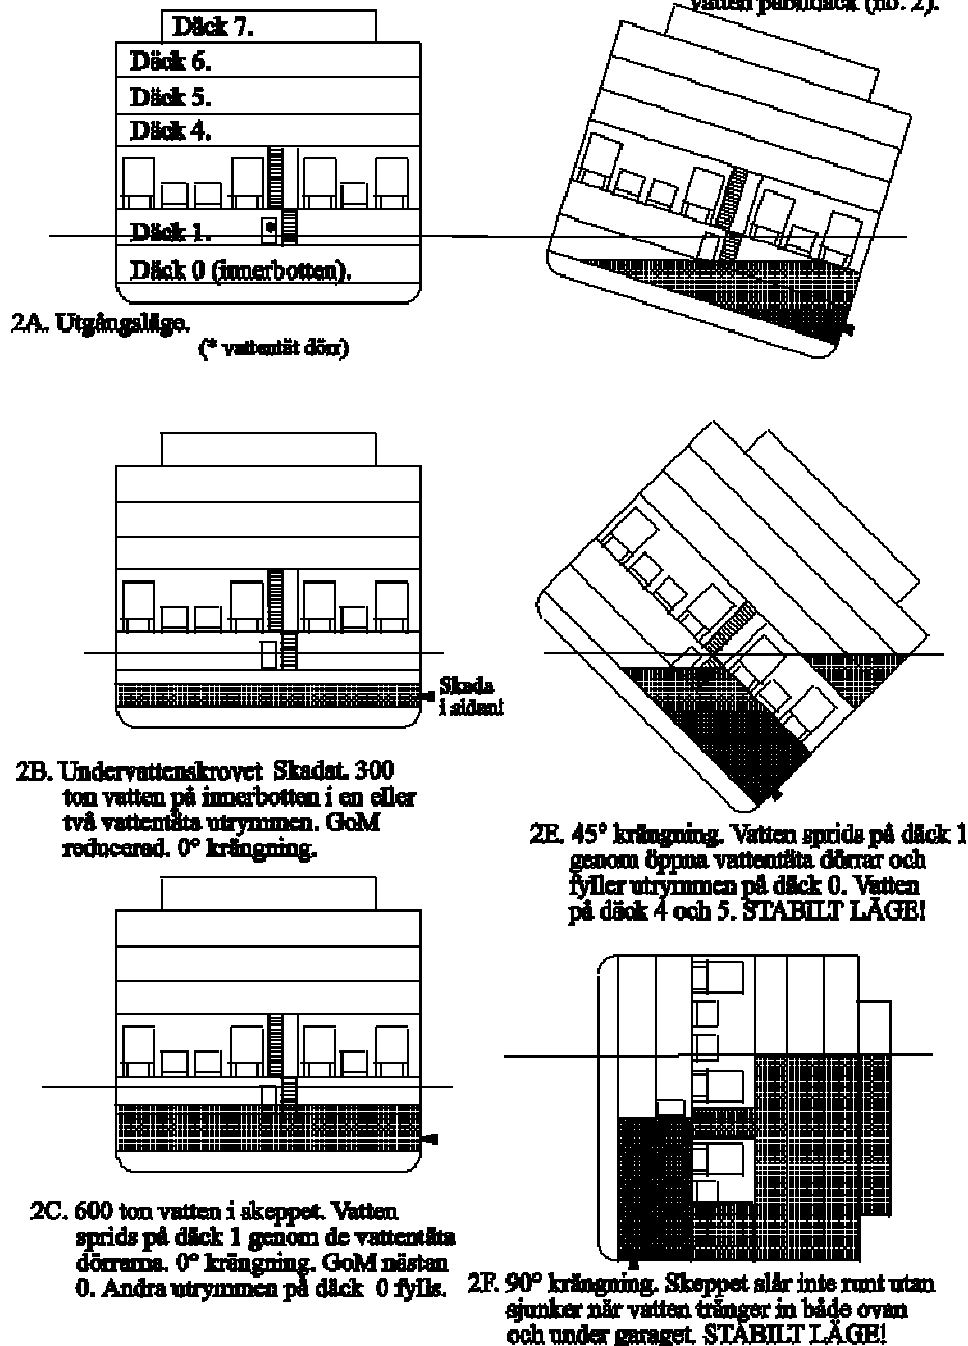
If a watertight compartment below deck 1 below the car deck of the 'Estonia' is flooded (figure 2.16.2) with water, i.e. the ship hull is leaking, the stability, the metacentric height GoM , is reduced due to free water surfaces (loss of inertia to prevent the vessel to list). If two compartments are flooded (figure 2.16.2B), the metacentric height is further reduced and there remains only minimal inherent stability. It means that the ship is still stable, but that she rolls slower. This is the rule requirement. Passenger ships, but not cargo ships, shall survive with two flooded compartments due to leakage. Passenger ships shall not sink due to leakage!

Fig. 2.16.2 Vatten under bildäck. 2D. Skeppet har krängt 15° (GoM < 0) till nytt jämviktsläge där fria vätske- ytor är mindre (GoM > 0). Inget vatten på bildäck (no. 2).

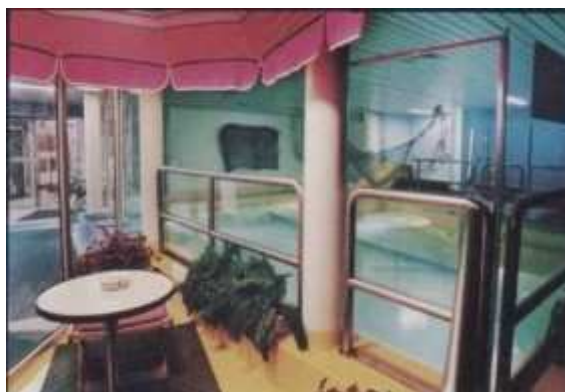
It is very possible that sea water flowed into the ship on deck 0 four meters below the water line, e.g. between frames nos. 85-98 and/or 98-110, i.e. the pool and the conference/sewage tank rooms, long before 01.00 hrs. The pool area was a rust trap, impossible to inspect the hull plates behind linings and decorations and and it is possible that the rusty bilge plate fractured and was pushed in, etc. But deck 0 is three meters *below* deck 1. If a compartment on deck 0 were flooded, the water would naturally rise up to deck 1 through the stairwell and then spill out on deck 1 centre corridor. Actually the water would spill out before due to rolling and then flow to the starboard side due to the list. The pool compartment had a volume of about 750 m³. The conference compartment was slightly smaller. It may have taken 5-10 minutes to fill up these compartments to deck 1 level, longer, if the bilge pumps were running full blast.

Fig. 2.20.1 – Swimming pool on 'Estonia deck 0 recessed into double bottom

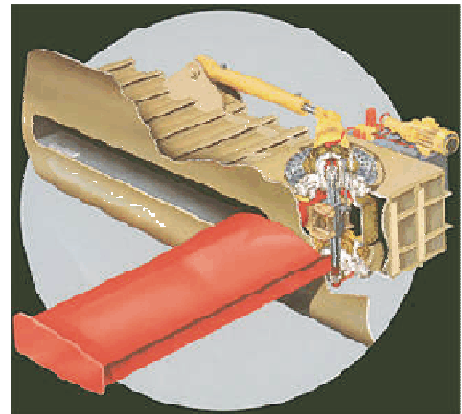
Figure 2.23.1

Between the 10 and 14 January 1994 the 'Estonia' was taken out of traffic and put in dry-dock at Nantali, Finland, when i.a. a pair of folding stabilizer fins were installed. The stabilizers were manufactured by Brown Brothers & Co Ltd, at Edinburgh, Scotland. One stabilizer unit is shown in the picture right. The fin folds out aft, i.e. the forward of the ship is to the left in the picture. The length of the fin was about 4,0-4,5 metres and the weight of one unit was about 15-25 tons. In order to install the stabilizers two big openings were cut in the bilge strakes of the ship hull. Actually - the openings cut in the bilge plate on each side was about 6,0-6,5 meters long and 1,5-2,0 meters high and a lot of internal structure must have been removed. Then the prefabricated boxes with the stabilizers were welded in place to internal brackets and reinforcements.

Unfortunately the stabilizers are not shown on the drawings of the ship in the Final Report (5). There is no information, if the drawings of the new installation, its reinforcements and the installation work were approved and supervised by the administrations and the class. If the work was done by *qualified* welders and platers under proper conditions is also unclear. This is quite amazing.

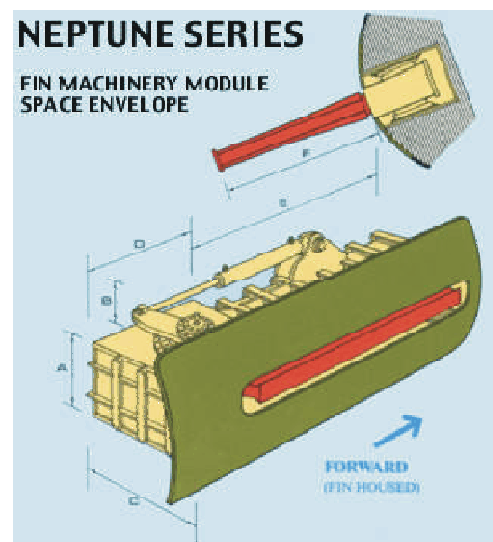
Figure 2.23.2

Less than nine months before the accident the 'Estonia' was modified in record time during *four* days in the middle of the darkest and coldest winter in an open dry-dock, and the matter is not described in any detail in the Final Report (5). The '[Erika](#)' accident 12 December 1999 took place after major hull steel repairs had taken place and in that case the accident investigators blamed the accident on deficient repair works - in dry-dock! They actually stated that all old corroded steel was not removed and that the new steel was incorrectly welded to old steel.

Thus in January 1994 big holes were cut in the highest stressed parts of the underwater body of the 'Estonia', but the Commission never investigated, if the job was properly done.

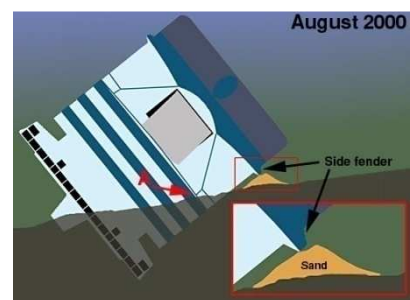
It must be pointed out that the Bemis expedition lacked facilities to examine the whole wreck or *hull* by divers in detail for damages. They could only examine a few locations and a very small area at every location. The effective dive time per team was only 20 minutes and a lot of time was used just to have a look around. Unfortunately the divers did not examine particularly interesting areas, e.g. the deck beam at fr. 159 on the fore castle deck (the Commission suggests that the beam is cut off by the visor hydraulics, but it is not possible) or the starboard side just above the bilge, i.w.o. the sauna/pool compartment and the heeling tank (where this author believes there is a long fracture).

Figure 2.24.2 - Sand heap at the side

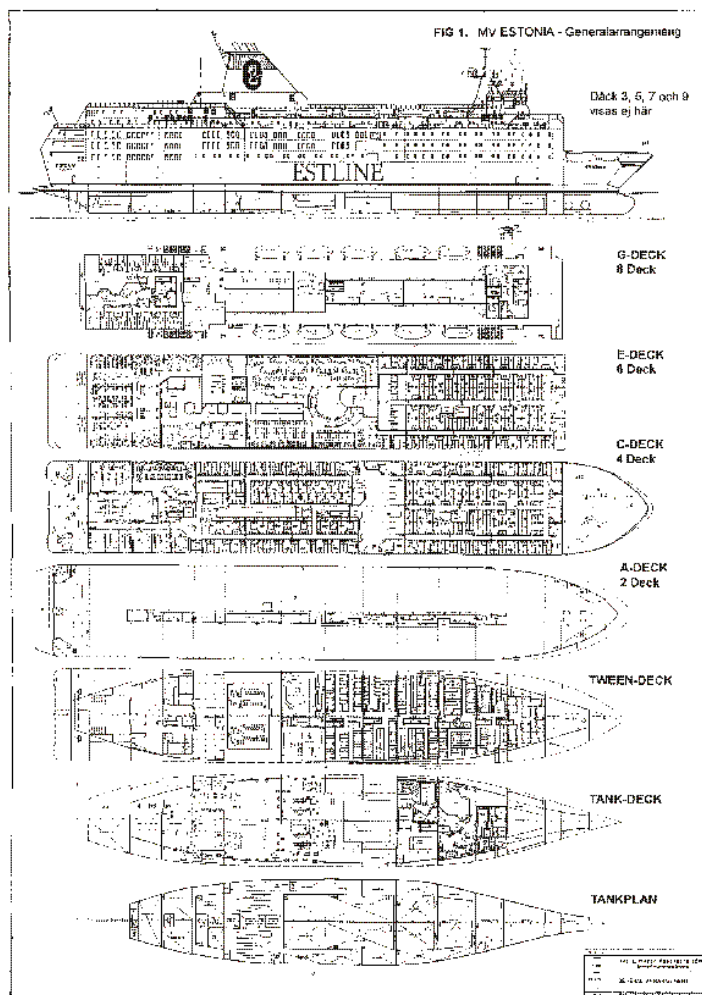
2. At 00.55 hrs the author thinks the ship suffered **hull damage** below waterline - maybe in way of the starboard stabilizer fin box room or the starboard sewage tank compartment and the room was flooded.

The hull damage was probably due to a collision.

Figure 2.26.1 – Start of sinking before underwater hull leakage occurs

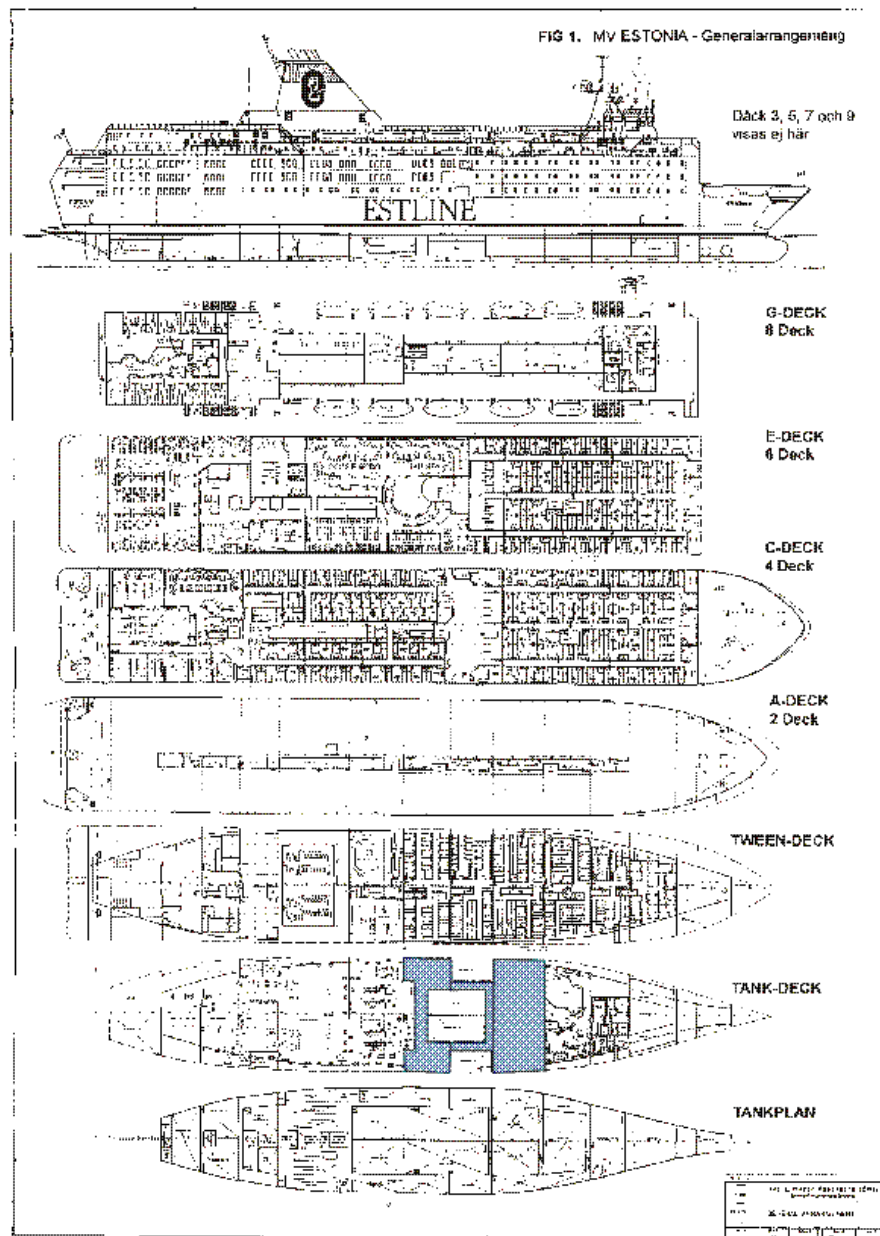
Two strong bangs had suddenly been heard all over the ship. The inflow might have been 100-200 ton/minute.

The effective open area of the damage was about 0,3-0,5 m². Apparently the watertight doors to the two forward or aft spaces were open - a corridor space - so that three compartments were flooded.

Figure 2.26.2 – Leakage – two, three compartments flooded!

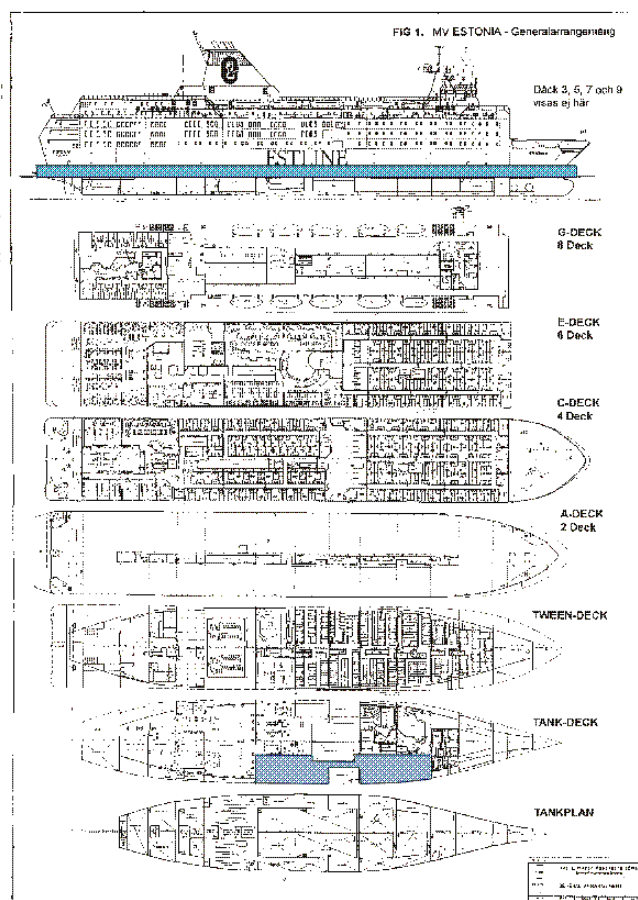
It is thought that the Master tried to close all watertight doors, but by mistake some doors were instead opened at about 01.00 hrs - to the generator room aft and to the swimming pool room forward of the flooded compartments on deck 0 (tank top) causing two strong bangs. Thus the water - say about 600-1.000 tons - in the flooded three compartments spread to five compartments - 120-200 tons in each. Then the ship lost its initial stability due to too large free water surfaces causing negative GM [2.17](#) .

Figure 2.26.4 – Stability lost at 01.02 hrs, vessel listing, water at starboard side on deck 0

The ship suddenly listed at 01.02 hrs and come to rest at about 01.05 hrs with a 15 degrees list. Alternatively it was the fracture in the shell plate that developed forward and aft so that the starboard heeling tank was suddenly flooded causing the sudden list. At this time the engine crew on deck 0 or 1 decided to evacuate to deck 8. All passengers were also evacuating. The ship was rolling strongly around the 15 degrees list position due to small GoM and, when the ship rolled to port, it was possible to walk across decks and climb up in stairs. When the ship rolled to 40 degrees starboard you had to hold on to something. The situation looked like shown above right with floodwater indicated in grey on the tank top. Strathclyde University has kindly pointed out that the ship cannot list more than 21 degrees in this terrible five-compartments flooded condition and this might be so.

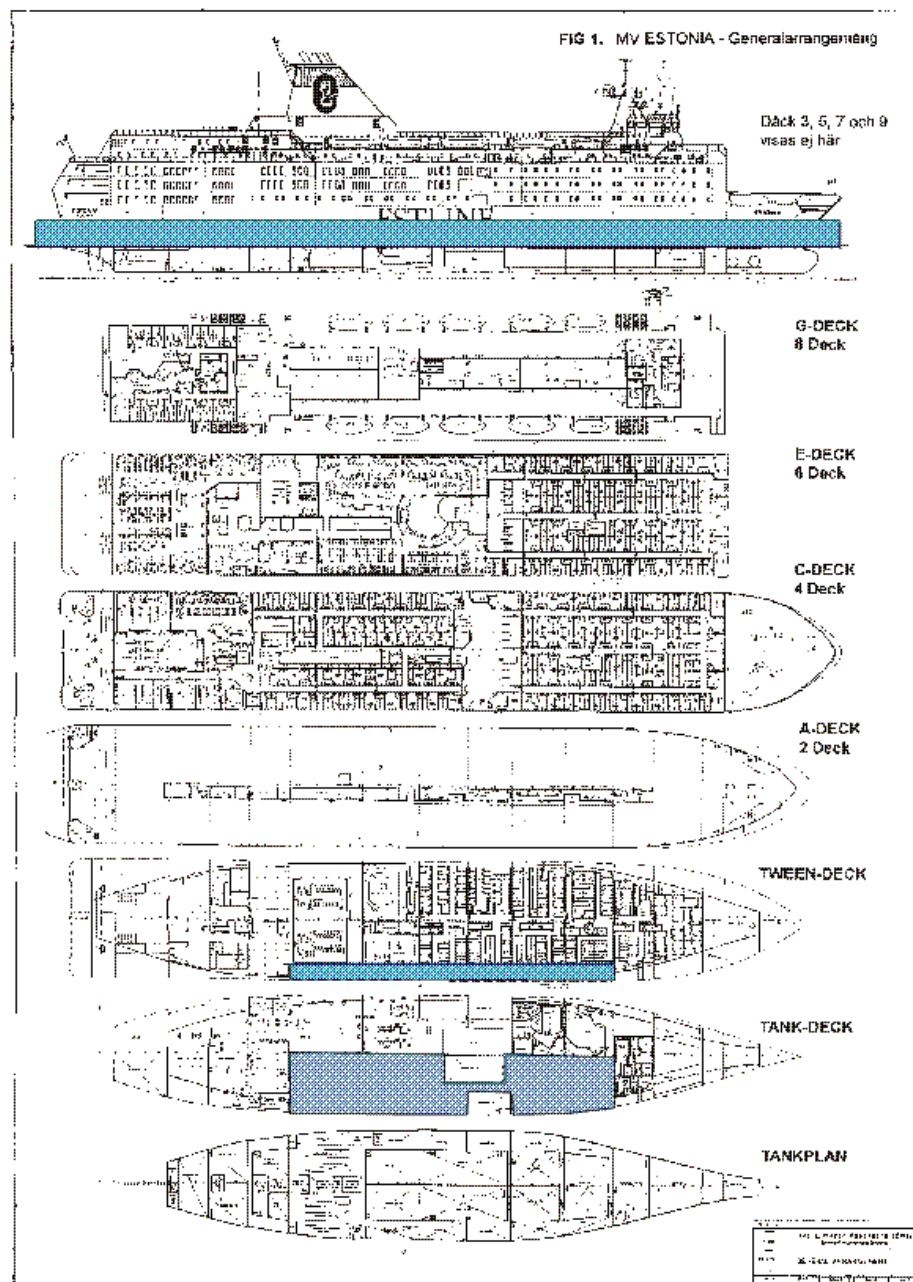
4. It is then thought that the watertight door in the centre line on deck 0 between the generator and engine rooms was also open and that water spilled into the main engine room at say about 01.12 hrs - six compartments flooding! The ship listed more and had 30 degrees list - but it was still stable with say 800-1 200 tons of water on deck 0. The ship was now floating with help of the weather tight *superstructure* - the car deck between decks 2 and 4. Ramp and visor were in place. Only little water flowed in at the forward ramp. The situation looked as shown right:

Figure 2.26.5 – Stable condition with water on decks 0 and 1

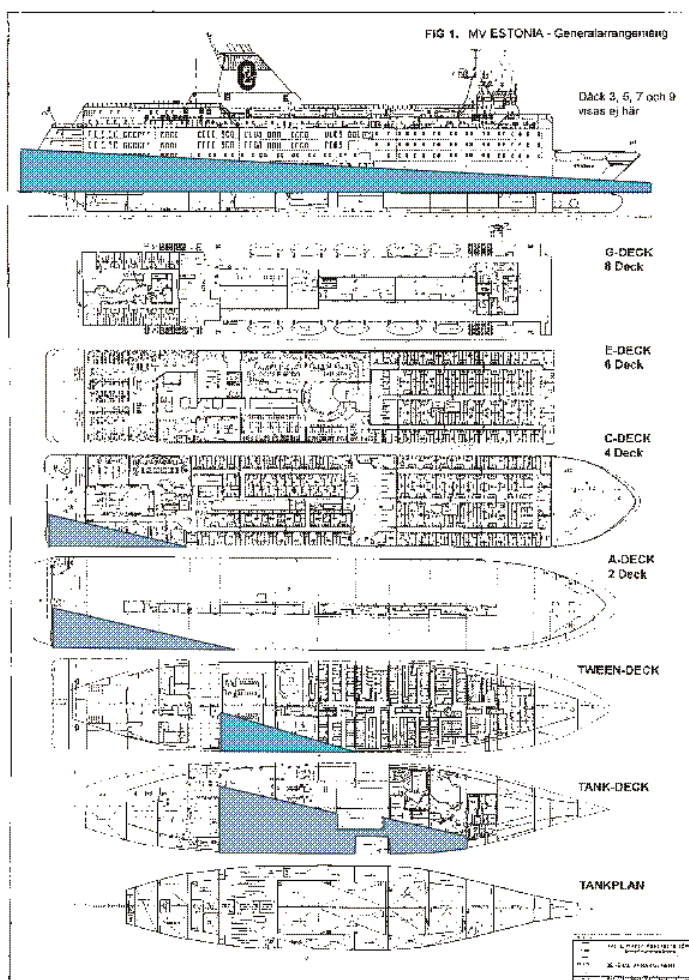
5. But more water flooded in through the leak and the list increased and deck 4 and above - the deckhouse - was flooded. The deckhouse was of course neither water- nor weather tight. What happened now was the following: as the ship listed the ventilator openings, say open area 0.5 m², on open deck 4 aft on top of the superstructure came under water and water flooded down through them onto the car deck 2 aft - say 200-300 ton/minute. As a result the ship started to trim on the stern, listed more and started to sink quickly stern first. Evidently the ship had been sinking since the leak started but now the situation was very serious. The water in the six compartments on deck 0 flowed to the stern. The situation at about 01.25 hrs may have been as seen right:

Figure 2.26.6 – Water on deck 2 (car deck) aft and trim on stern

The ship may then have regained stability. But the author thinks that the hydraulic pressure in the watertight door operating system was low due to stupid operations from the bridge and the doors were blocked in the open position.

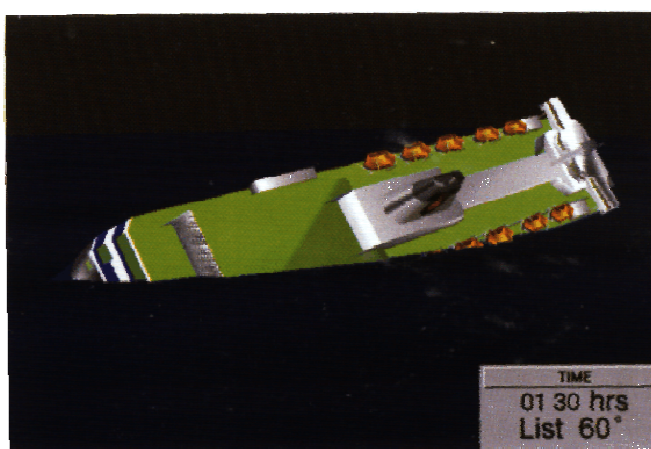
Then the ship was doomed. The deck house and car deck were flooded more than as seen on the figure right from the Final report (5). A ship can evidently not float in that position, but this the Commission suggests - the ship should have sunk 22 minutes later! The ship probably sank hitting the bottom already at say 01.32 hrs with the stern first, while the bow - probably with the visor in place - was above the water.

Figure 2.26.7 – From (5): Estonia sinks 20 minutes later!

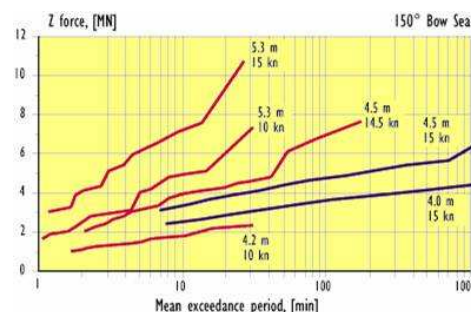
The Final report (5) has simulated the total load (the Z-force) acting on the Estonia visor. The simulation (blue in Figure 12.7 of (5) right) suggests it takes 800 hrs (!) before the Z-force is >6 MN (600 tonnes) upward in a seaway similar to that at the time of the accident (Beaufort 7 with 4,3 meter waves)! 6 MN is a very big wave load that you would not expect in the given weather. How could the Commission suggest that? It is not easy just to calculate [hydrodynamic forces](#) on a free floating body of known, uniform shape (a cylinder?) at zero speed in waves and it is even more complex to do the same on a fixed part (a visor) of non-uniform shape (with flare!) attached to a free floating, *moving* body. And that is without considering any **wave impacts** on it. An impact is not a hydrodynamic force.

Figure 3.2.1 – Z-force on visor; fig. 12.7 of (5)

You could also compare with Figure 12.7 in the Final report (5) (page 158) where above is stated to be plotted; every minute the Z force may exceed 2 MN, every two minutes the Z force may exceed 3 MN but you need 50 minutes - not 4 minutes - to exceed 6 MN. **Thus the results of Supplement No. 410 are not correctly copied in Figure 12.7 of the Final report (5).**

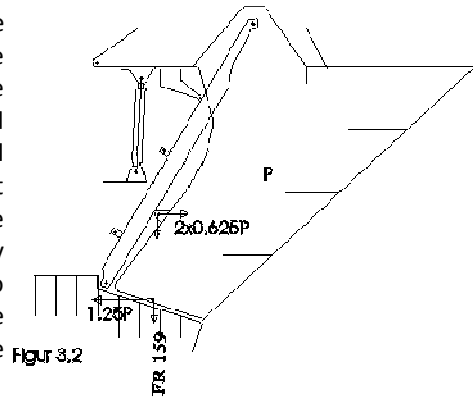
The vertical load P on the visor can only be transmitted to the *superstructure* and deck 2 via the three locks and as friction in the vertical packings as the visor is pushed aft into the packings by the locks and external waves. As the vertical buoyancy load is applied on the visor about 2,5 metres forward of the locks and the vertical distance between the side and Atlantic locks is about 2,0 metres - it is assumed that the visor is submerged into a big wave - it is simple to show that a vertical upward load P (generally visor buoyancy minus visor weight and inertia) tonnes on the visor is transferred to the locks as a compressive horizontal force $0,625P$ via each of the two the side locks and as a tensile horizontal force $1,25P$ via the Atlantic lock (ignoring friction in the packings). See figure 3.2 right.

A vertical load P pushing up the visor will always push the side lock visor lugs towards the *superstructure* and will always try to pull away the Atlantic lock visor lug from deck 2. **Therefore the side visor lugs were always in *compression* and the Atlantic visor lug was always in *tension* in service at sea.**

No load should have been transmitted via the deck hinges on deck 4 as there should have been a positive clearance between the visor hinge bush and pin - see figure 3.2.

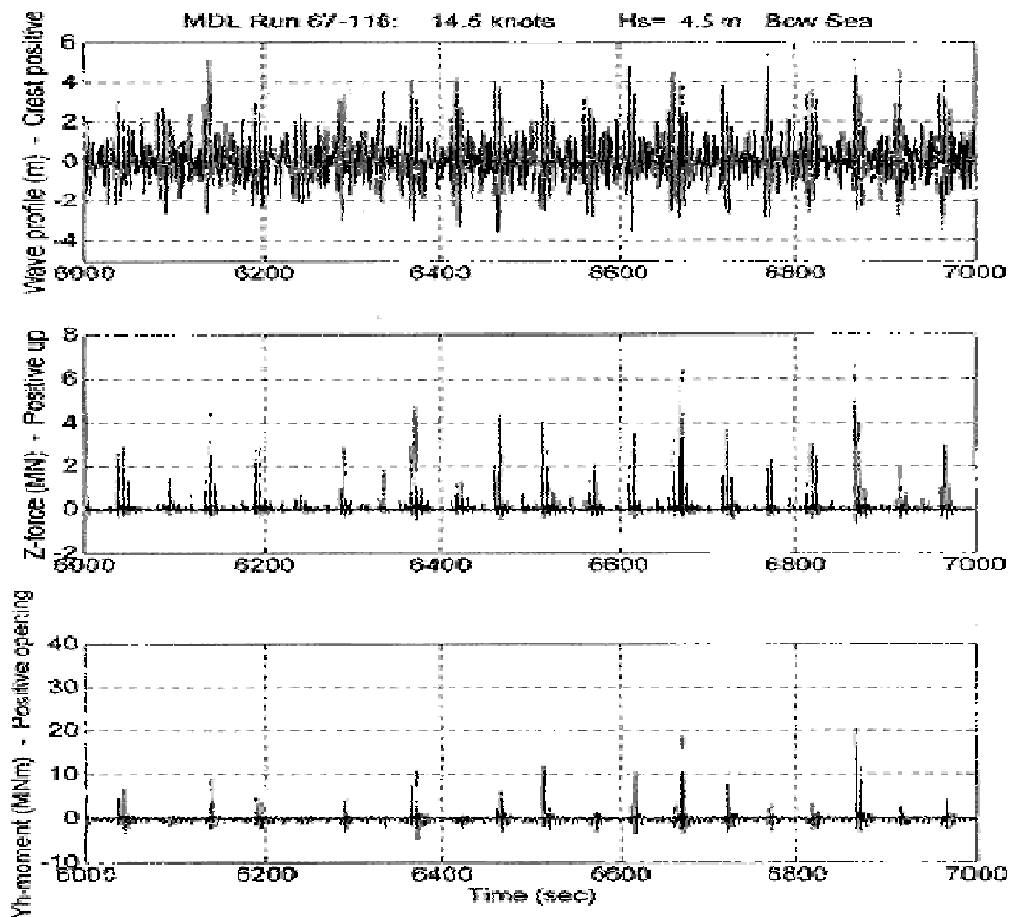
In Figure 12.3 in (5), reproduced below, is shown that only the vertical force (in z-direction) was >4MN (>400 tons) six times during 1 000 seconds of model test, i.e. every third minute the visor experienced a vertical (z-direction) impact force >400 tons. These big impacts apparently occur when the ship encounters big waves >6 meters (not very big actually) - the normal waves are about four meters high but seven, eight times in 1 000 seconds the waves are more than seven meters high - and every time there is an impact. The author has serious doubts about these model tests [Appendix 2](#) and considers the written report of the test as pure falsifications (the forces have been enlarged 5-10 times or did not exist at all).

There exists no method to extrapolate full scale forces from forces measured in model tests. The full scale Z force in figure 12.3 from (5) below is not proven (and as stated before - the model tests and the extrapolation to full size cannot be re-done by any independent scientist!)

The extreme loads in z-(vertical) direction on the visor, with 30 minutes respectively 10 hours mean exceedance period are, according table 12.3 (in 150° heading, 15 knots speed, 1 meter bow wave and 4.0 meters significant wave height) in (5) only 2.95 respectively 4.20 MN, i.e. much less than was measured in the model tests. In chapter 12.3 the Commission summarises above (table 12.5) that the most probable vertical (z-direction) load was 3.6 MN (about 360 ton) during 30 minutes. In chapter 15.2 - the summary - The Commission repeats that *the maximum resultant force* (on the visor was) *between 4 and 9 MN*, but adds that the maximum vertical load was only between 3 and 6 MN, in spite of a load of >4MN every third minute in model tests. No corrections were made for the weight of the visor or water inside the visor.

Figure 3.7.1 - Figure 12.3 in (5) - Example of time series from model tests

The Commission thus suggests that a vertical impact force (P - figure 3.2) of 360 tons (3.6 MN) pulled open the Atlantic lock at about 00.55 - 01.05 hrs - it might also have been the port hinge or a side lock that broke first even if the former did not carry any load, when the Atlantic lock was intact, and the latter was in compression, when the Atlantic lock was intact.

To me figure 13d (and also figure 12.3 in (5) above) seems faked. First it is never explained in the SSPA report how suddenly very big *impacts* occur against the visor - how and why solid water slams perpendicular against the visor plates and how the vertical component becomes every 4 minutes > 600 tons (full scale). An impact is not solid water! An impact is locally compressed air between the wave and the shell plate surface that suddenly escapes at a certain high pressure. Nevertheless - more or less at every pitching - every 6 seconds - the lifting force exceeds the visor weight in the model tests, which would mean that every 6 seconds the visor was lifted up from its supports - by compressed air? - and then came crashing down. But nobody heard these strange phenomena on the 'Estonia'. Evidently the model tests are faked. I am 100% certain about it.

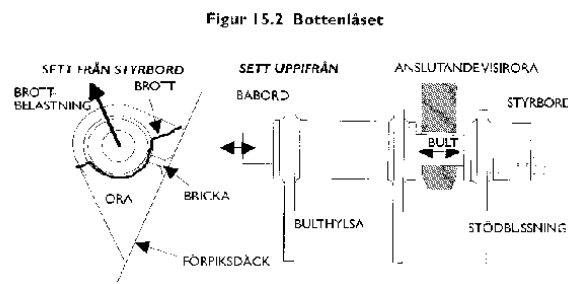
Figure 3.7.2 - Figure 15.2 in (5) Bottom locking device

The Atlantic lock looks as follows (figure 15.2 in (5)) right:

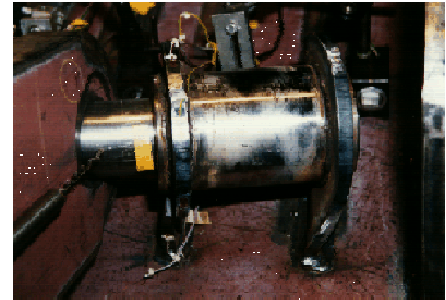
Evidently the visor lug itself will not bend, when the fore peak deck lugs are ripped apart. The damages to the forepeak deck lugs would look as seen in figures 3.7.6-7 below (where the bushings are completely incorrectly welded with only 1 mm to the lugs). Now on the wreck all three lugs were found ripped apart - and rusty! - and you wonder how it could have taken place. A logical explanation may be that the visor lug had been pushed against the port bushing by a transverse load, which pushed the bushing out of the lugs, and the lugs were later pulled apart as found. The weldings of the lugs to the bushings were also found rusty. The initial damage could very well have occurred *before* the accident on 28 September 1994.

Figure 3.7.6 Port fore peak deck lug (right) and the middle lug bent, when the starboard lug has been pulled apart

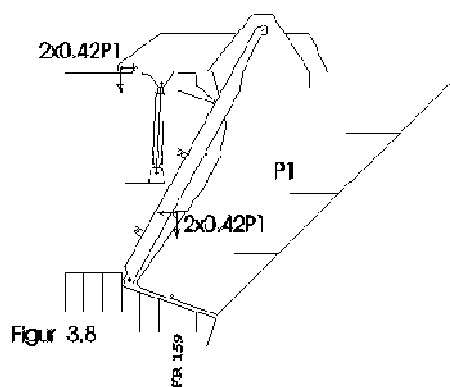
The Commission states (see chapter 15.3 in the Final Report (5)) that the load-carrying capacity of the bottom lock was insufficient to satisfy various requirements, but in fact the bottom lock was not required at all. The Commission invented that the Atlantic lock was required for the safety of the ferry while in reality it was only an extra reinforcement to *unload* the hinges. If the Atlantic lock was broken (at 00.55 hrs?), the horizontal loads in the side locks were reduced (from $0.625 \cdot P$ to $0.42 \cdot P1$), but the direction was changed - P1 caused a *tensile* load in the side lock lugs.

The Commission then states in the confusingly written Final Report that another impact load P1 (at 01.05 hrs?) on the visor caused another tensile load that pulled the side locks apart, i.e. the side lock lugs were ripped off out/sideways with parts of the visor aft bulkhead plating. Of course there is no evidence for that. It is another invention of the Commission!

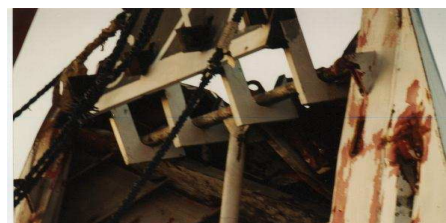
On other photos, e.g. right taken immediately after the salvage of the visor, the manual hook is however undamaged! The starboard hook - undamaged - is seen left in the picture.

Fig. 3.8.3 - Visor just after salvage - manual hooks

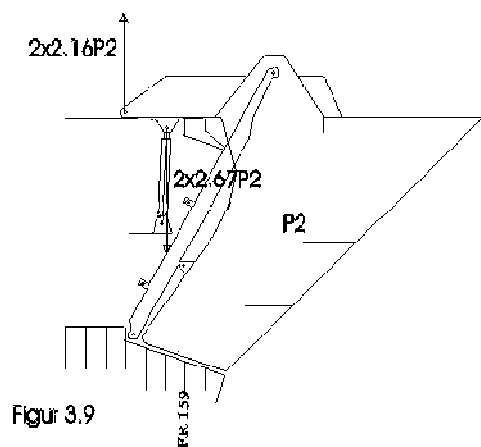
Figur 3.9

Assume that a vertical upward force P_2 now acted on the visor. This force P_2 causes a pulling force $2.67 \cdot P_2$ in each hydraulic cylinder and a compressive force $2.16 \cdot P_2$ in each visor hinge lug (see figure 3.9 right). The Commission suggested that the compressive force $2.16 \cdot P_2$ was enough to pull (?) or bend apart the hinge lug and that the pulling force $2.67 \cdot P_2$ was sufficient to pull the hydraulic cylinder from its support. Nobody heard, when these four attachment points were destroyed. Note that the hinge lugs are in compression (and there is bending of the arm), while the Commission early on had suggested that the hinge was pulled apart by a pulling force in the forward direction of > 700 tons. How could such a force develop. The Final report says little.¹¹⁰ In chapter 15.10 in the Final Report (5) is clearly stated that

"The load on the hinges ... is acting in an uncritical direction ...".

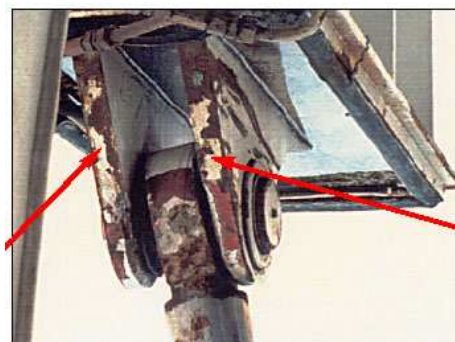
The port visor actuator lifting lugs below the visor arm and its lifting piston are shown in figure 13.10.1 right. The two lugs, where white paint is still visible, are alleged to have cut through steel!

And how could the cutting edge on the visor arm lugs cut structure 400 mm *below* the deck from *aft* to *forward*? The cutting edges of the lugs seem to have been in the air flat in line with the open weather deck no. 4 *above* the face !

Figure 3.10.1 - Visor *port* lifting arm lugs and actuator *after* the accident and *after* having cut through deck plates and deck beams. The paint on the lugs' forward and inside edges remains!

The pistons of the lifting hydraulics were still attached to the lugs. Did the round hydraulic cylinders or the round piston rods cut through the beam? The actuator piston is still painted white!

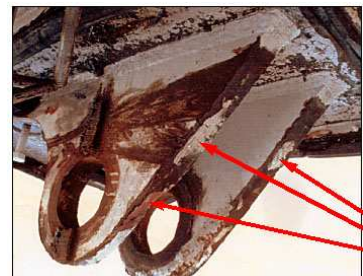
The vi No such marks can be seen. And evidently there should be more scrape marks inside the visor housing if it had been in touch with the ramp. And finally, there should be scrape marks on the starboard cylinder, if it had cut through the superstructure plate and beams. But its paint is undamaged.

Figure 3.10.8 Starboard visor actuator lugs below the visor arms after the accident and after having cut through steel. Note that paint remains at the forward and inside/outside edges.

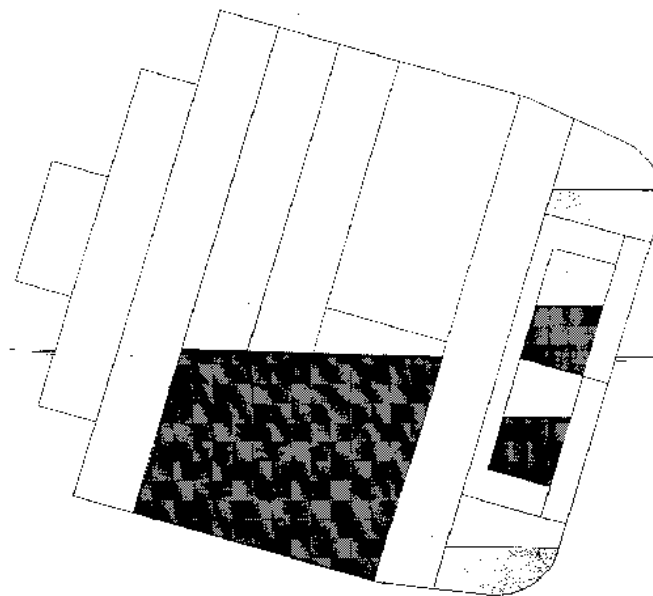
Figure 3.11.1 - Figure 4.19 of Supplement no. 504

The Commission suggests that decks 4 and 5 were flooded at starting 01.24 hrs and that deck 9 forward, the bridge, was flooded at 01.35 hrs, when the clock stopped. But the intermediate decks 6-8 were not flooded! **It is an obvious falsification!**

Figure 4.19 The equilibrium floating position of the ship for the case when the cardeck and decks between 4-6 are out. The cross-section is at the longitudinal coordinate $x=79.4$ m from the after perpendicular.

No calculations are evidently shown (unless it is figure 3.11.1 above (figure 4.19 of supplement no. 504)), because the 'Estonia' with 18 000 tons of water on board in the *superstructure* and *deckhouse* was unstable and should have capsized [2.16](#) much earlier.

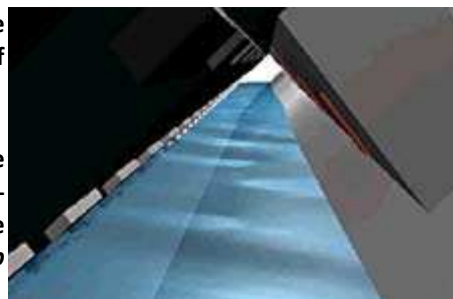
The water (>4 000 tons) on the car deck was not any longer on the deck (!) - it was of course on top of the starboard inner side [2.16](#) of the superstructure - see fig. 3.17.1 right.

That water could of course not (b) flow down to lower decks in the hull as suggested, etc. - it could only tip the vessel upside down - capsize. And how could 4 000 tons of water have entered the superstructure space in the first place, if the visor and the ramp were still in place at 01.20 hrs and the list was 50-60 degrees?

Fig. 3.17.1 - 40 degrees list with 2 000 tons of water in the superstructure. With 4 000 tons the list would be 50 degrees and the water would hit the underside of deck 4.

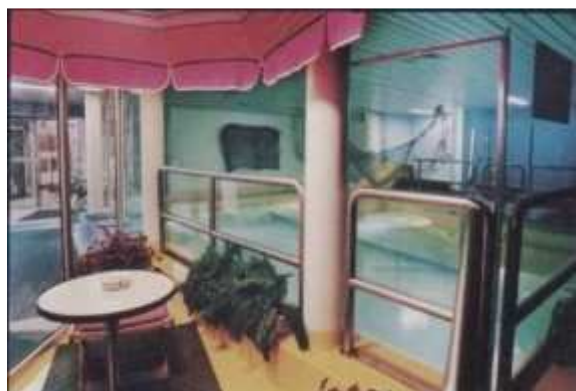
Fig. 3.18.2 – Swimming pool on 'Estonia' deck 0 recessed into double bottom
