DISASTER INVESTIGATION

All about the M/V Estonia disaster 1994

A contribution to better ferry safety at sea

© Anders Björkman, 2001 (and updated later), 2009

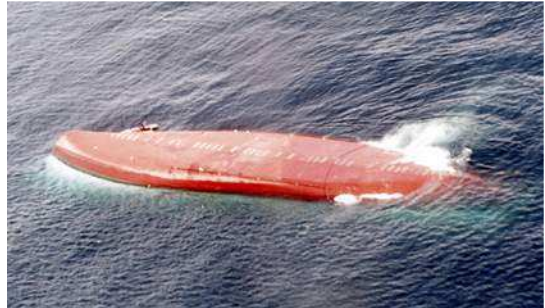
Fig. 3.21.1 – Ferry floating after capsizes

However, the Stockholm rule makers now assume that the ferry or passenger ship with the damaged hull *rolls* in *severe* weather with the side damage *towards* the wind and waves; that water flows up (sic) on the car deck into the *superstructure*, which is damaged i.w.o. the collision impact area above the waterline, and *collects* on the car deck and that; as a result, the ship *capsizes*, i.e. tips upside down and floats upside down as shown in figure 3.21.1. The assumed damage case is as follows:

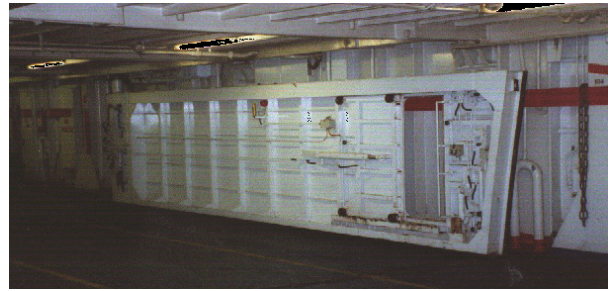
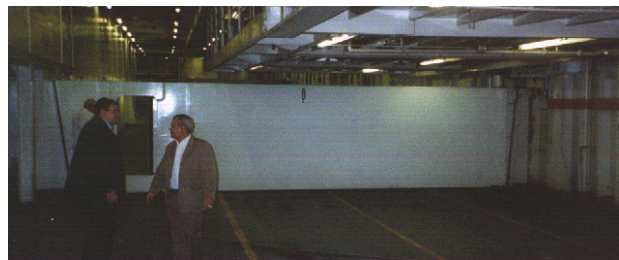
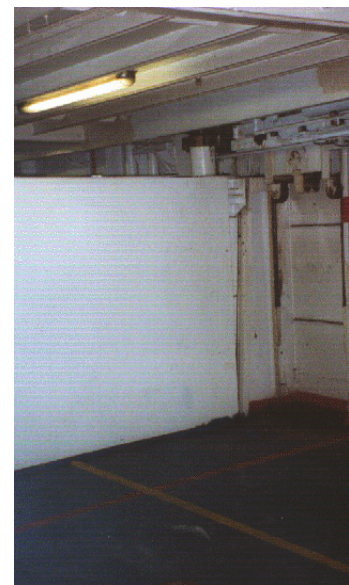
The cost to install watertight divisions varies depending on many variables - the number of divisions and other modifications, escapes, ventilations, fire protection, etc. An estimate is about SEK 25 million per ferry and total cost at least SEK 2 000 millions. **Norway** applied the rules ahead of all others based on the theoretical assumptions and forced its owners to install barriers based on the theoretical assumptions. The pictures are an example of such folly.

Figure 3.21.2 - Movable 'watertight door/bulkhead' in the side of the superstructure

Figure 3.21.3 - The movable 'watertight' bulkhead in the superstructure in closed position

Figure 3.21.4 - The movable 'watertight' bulkhead at the side

Does it look safe? Later, 2002, the IMO has proposed that the car deck doors shall be watertight at the top - this amendment may come into force 2004 or 2005 - and then all the Stockholm agreement ferries have to be re-built again.

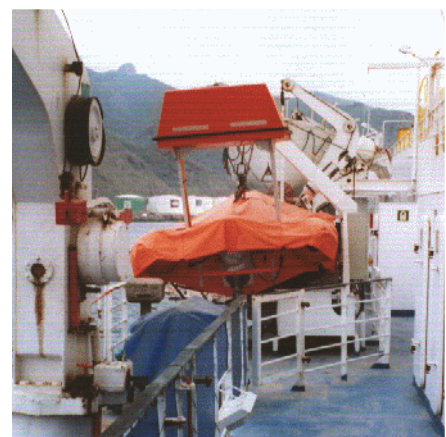
Figure 3.21.5 - New, fast rescue boat on a ferry. It cannot be launched in severe weather

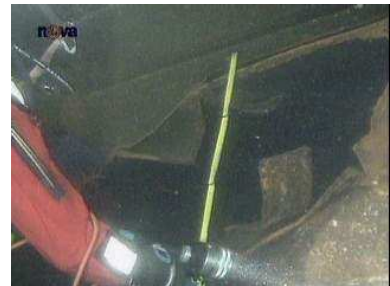
Figure 4.1.1 – Undamaged front bulkhead according to Lehtola!

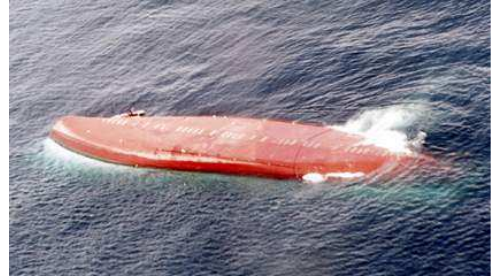
Figure 4.5.1 Result of capsizing! Vessel floats upside down!

Then they decided that the 'Estonia' *slowly* sank due to water in the *deck house* (!) - in spite of the fact that the 'Estonia' should have floated upside down on the intact watertight subdivision in the *hull* below the car deck/*superstructure*, when the deck house was flooded. Totally false stability calculations were produced - and published [3.12](#)!

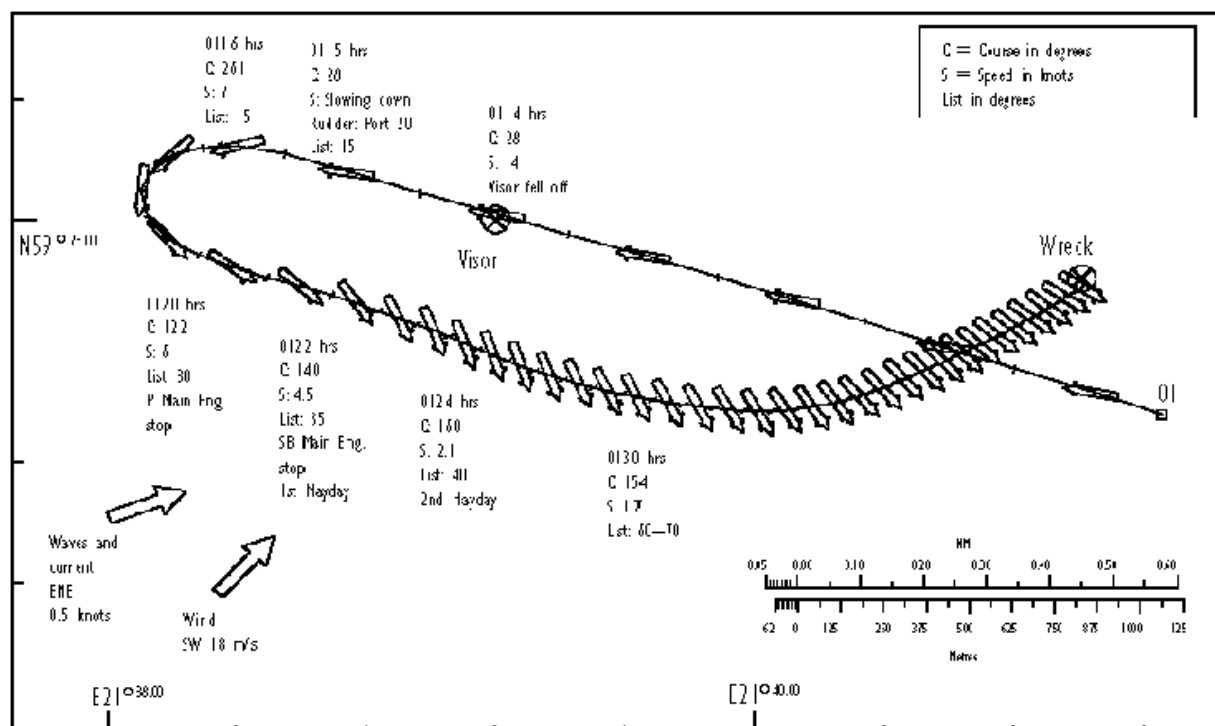
Figure 13.2 - Course of events - of the Final Report is shown below: -

So the Commission took the figure 4.12 in supplement no. 522 of (5), produced by Huss/Rosengren, and shamelessly changed all angles of list/times to '*suit*' (e.g. the manipulated testimonies of the crew [1.48](#)) - which

is the figure 13.2 above in the Final report (5) - with no considerations to the physical relationship between angle of list and amount of water on the car deck in the *superstructure*. Otherwise figures 4.12 in supplement no. 522 and 13.2 in the Final report are identical!

That Dr. Huss, FRINA, and Captain Rosengren at this occasion didn't resign from the Commission is a mystery. Then they had a golden opportunity to leave the Commission with some honours. But Dr. Huss never resigned, and surprisingly, he still defends (see below) the above manipulated figure 13.2, which is only a manipulated version of his own plot/figure 4.12 in his report; supplement no. 522. Why - [2.7](#)?

Figure 13.2 in the Final Report is a sloppy modification of figure 4.12 in supplement no. 522 to the Final Report by Michael Huss, Ph.D., 'Simulation of the Capsize', which in turn was a theoretical failure trying to reconstruct the accident by the Marine Academy of Kalmar. The modifications between Huss (H) and the Commission/Final report (5) concern, i.a. the angle of heel and the amount of water on the car deck at various times after the visor was lost as shown in the below table: -

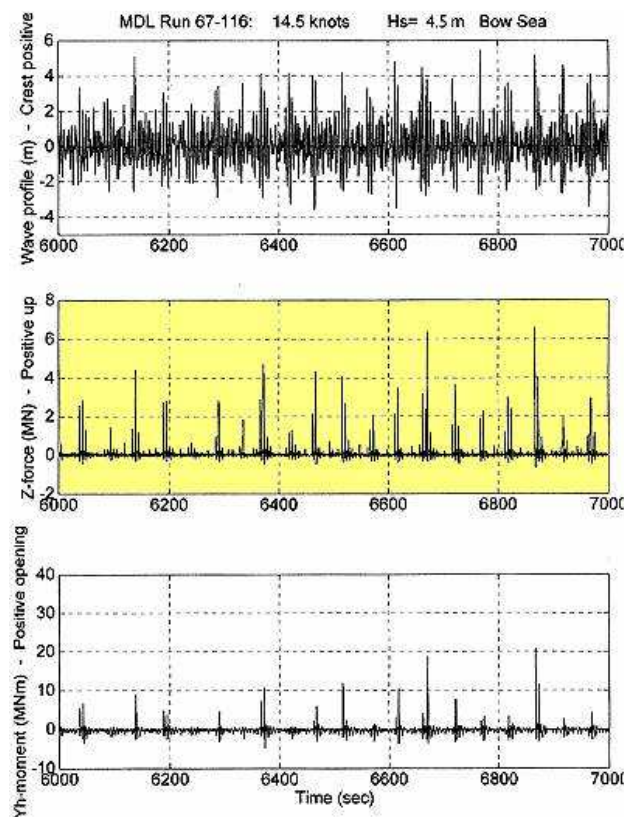
Figure 12.3 of (5)

In Figure 12.3 in (5), reproduced below, is shown that only the vertical force (in z-direction) was >4MN (>400 tons) six times during 1 000 seconds of model test, i.e. every third minute the visor experienced a vertical (z-direction) impact force >400 tons. These big impacts apparently occur when the ship encounters big waves >6 meters (not very big actually) - the normal waves are about four meters high but seven, eight times in 1 000 seconds the waves are more than seven meters high - and every time there is an impact. The author has serious doubts about these model tests [Appendix 2](#) and considers the written report of the test as pure falsifications (the forces have been enlarged 5-10 times or did not exist at all).

There exists no method to extrapolate full scale forces from forces measured in model tests. The full scale Z force in figure 12.3 from (5) below is not proven (and as stated before - the model tests and the extrapolation to full size cannot be re-done by any independent scientist!)

12 wave loads (8%) between 2 and 3 MN (still **impacts** because the duration is short) and

16 wave loads 10.7%) between 1 and 2 MN in the upward direction (also short **impact** loads).

The remaining wave loads - about 100 off (67%) - seems to have been smaller than 1 MN. Thus big wave loads - **impacts** - were very frequent according to this test -

To me figure 13d (and also figure 12.3 in (5) above) seems faked. First it is never explained in the SSPA report how suddenly very big *impacts* occur against the visor - how and why solid water slams perpendicular against the visor plates and how the vertical component becomes every 4 minutes > 600 tons (full scale). An impact is not solid water! An impact is locally compressed air between the wave and the shell plate surface that suddenly escapes at a certain high pressure. Nevertheless - more or less at every pitching - every 6 seconds - the lifting force exceeds the visor weight in the model tests, which would mean that every 6 seconds the visor was lifted up from its supports - by compressed air? - and then came crashing down. But nobody heard these strange phenomena on the 'Estonia'. Evidently the model tests are faked. I am 100% certain about it.

You should look at the time series of the model tests, e.g. figure 12.3 of (5) and figure 13d of supplement no. 410. Suddenly - **within a fraction of a second the vertical Z force changes from 0 to say > 6MN (600 tons!)**. This change is evidently **not** due to (a) a sudden change in the weight of the visor (0.53 MN constant), or (b) the inertia force (it changes slowly 0.2-0.3 g = 0.12-0.18MN with the motion period), or (c) the hydrodynamic force (max 0.12-0.15 MN), or (d) the hydrostatic buoyancy force (max 0.4-0.5 MN) opposing (a) or (e) the Froude-Krylov force or (g) the stationary flow force (negligible).

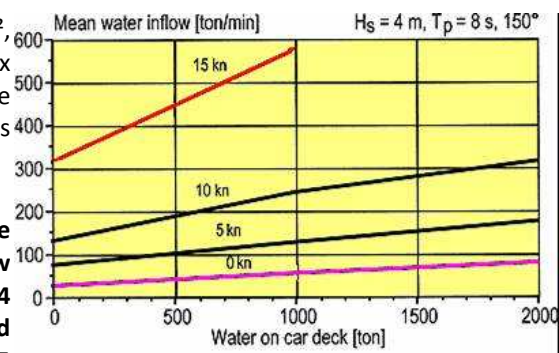
It means that total inflow in regular seas is 1 891 tons/minute with speed forward! According Huss (supplement 522 figure 4.2) the inflow is only 270 tons/minute. Hull falsifies the inflow by a factor of seven! In reality the inflow is probably much larger. The first 180 tons inside the superstructure trims the ship on the bow but has no time to flow out, the relative motion changes and the ship bow opening remains *longer* below water, more water flows in - the ship goes down like a submarine. It can easily be verified with model tests.
