LIES AND TRUTHS ABOUT THE M/V ESTONIA ACCIDENT

Anders Björkman ©

January 1998

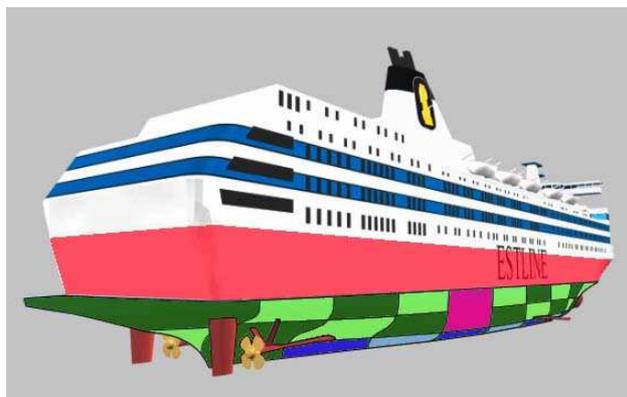
On top of the hull the 'Estonia' had a weather tight *superstructure* (marked red in the figure above) where you loaded trucks and cars - the car deck or garage.

On top of the superstructure is the *deck house* (white with blue stripes in the figure above) where most passenger cabins and public spaces were located.

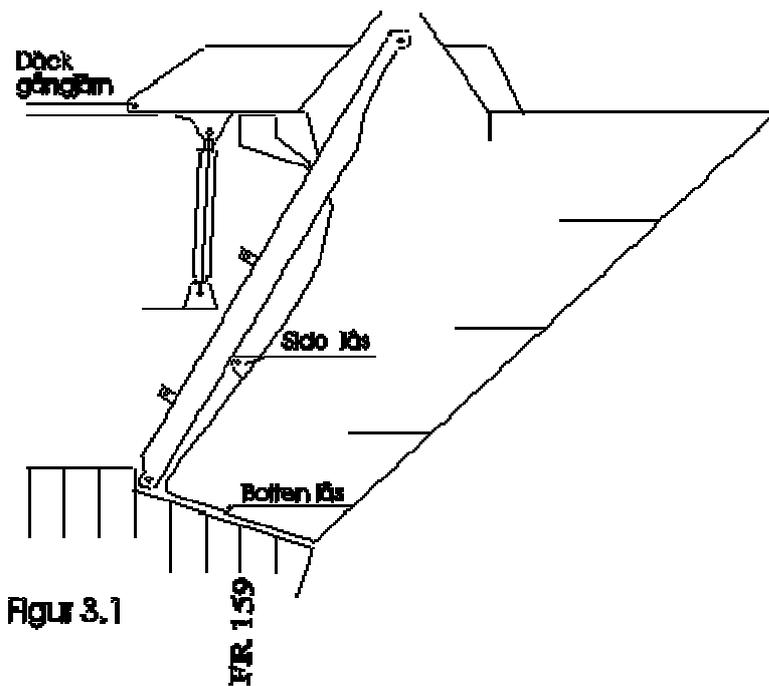
Figur 3.1

The visor of the 'Estonia' was of very simple and basic recognized design. See figure 3.1. The visor consisted only of steel plates and stiffeners supported by three tiers of horizontal girders and the upper deck and a bottom horizontal support girder and some vertical web frames. The total weight was about 55 tons.

The visor was held in place against the hull by three locks - two side (sido) locks and one bottom (botten) - Atlantic - lock. The function of the locks was generally to transfer the vertical wave/buoyancy load on the visor to the hull. Without the three locks the visor would otherwise flip up around the deck hinges by the vertical wave/buoyancy load. The locks were of basic design. Each lock consisted of a lug on the visor, which fitted between two bushes of a locking pin assembly on the hull. The two bushes of the locking pin assembly were held in place by lugs or hull plates. A pin held by the bushes would lock the visor lug. The pins were hydraulic operated. When the pins were engaged, they activated limit switches, which in turn activated the green light on the control panel to the effect that the locking pins had been pushed into the locks and the visor was locked. Evidently the locks could not transmit sideways loads.

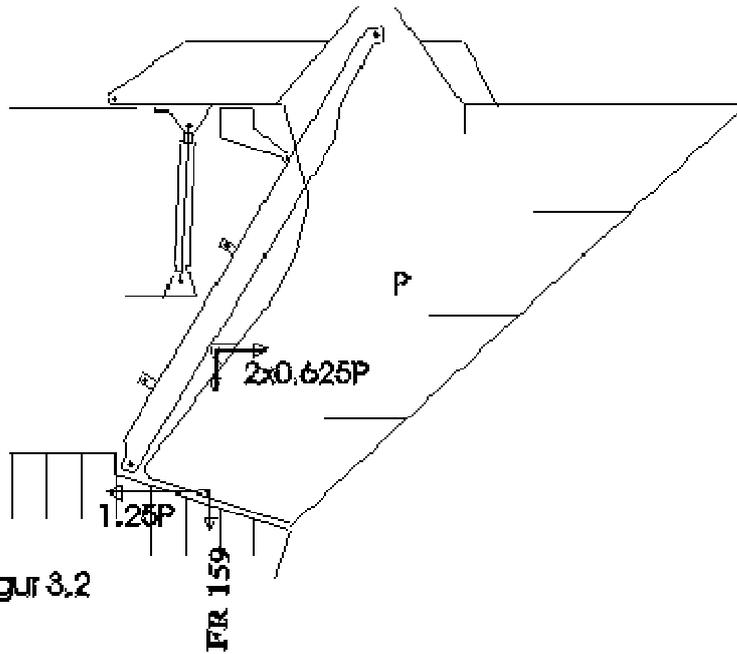
Figur 3.2

External loads act on the visor at sea, when the visor is submerged into the waves, when the ship pitches and heaves. The principal vertical load is buoyancy, when the visor is submerged by the ship's motion. The vertical buoyancy load is mainly a function of the volume of the visor (about 165 m³) and to a less extent the velocity of submerging the visor. Another vertical load, which may act on the visor, is an impact (slamming) load of transient nature. It depends a lot on the speed and course of the ship and the shape of the visor and the angle between visor and waterline.

The vertical load P on the visor can only be transmitted to the hull via the three locks. As the vertical buoyancy load is applied on the visor about 2.5 meters forward of the locks and the vertical distance between the side and Atlantic locks is about 2.0 meters, it is simple to show that a vertical upward load P (generally buoyancy minus visor weight) tons on the visor is transferred to the hull as a compressive horizontal force $0.625P$ via each of the two the side locks and as a tensile horizontal force $1.25P$ via the Atlantic lock. See figure 3.2

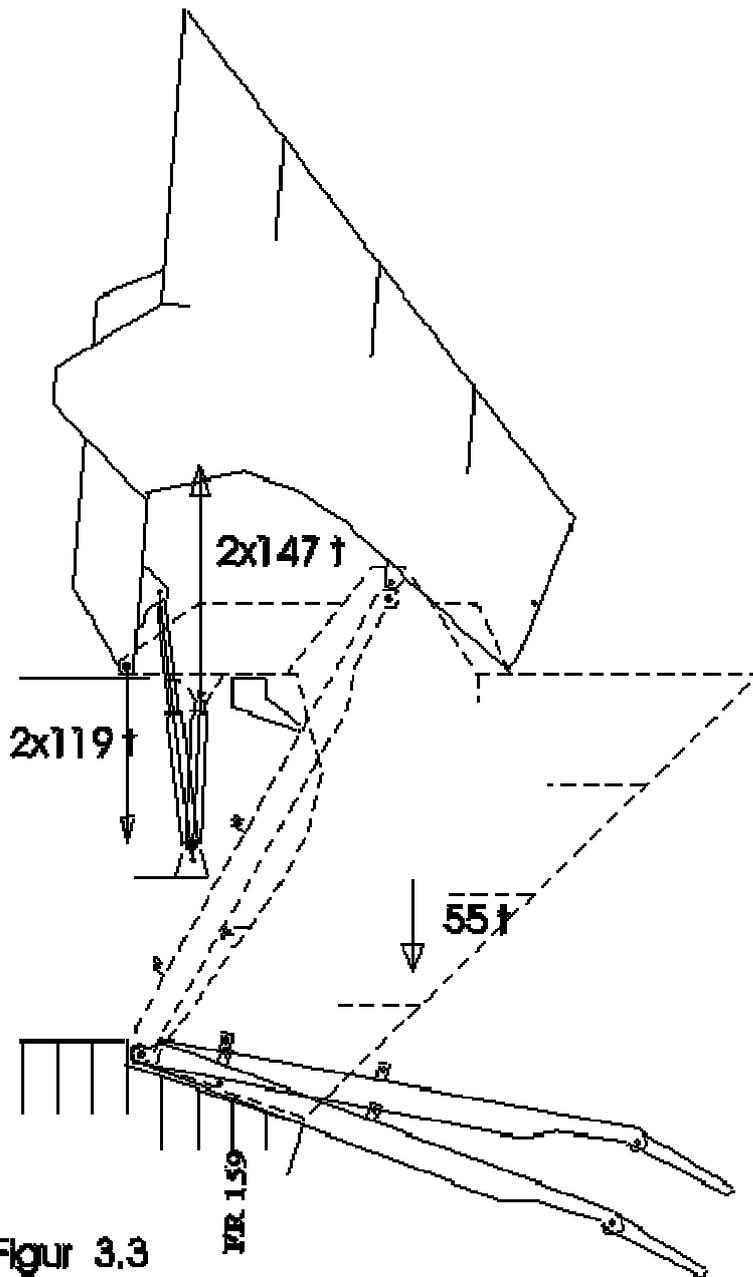
Figur 3.3

The function of the visor is very simple. The hydraulic locking pins are pulled out by remote control and the visor can be pushed up and be opened by two hydraulic pistons acting on the visor lifting arms connected to the deck hinges. See figure 3.3 below. To push up the visor you need initially a total force of the hydraulic pistons of abt. 293 tons (147 tons per piston). The force acting on each deck hinge is then about 119 tons, even if the hinge was designed to easily handle 200 tons. As the visor is lifted up, the required lifting force is reduced (as the bending moment in the lifting arm is reduced) and thus also the force on the hinge is reduced. Thus - the maximum force acting on each deck hinge - 119 tons - is applied, when the opening starts or the closing ends.

Closing the visor is evidently the reverse operation. Just before the visor comes to rest on its supports, the maximum force on the deck hinge is again experienced. The load on the hinge becomes zero, when the visor rests on its supports. When the three visor locks are thereafter engaged, the visor should in principle have been pushed against the rubber seals around the visor and there should have been no clearances in the three locks, while there should have been a little clearance at and in the hinges. The vertical (upwards) load on the visor would then be transmitted to the hull only via the locks at sea.

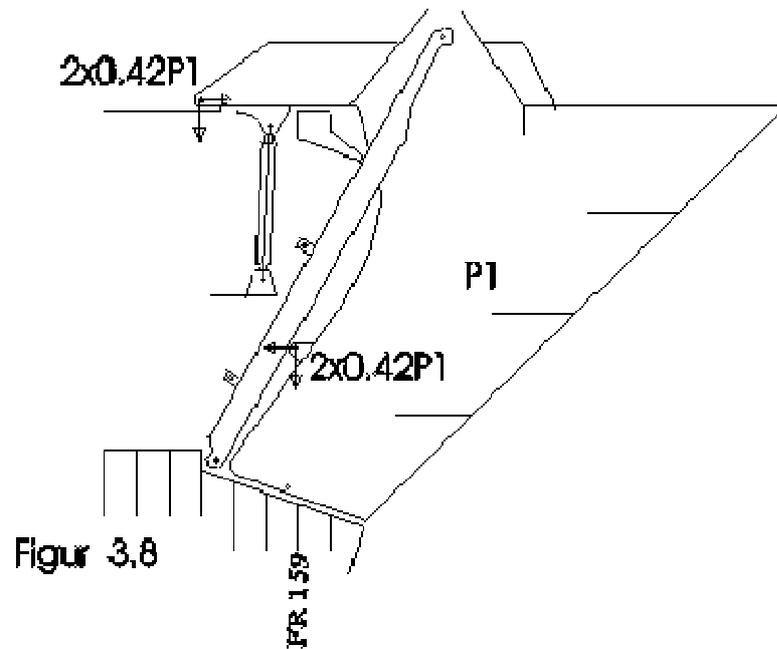
3.8 THE JAIC DAMAGE ALLEGATIONS - THE SIDE LOCKS

Immediately after the Atlantic lock fails as alleged by JAIC, the load transmission between visor and hull changes. A vertical load on the visor should now only be transmitted via the side locks and via the deck hinges.

It is simple to show that a vertical load $P1$ on the visor is transmitted as $0.42 \cdot P1$ horizontally at each lock and hinge. The load is generally tension in the side visor lugs and compression in the visor hinge arms. See figure 3.8. Actually, you can see that the Atlantic lock was not required in the first place as the visor is held in place by two side locks and the deck hinges. This was the way bow visors were built in the beginning (1960's) - two side locks and two deck hinges. The Atlantic lock was added later to un-load and to reduce wear and tear of the deck hinges.
